Overview

The Newington Town Hall roofs consist of three types of roofing systems. Asphalt architectural shingles are on the steep slopes. A multi-ply asphalt built-up membrane with a gravel coating is on the flat roof decks of the original construction as well as the earlier additions. There is also an EPDM rubber roof with a ¼ inch per foot slope on the newest addition. The asphalt shingles and the multi-ply asphalt roofs appear to be a minimum of 15 years old.

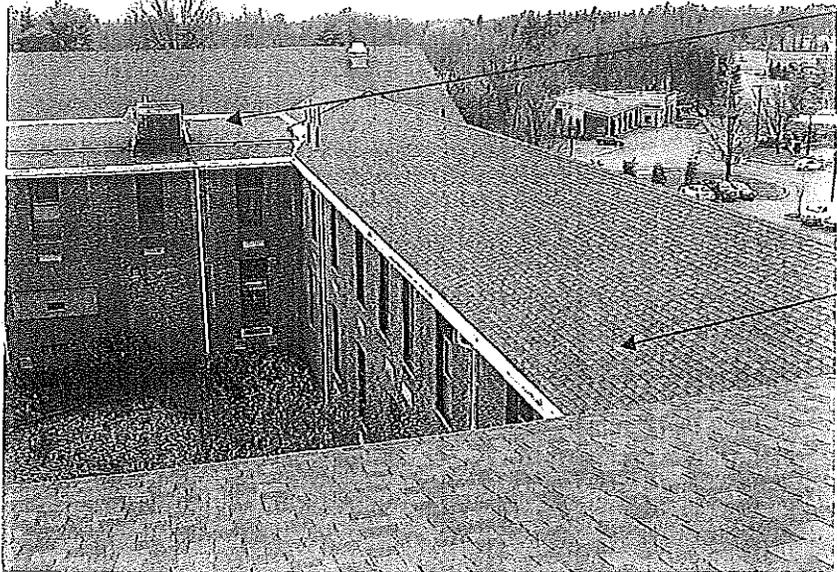
Multi-ply asphalt built-up membranes with gravel coating on flat roof deck

Asphalt architectural shingle roof on steep sloped decks

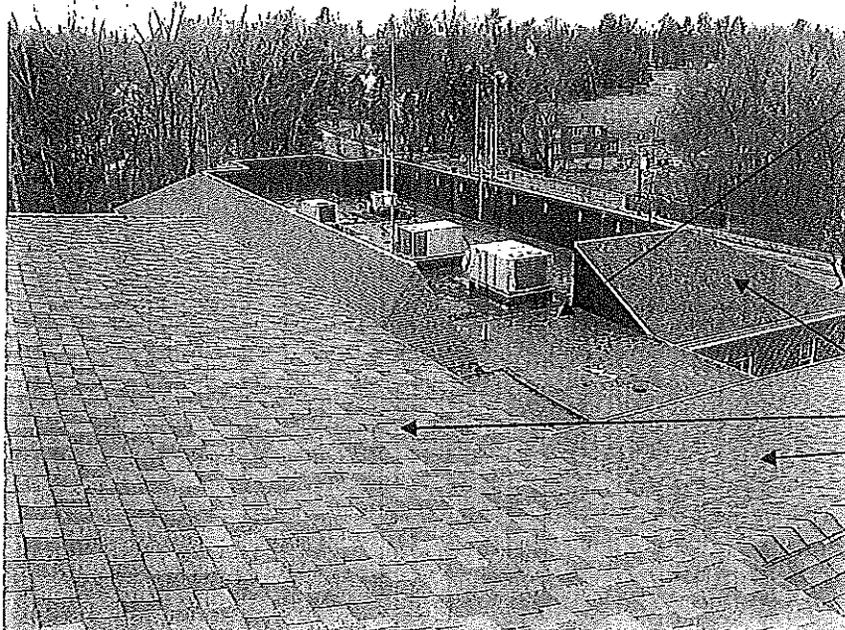
EPDM rubber roof membrane on 1/4 inch per foot slope on New Addition

Asphalt architectural shingles on steep slopes

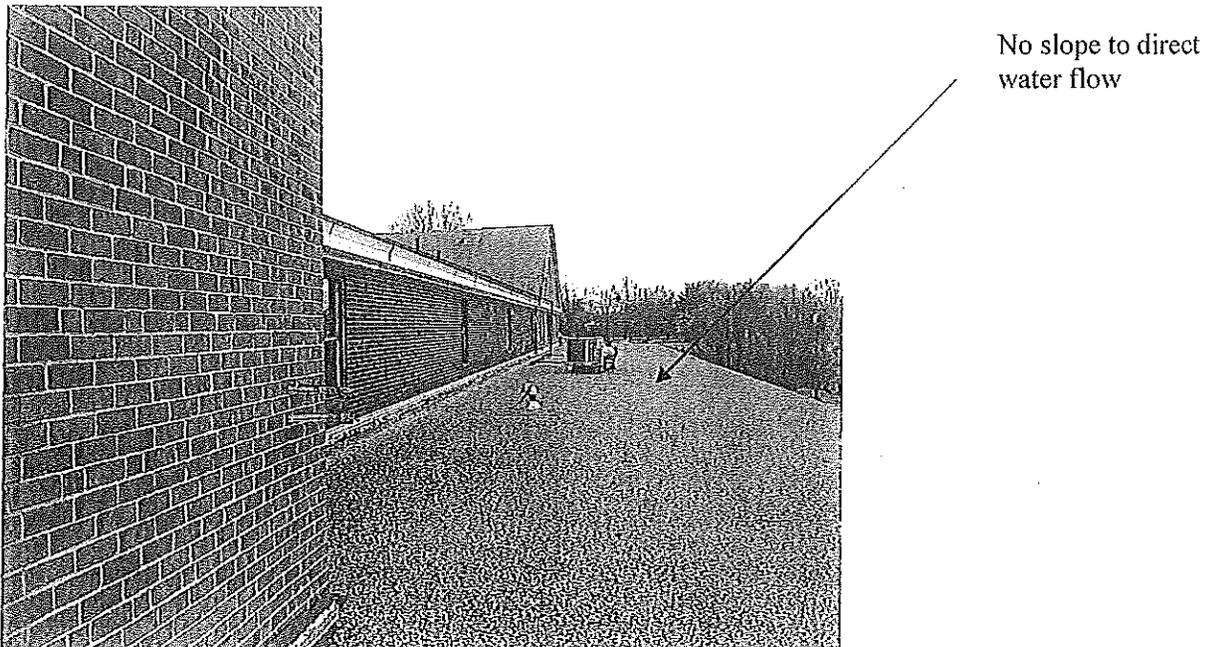
The multi-ply asphalt built-up membrane roofs on the original construction were installed on roof decks that are totally flat with no slopes to direct water flow.

The existing multi-ply built-up asphalt roofs have reached the end of their expected life cycle. The roofs must be removed down to the decks and replaced with a new 20 year warranty single-ply membrane system with a 1/4 inch tapered insulation layout to improve water management and eliminate the ponding water. Where possible additional drains should be provided and at other locations where new drains are not possible because of existing conditions, a better designed gutter system should be installed to increase the capacity and efficiency of the roof drainage system drainage. In addition the height of the steel dunnage supporting the roof top equipment should be raised to a minimum height of 18 inches clear above the roof line to allow for inspection of seams and roof repairs.

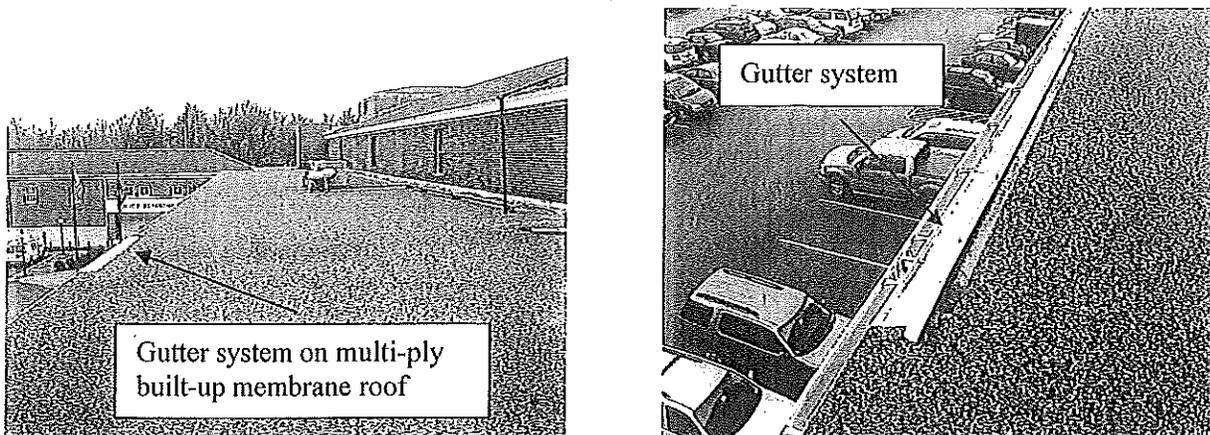
The roofs on the original building have no drains. They rely exclusively on a system of perimeter gutters and downspouts which appear undersized and incorrectly proportioned to handle the volume of water coming off the roof surface.

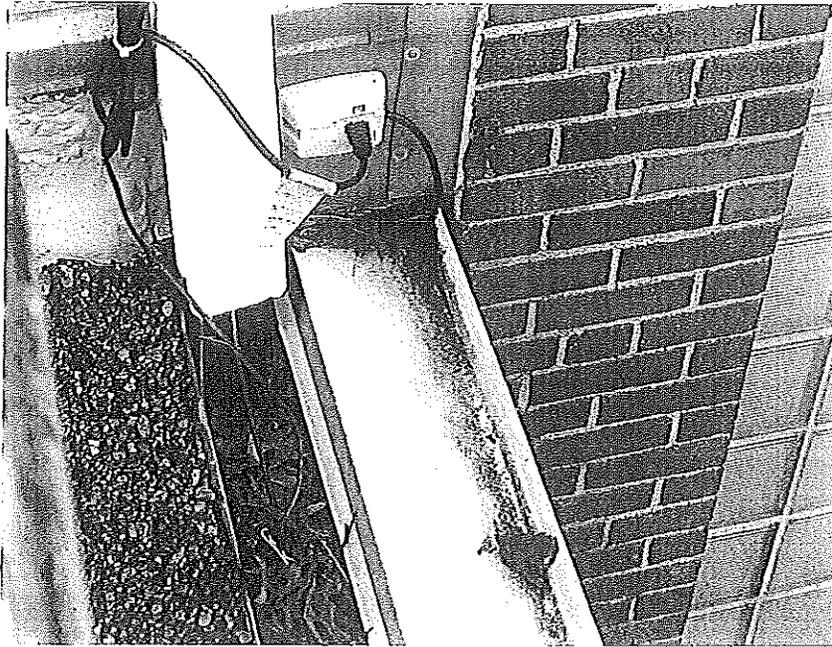
The gutters typically fill with leaves and gravel which is washed from the roofing surface blocking the gutters and reducing their capacity.

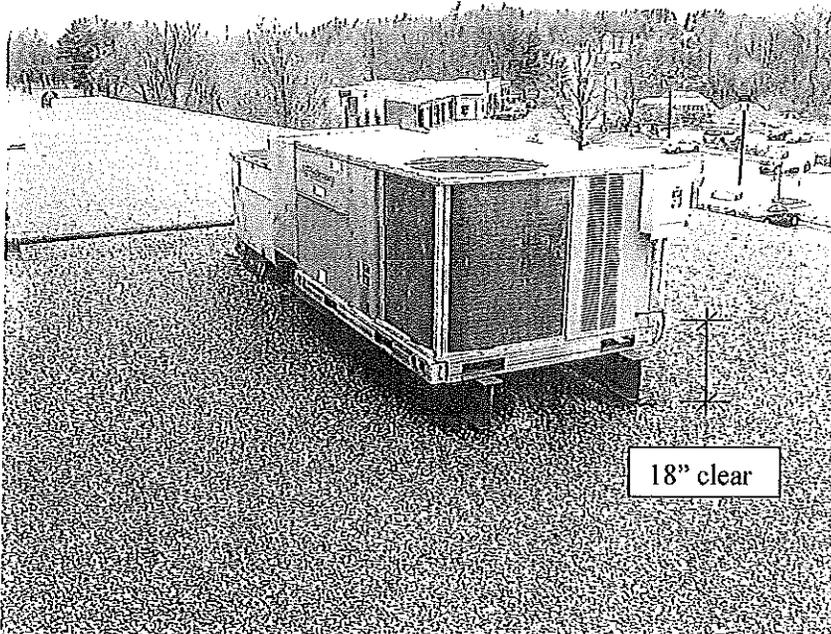
The steel dunnage which supports the roof top mechanical equipment were installed too low to the roof surfaces to allow sufficient height for roof repairs that might be required beneath the unit. The roofing industry recommends a minimum of 18 inches clear between the bottom of steel and the roof surface.

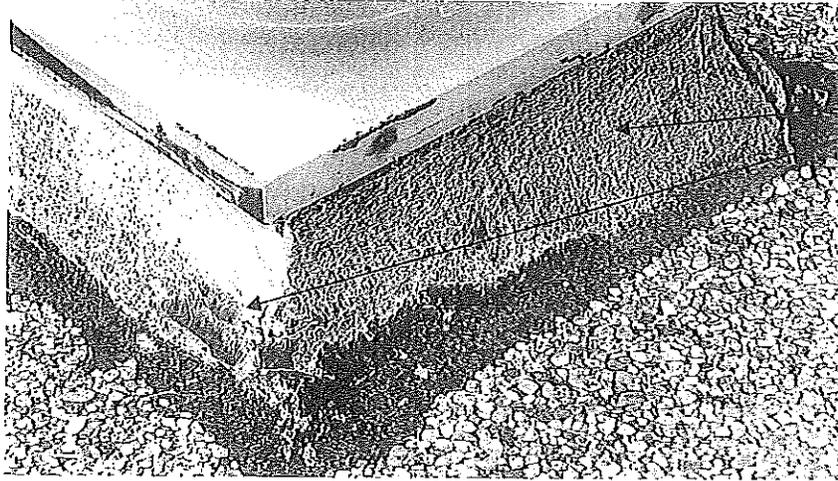
The membrane flashings around the mechanical equipment curbs are deteriorated and have lost their protective asphalt coating exposing the fiber reinforcement scrim which wicks water into the system.

Exposed reinforcing scrim on the membrane flashing

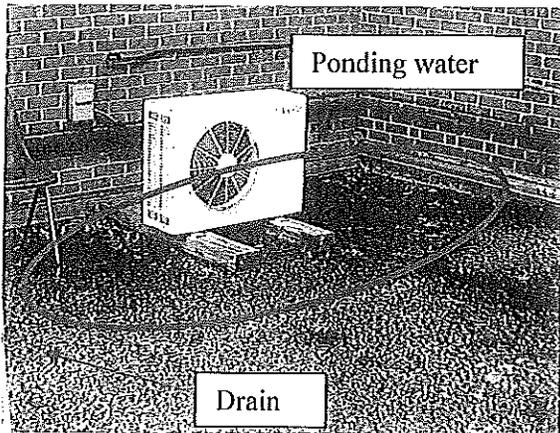
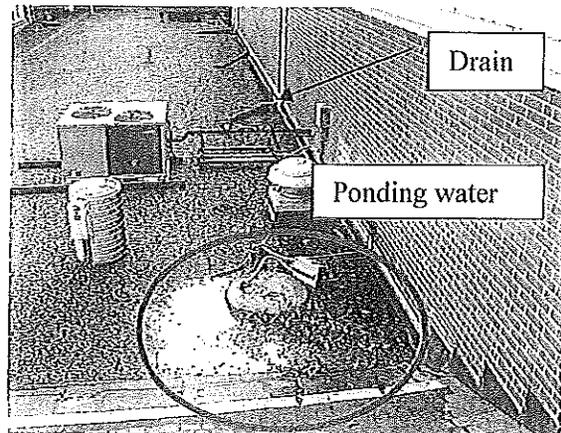
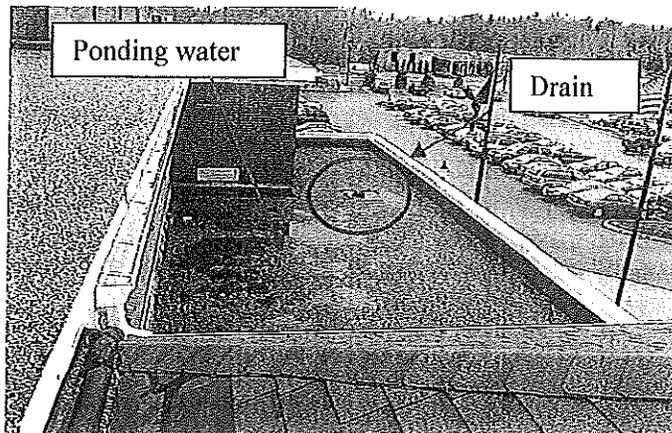
The multi-ply asphalt built-up membranes on the 1970's addition have drains, however, the roofs are not sloped to the drains and consequently many areas have ponding water which deteriorates the seams and allows water to enter the roofing system.

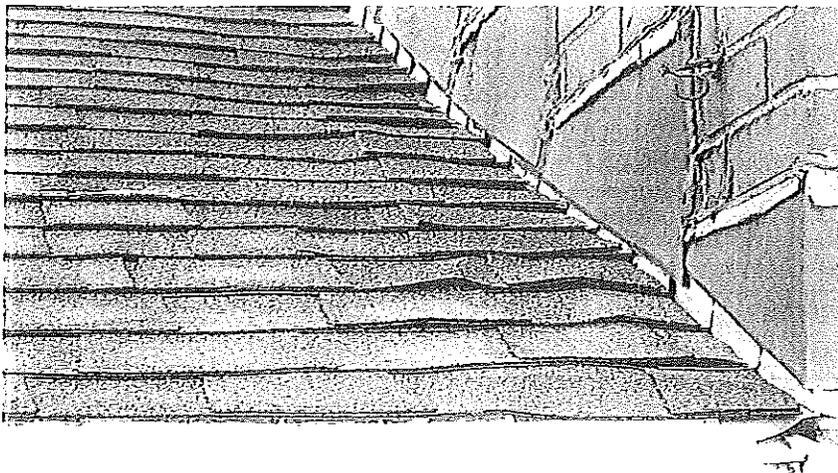
The shingles are not secured tightly to the deck due to the poor pull out resistance of the substrate causing leaks to occur because the shingles are lifting and curling.

The shingle roofs were not installed on an acceptable nailable substrate nor were they vented adequately, consequently the shingles leak as they move, lift and curl on the surface of the roof. The only solution to this problem is to remove the shingles down to deck and install an acceptable prefabricated, vented, nailable substrate designed for this purpose before installing a new architectural asphalt shingle roof assembly. The new design must include zinc coated copper valley flashings and proper ventilation at the eaves and ridges to insure the longevity of the new shingle roof. The project should also include a new system of gutters and downspouts sized to meet the roof's requirements.

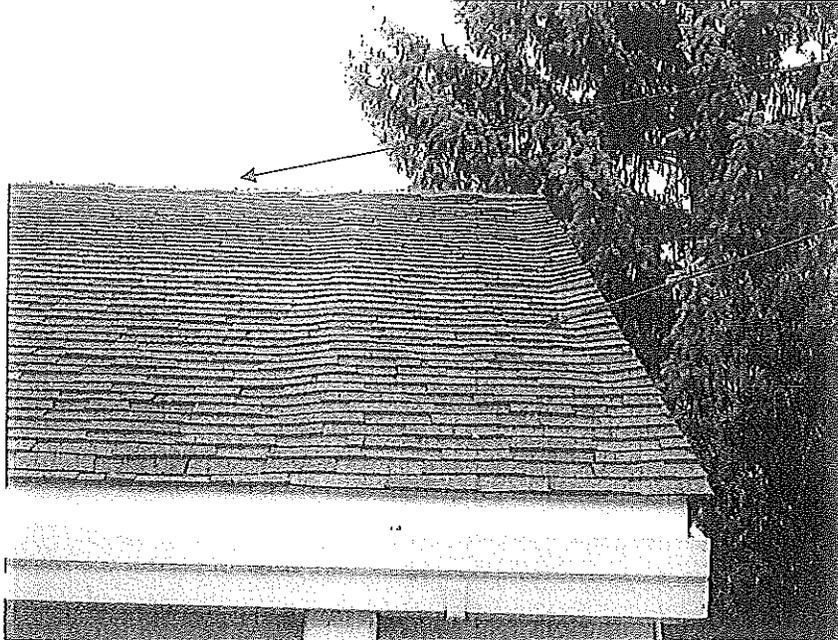
No factory recommended ridge vents were observed. Ridge vents are typically specified to help to prolong the life span of a shingle roof installation by preventing excessive heat in the attic space that causes the shingles to dry out and deteriorate. In addition, soffit vents which help create a fresh air flow into the attic space are inadequate or nonexistent contributing to the accelerated aged condition of the shingles.

No Ridge Vent

Shingles are loose and curling

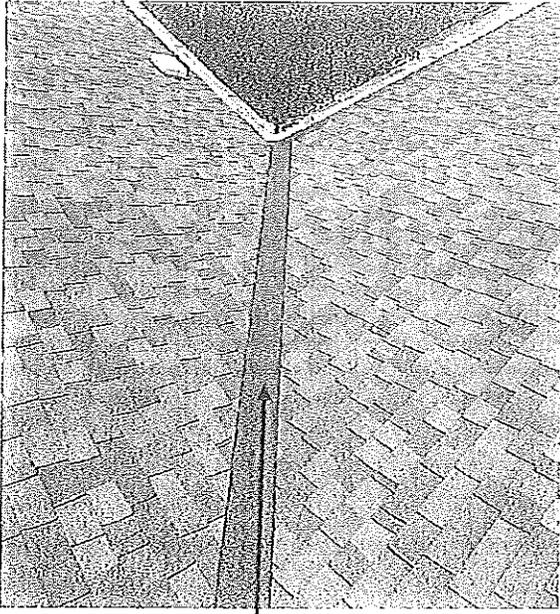
The valleys of the converging roof planes were not flashed with copper, but with a granulated membrane which is not an acceptable material for valley flashing. The protective granules that reflect the damaging UV rays have been washed away by the volume of water that runs down the valleys causing the membrane to become dried and cracked allowing water to enter the facility.

Granulated membrane is not acceptable material for valley flashing.

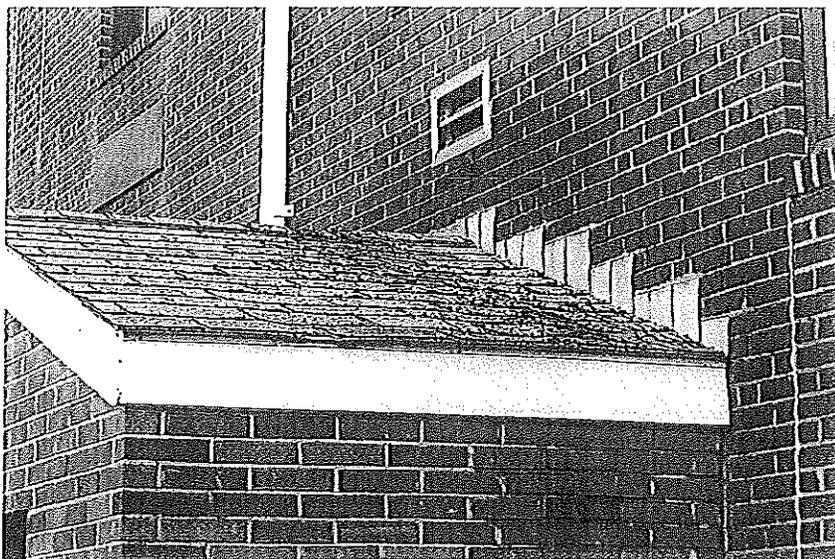
The asphalt shingles over the old entrance to the police department are dried cracked and extremely deteriorated.

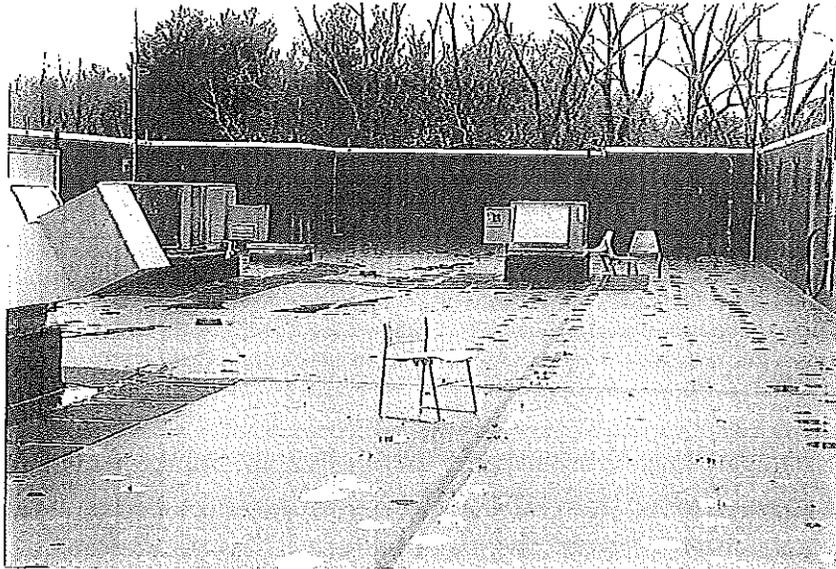
The EPDM roof on the new addition contains a ¼ inch slope to the drains, consequently no ponding water was observed and the membrane appears to be in excellent condition although the furniture should be removed in order to avoid as much foot traffic on the roof as possible.

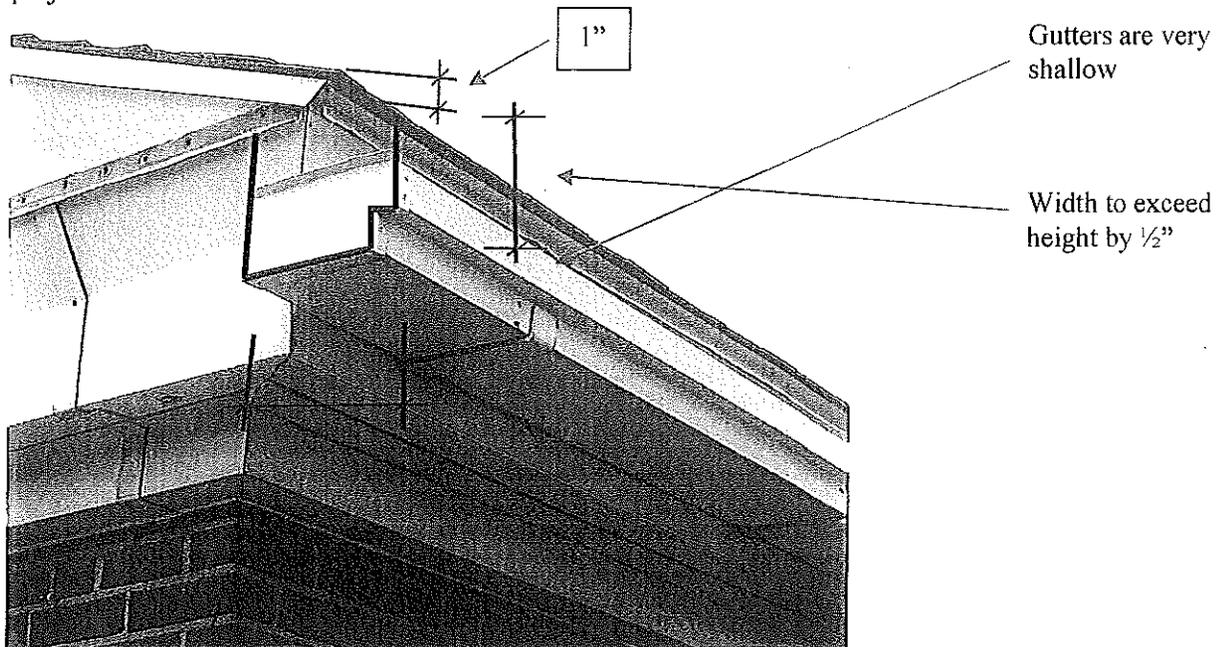
As previously mentioned the proportions of the gutters are not to industry standards. The national sheet metal association (SMACNA) recommends that the width of the gutter exceed the height by only ½", in addition, it also recommends that the top outside edge of the gutter should be installed 1 inch below the projection of the roof line

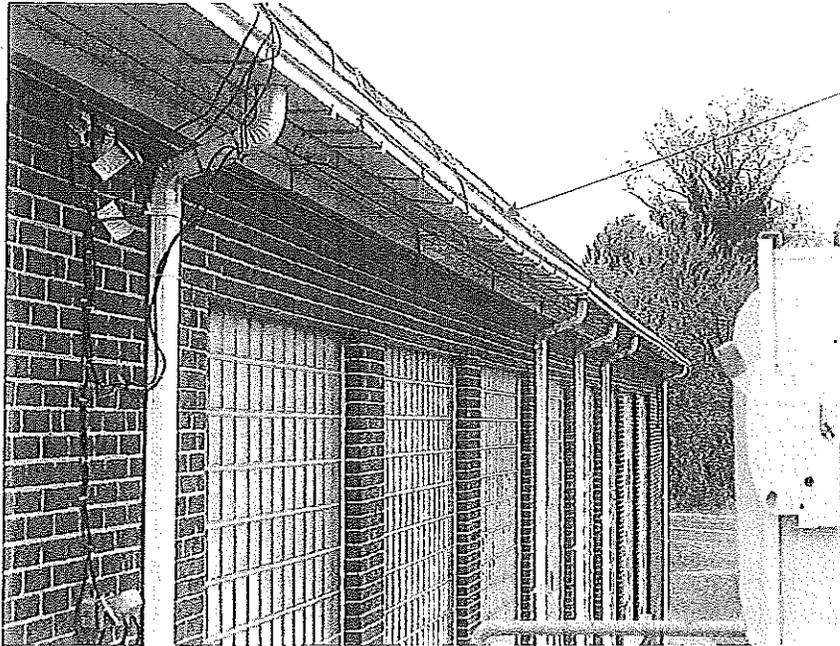
The gutters should slope toward the downspouts which should be the low points. It was observed that in some locations the gutter installation does not slope towards the downspouts, and in reality the gutter slope away from the downspouts locations.

Low point occurs in the middle of the section between downspouts

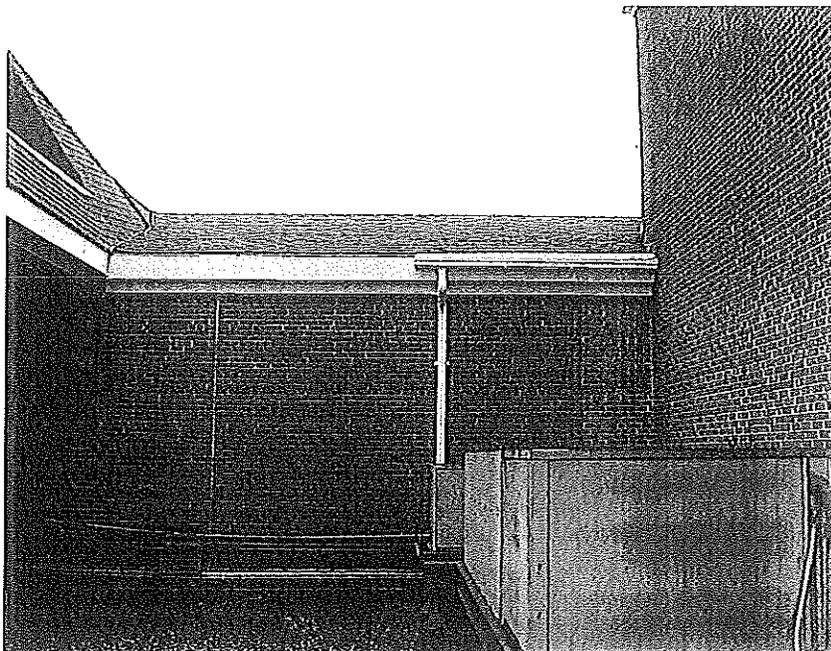
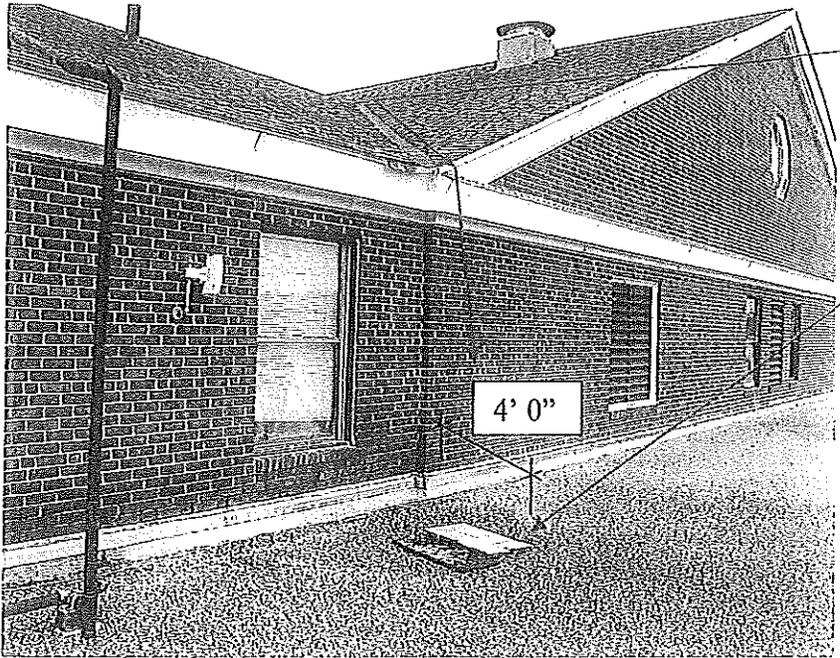
At one location only a partial gutter was installed where the gutters should extend along the entire roof edge. At other locations no gutters were installed, at the bottom of one valley the water shoots out about 4 feet onto the built-up roof below, where 6 concrete pavers were placed to protect the membrane.

Path of water onto roof below

Pavers provide the protection for lower roof

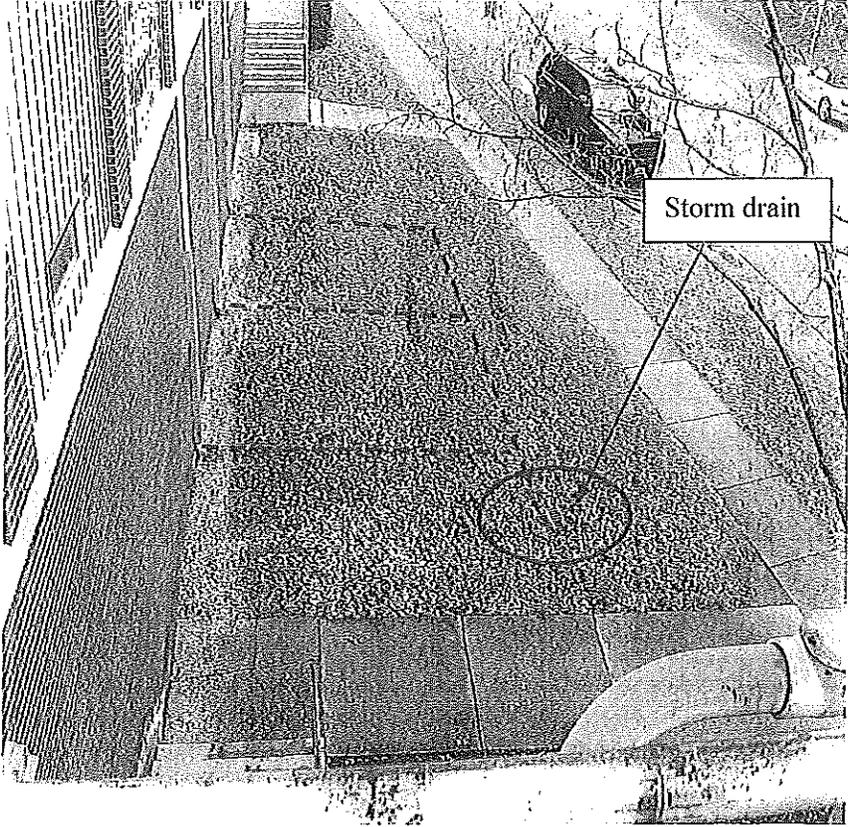
Storm drain

Many downspouts spill out onto the ground instead of being piped to the storm drain system, eroding the earth and creating areas of ponding water against the foundation walls.

Connect where possible all the downspouts to the existing storm drain system.

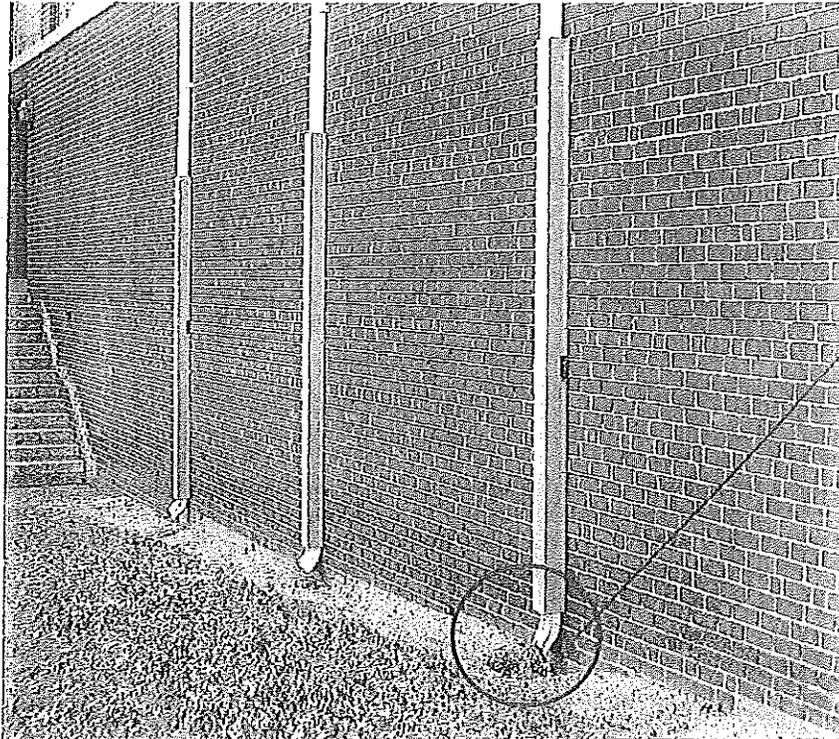
Erosion at bottom of  
downspout

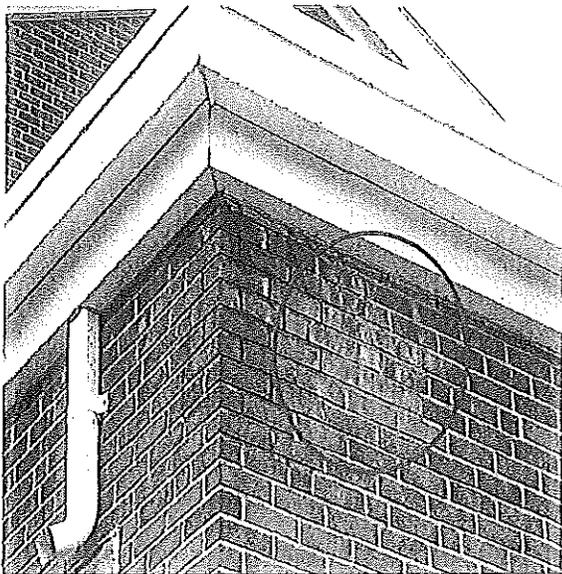
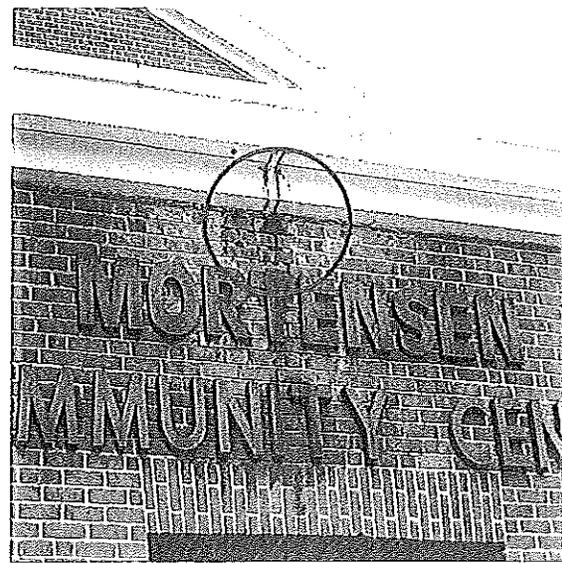
The gutters are leaking at several locations

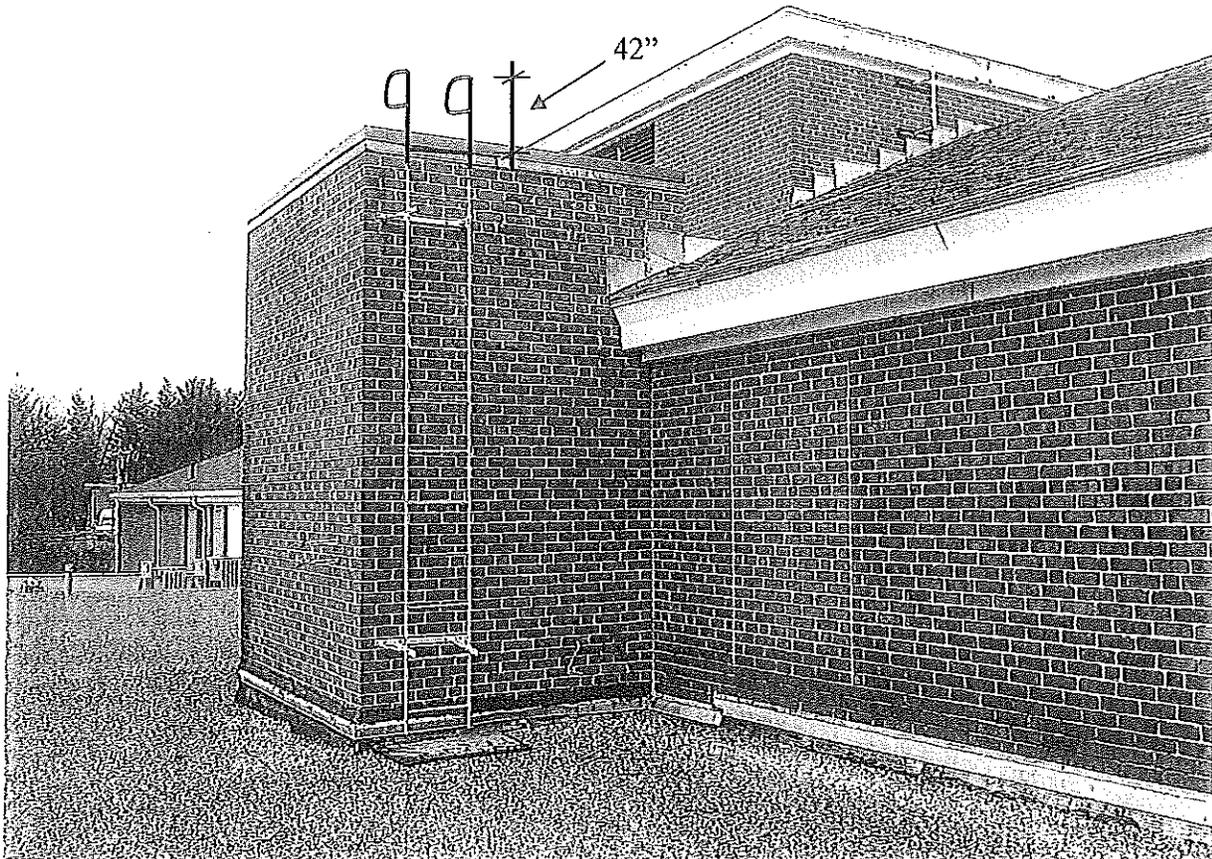
There is no easy safe access to the different roof levels and the only roof access ladder on the facility does not extend up above the top of the roofline 42 inches per OSHA guidelines. The lack of an easy access to the various roof levels discourages any regular visits for routine inspection and maintenance which in the long term would reduce the number of expensive repairs.

Install a ships ladder and hatch to provide easy access to the roof level as well as additional ladders to provide access to each individual roof surface.
