Owens Realty Services has been retained to provide consulting services to provide a conditions assessment, inclusive of a visual inspection and Code compliance review of the outdoor swimming pools at Churchill Park.

The assessment includes an outdoor 'C'-shaped swimming pool and an outdoor wading pool, decks and fencing, as well as swimming pool recirculation, filtration and chemical control systems.

Churchill Pool was built in 1965 on an elevated parcel of land at the southeast corner of Churchill Park. As with any pool of 55 years old it has a number of issues as a result of a harsh New England environment, heavy use, wear and tear.

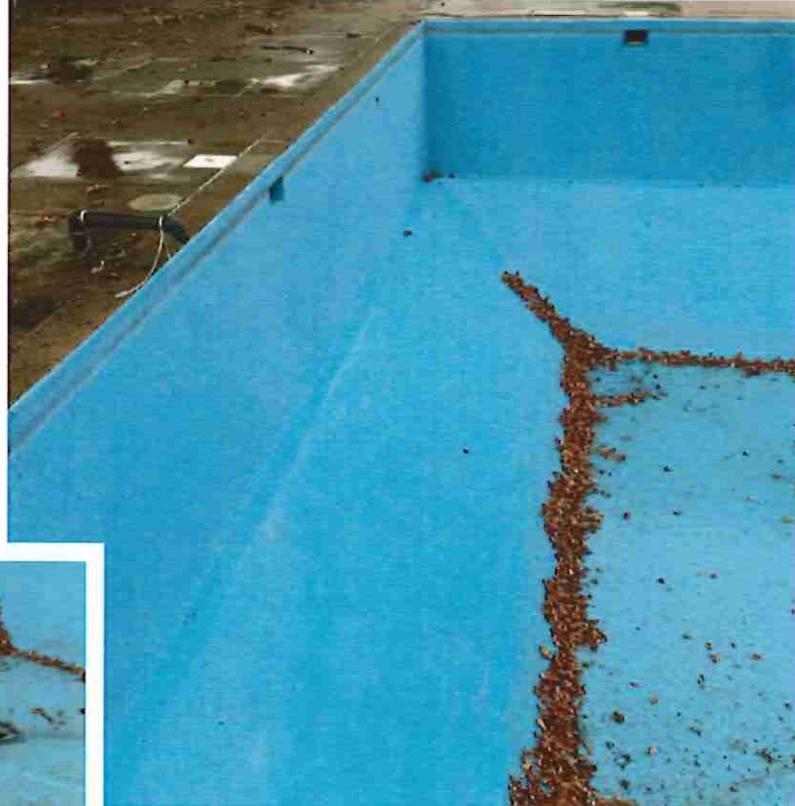
The deep end geometry does not comply with current DPH regulations with regard to diving boards (they have already been removed) but also with regard to the shelf at the five-foot depth and the slope at the pool bottom. DPH regulations require walls to be vertical for a depth of 6-feet. The shelf is at 5-feet.

Deep end. Diving boards have been removed due to non-compliant hopper geometry

The shelf around the hopper provides an effective foot ledge, but is not compliant with current CT DPH Regulations. Should any significant work to the pool be done, which would require a new Health Permit, this condition would need to be addressed.

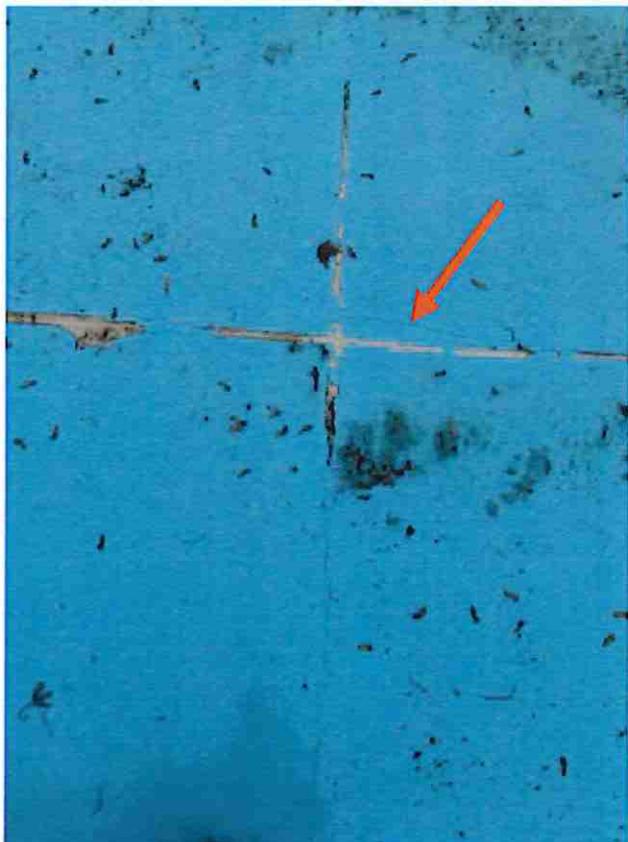
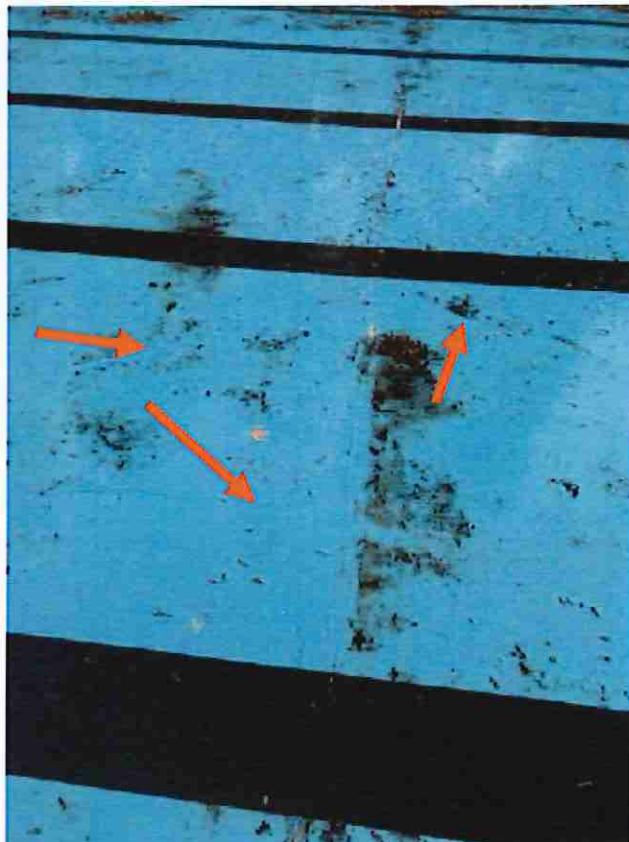
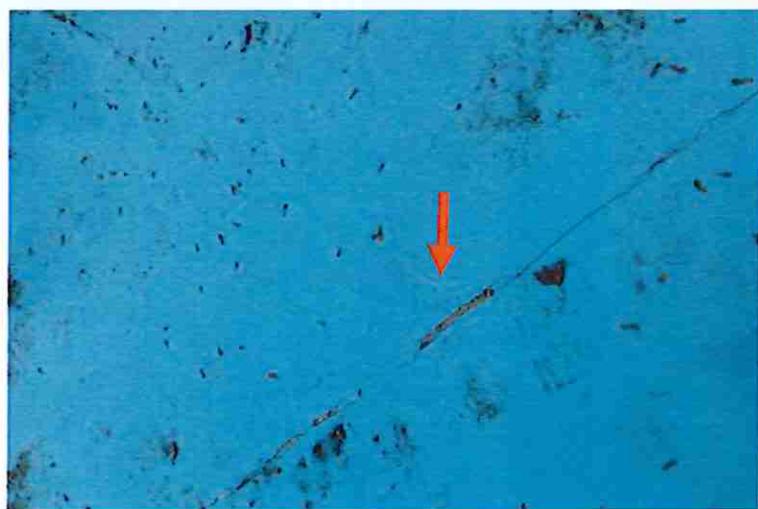
Many of the cracked and delaminated areas occur along expansion joints, where water infiltration makes the concrete susceptible to freeze/thaw damage.

All expansion joints are in need of replacement. It is recommended that sealant material is color-match to pool and not painted. The paint cannot adhere to sealant material and fails, leading to peeling paint and exposed concrete.

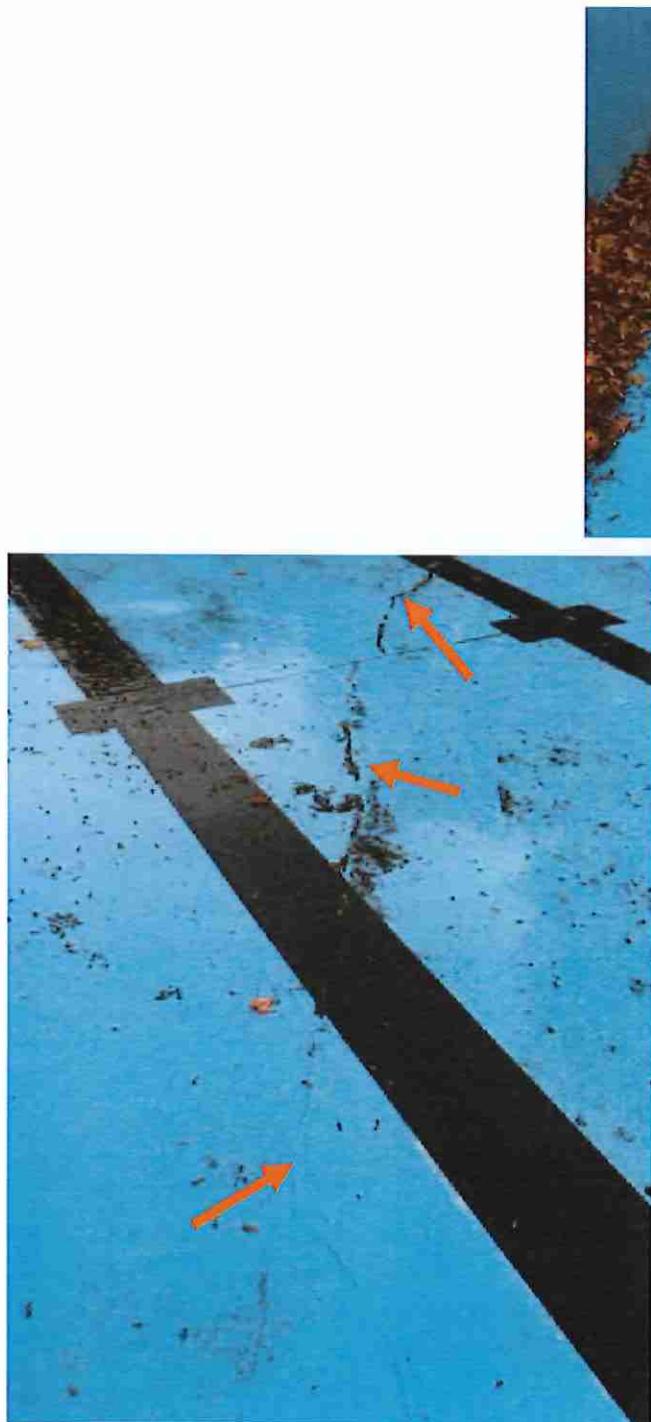
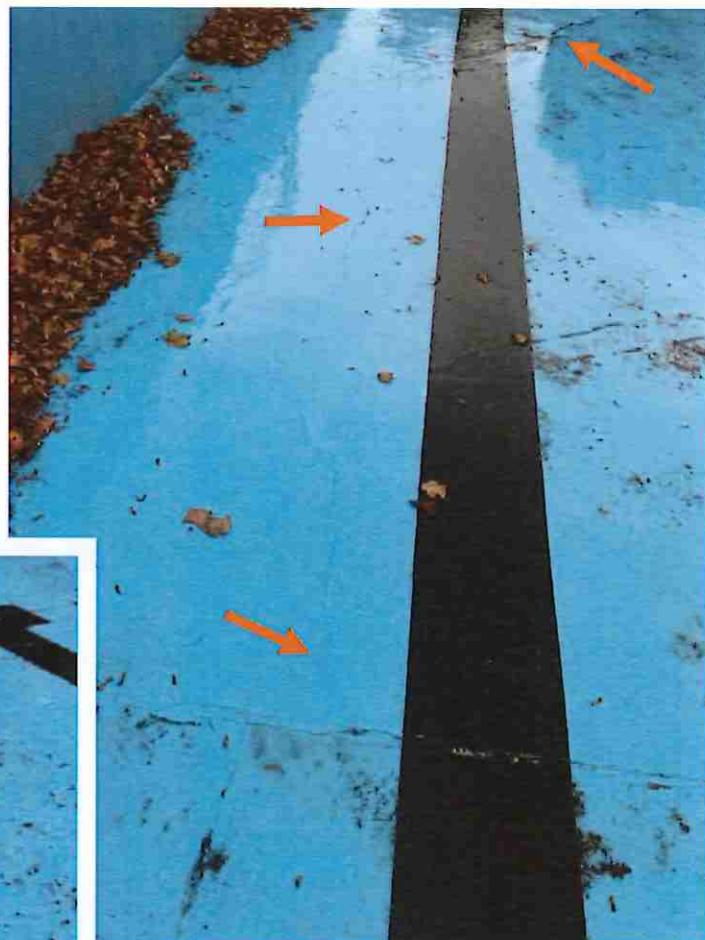
Several cracks run from expansion joint to expansion joint. Many may have occurred years ago, and are non-structural. However, they should be sealed to prevent water infiltration and corrosion of steel reinforcing, spalling and delamination of concrete.

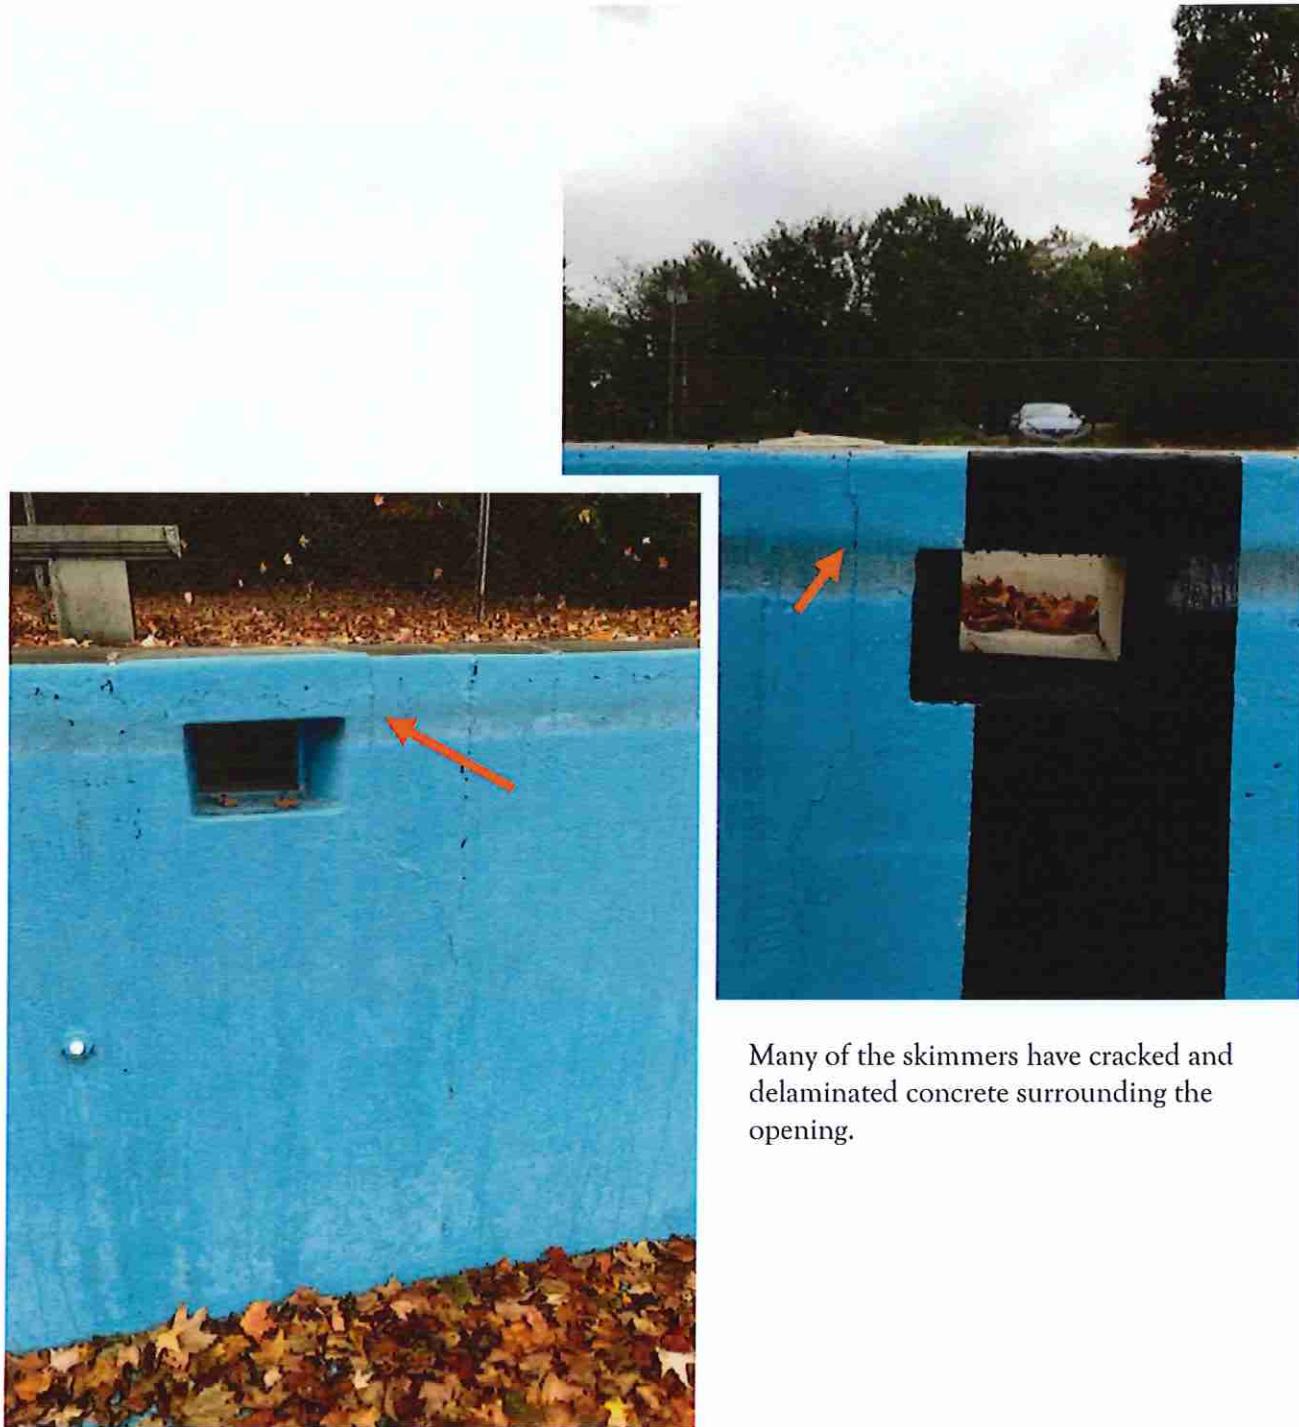
Many of the skimmers have cracked and delaminated concrete surrounding the opening.

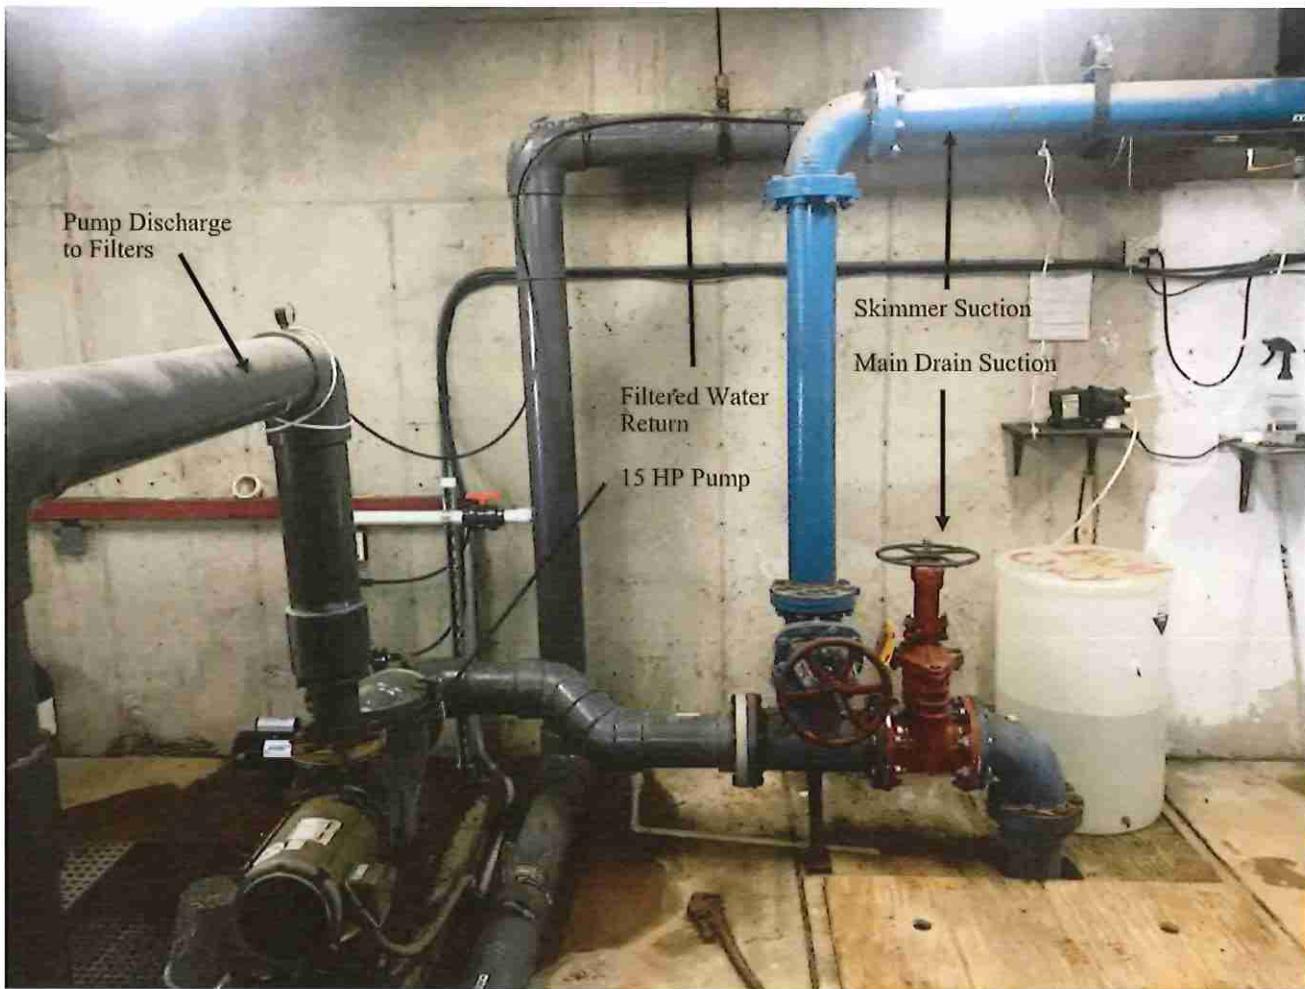
15 HP pool recirculation pump draws water in direct suction from skimmers and main drains.

In photo above, the blue, overhead pipe is a 5-inch cast iron pipe from the skimmers. The pipe dropping through the floor is a 6-inch cast-iron pipe from the main drains. Both are joined prior to the suction side of the pump.

- Piping is undersized and not in compliance with DPH Regulations.
- System is in direct suction without an anti-entrapment device. At calculated velocities, the drains are not VGB compliant, even if covers are certified.

If the pool is operated with the existing drains and piping in place, a secondary anti-entrapment system such as a supplemental vacuum release system interlocked with the pump should be installed.

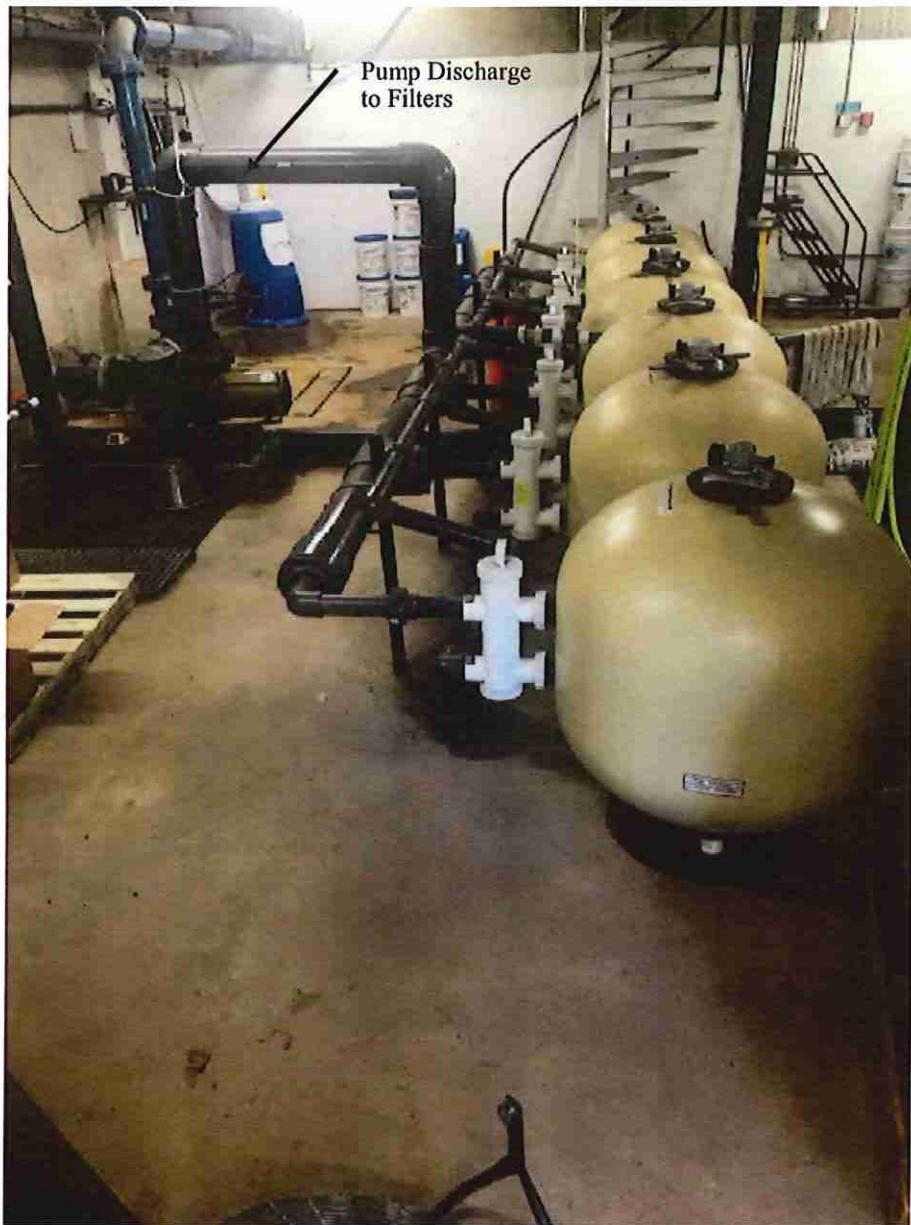
- Piping is undersized and not in compliance with DPH Regulations.
- There are no throttling valves or flow meters at each filter to confirm that each are flowing at the same rate.

Typical filter piping and multi-port valve. Position of the valve determines filter mode –vs– backwash mode.

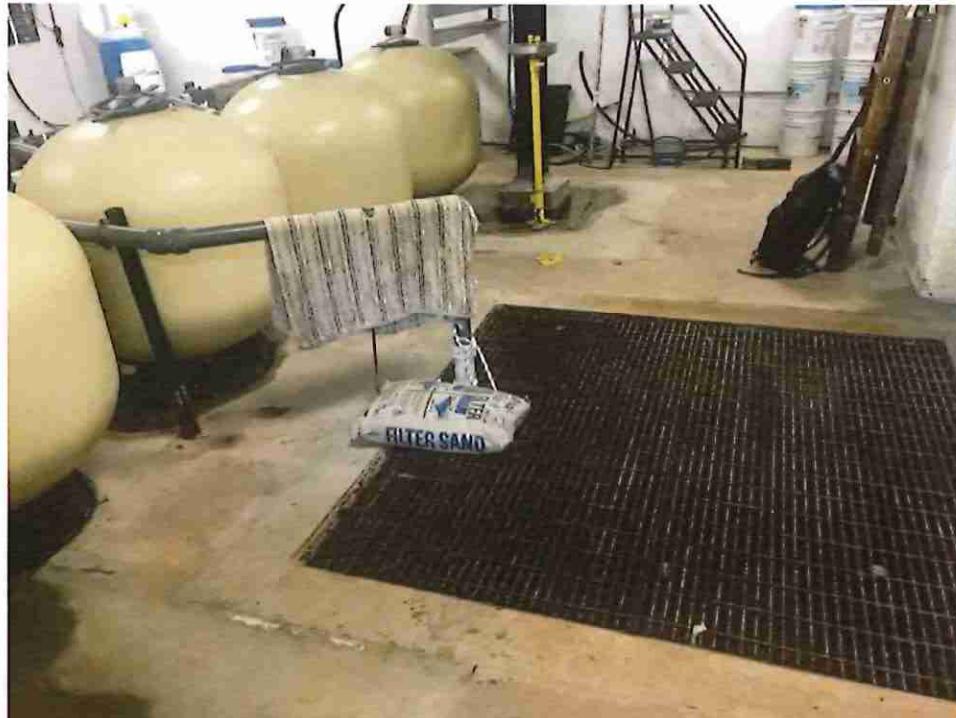
When the filter is in backwash mode, it discharges dirty filter water to a collector pipe that discharges to a waste pit, covered with a floor grate. Pipe size will only allow effective backwash of one filter at a time.

- The discharge of the backwash pipe terminates below the flood rim of the pit, which is not DPH compliant, as an air-gap is required.

The current arrangement could allow waste water to siphon back into the pool system.

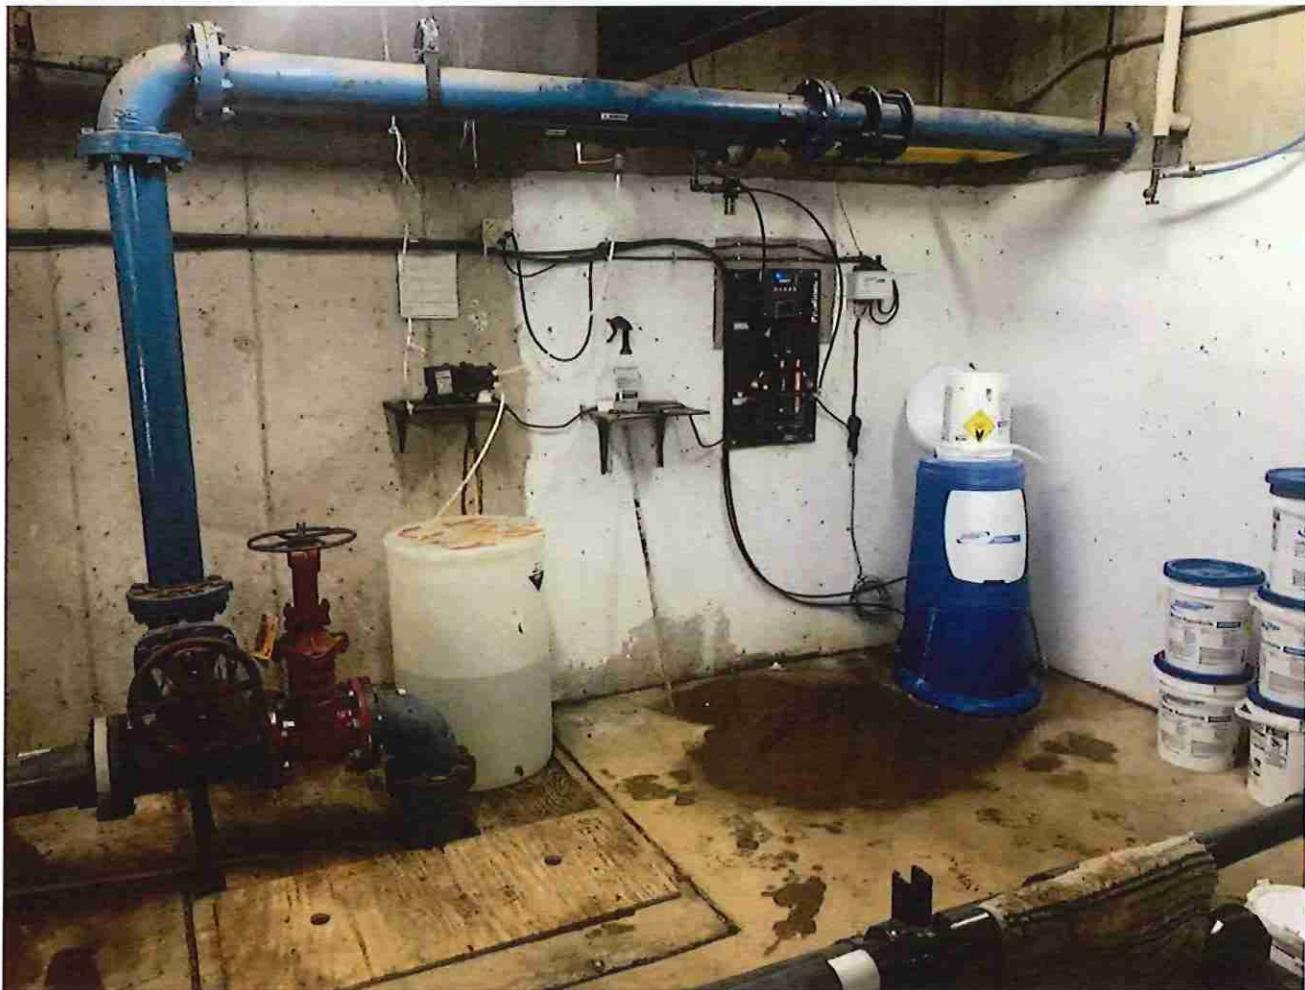
Pool water chemistry is maintained through an automatic water chemistry controller (Prominent CM-200). This system includes a flow-cell that monitors pool water conditions and adds chlorine for sanitizing and corrects pH by introduction of acid. This occurs continuously.

Water sanitizer is a calcium hypochlorite erosion feeder (Pulsar). pH correction is liquid acid, fed into the system through a peristaltic pump (Stenner). This system is appropriate and suitable for continued use.

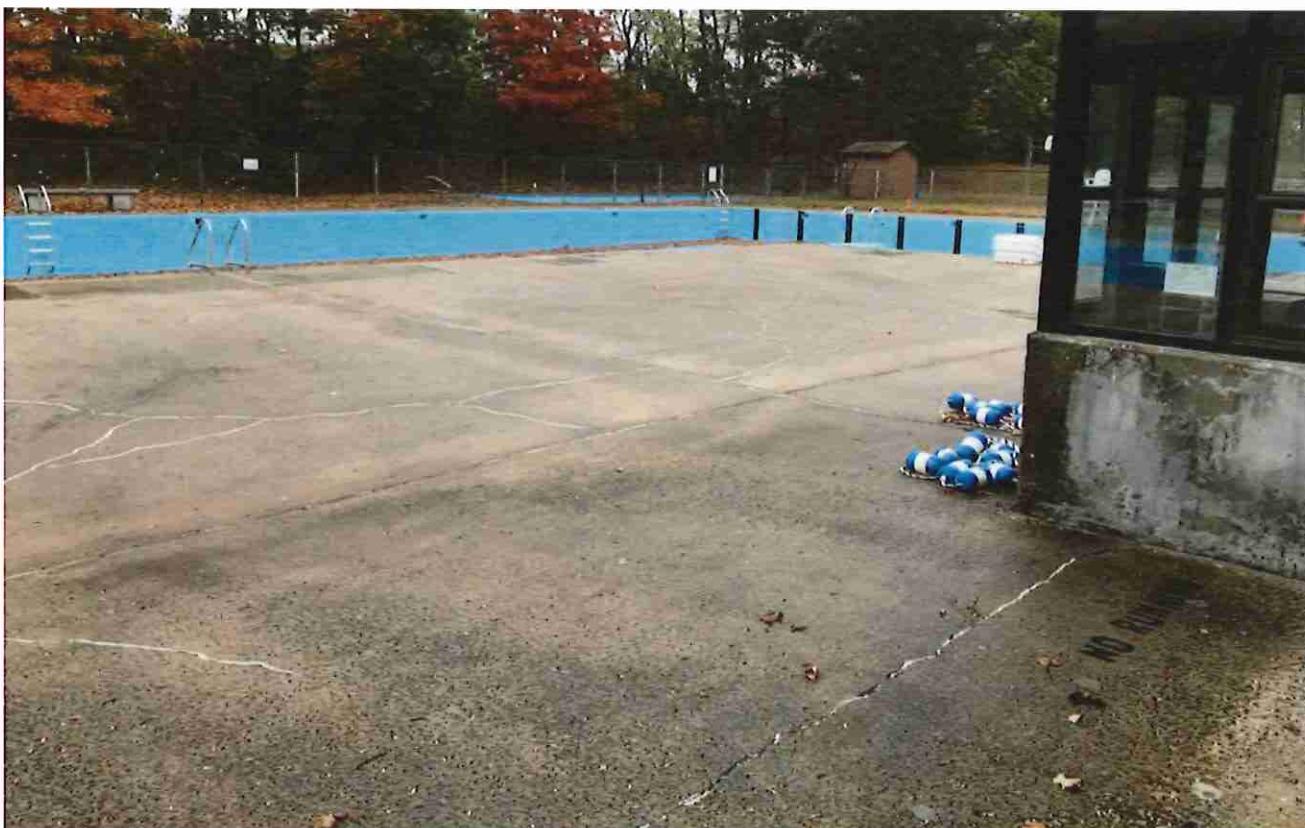
Above: Typical deck conditions. Note random cracking throughout deck areas. Most have been sealed with elastomeric sealants. Many have failed sealant and are allowing water penetration.

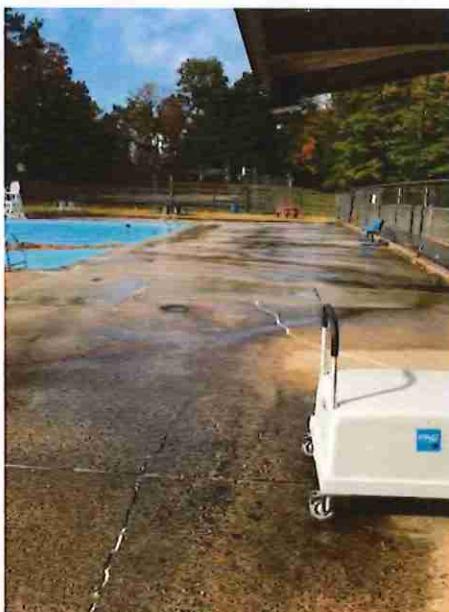
Left: Water runoff from roof is scouring the deck and eroding the concrete. Much of the water is falling onto failed sealant joints.

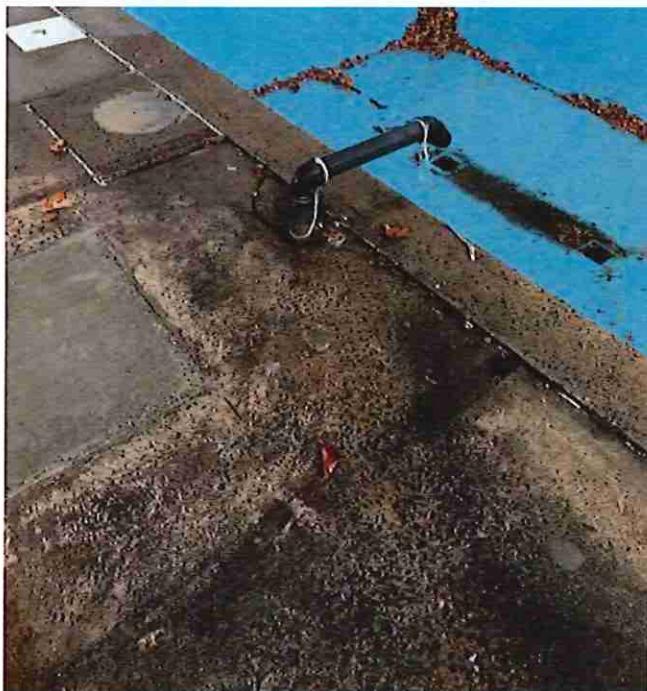
The deck at the deep end is in particularly poor shape. The diving boards have been removed, though the anchors remain in the deck and pose a trip hazard. The fill line which originally was under the diving board is now exposed and also poses a trip hazard.

Top Left: Patched concrete and exposed fill line.

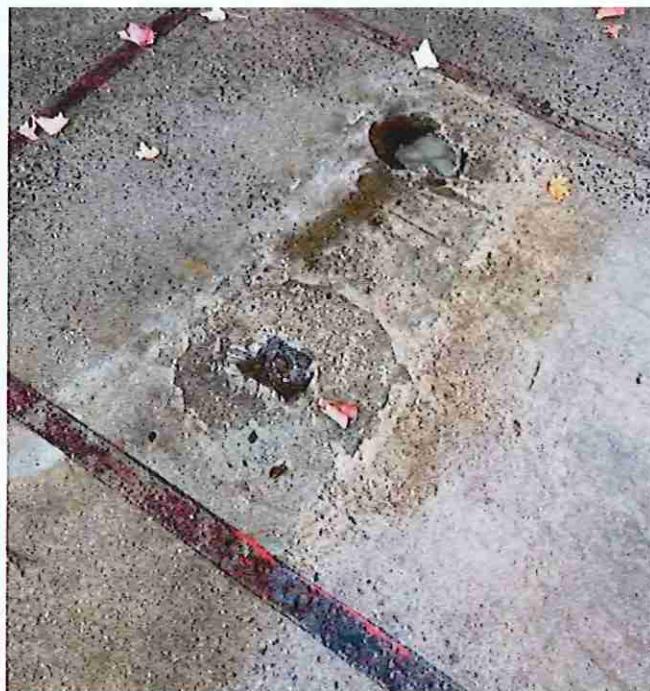
Top Right: Diving Board anchors remaining in deck.

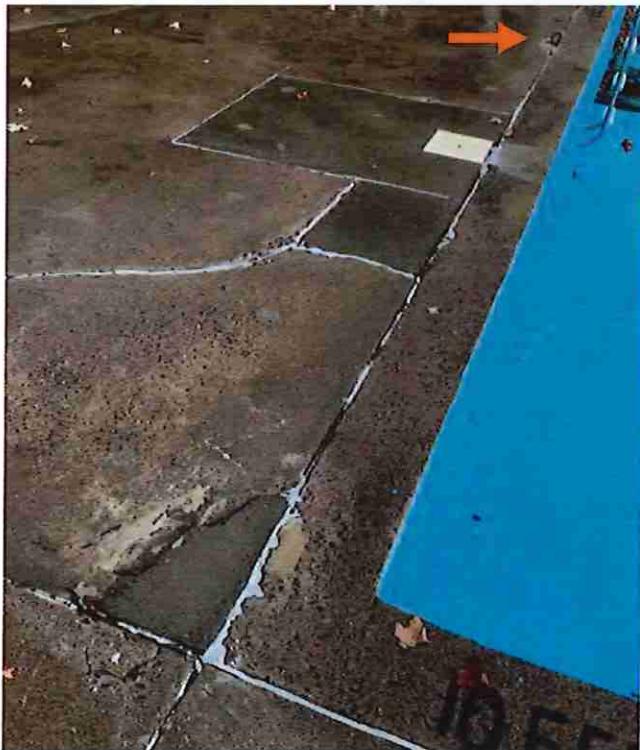
Left: Patched, cracked and spalled concrete and failed joint sealant. Note sealant backer rod exposed (at arrow).

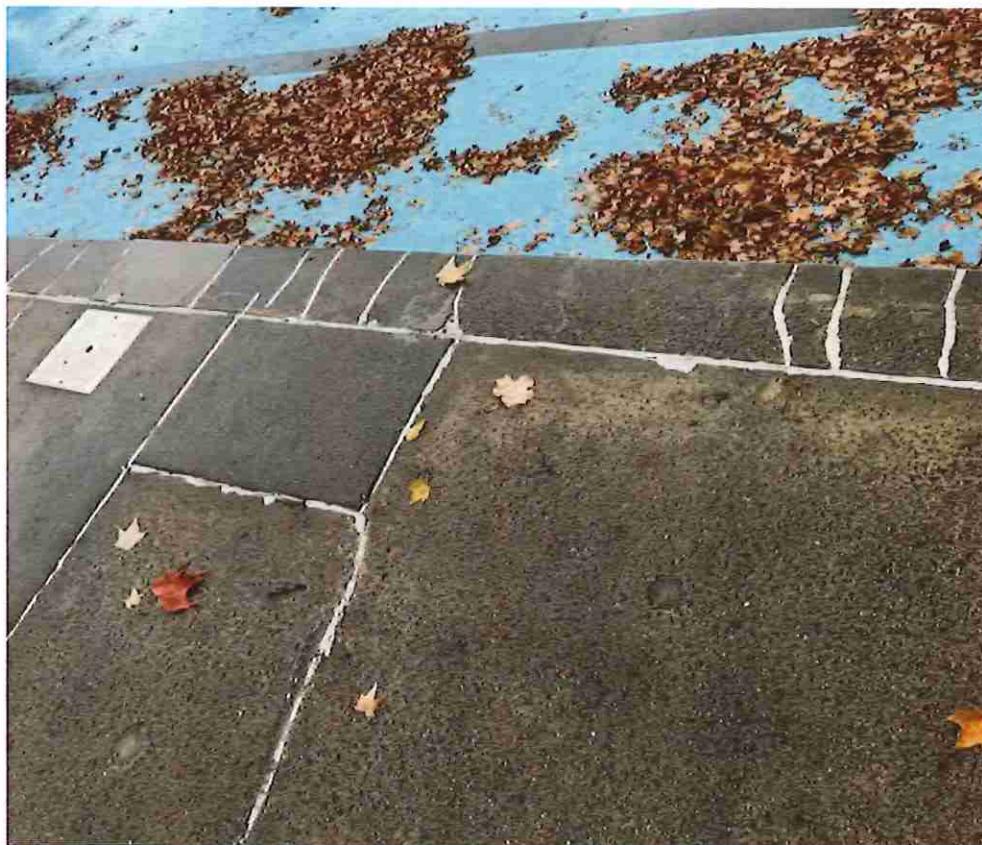
Left: Cracked pool deck and coping, which is integral with pool wall.

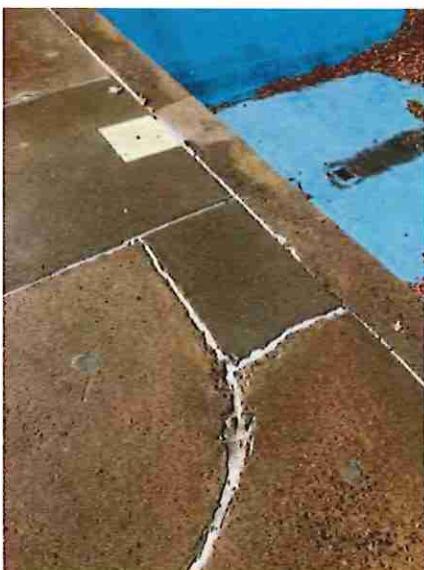
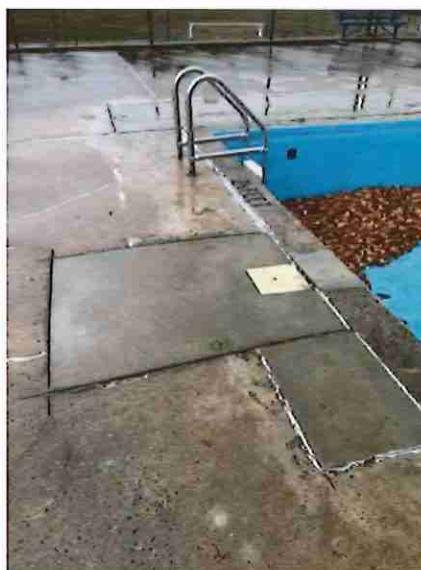
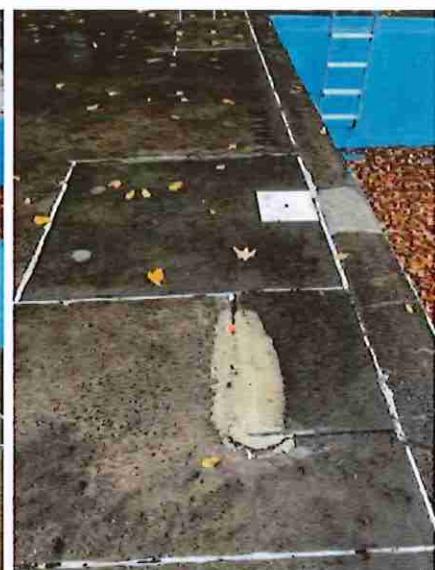
Below: Miscellaneous cracks and patches. Most deck patches were found to be hollow, either due to delamination of concrete or poor compaction below deck.

Note overcuts at some patches, which provide a path of water through deck.

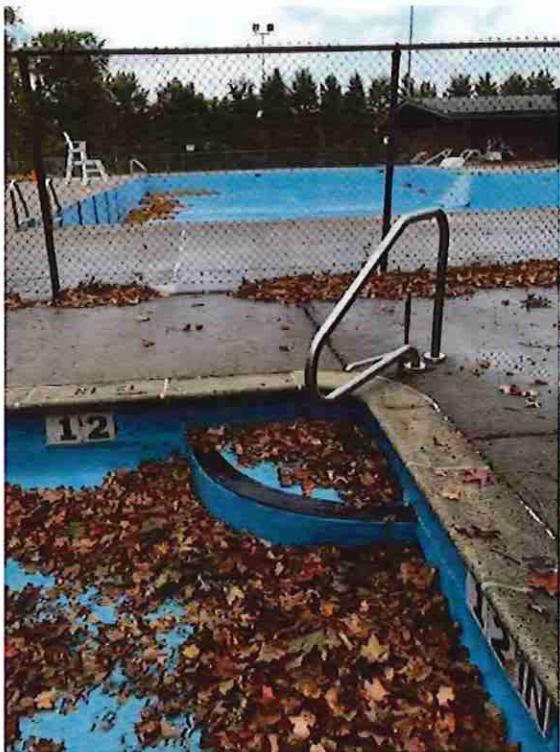
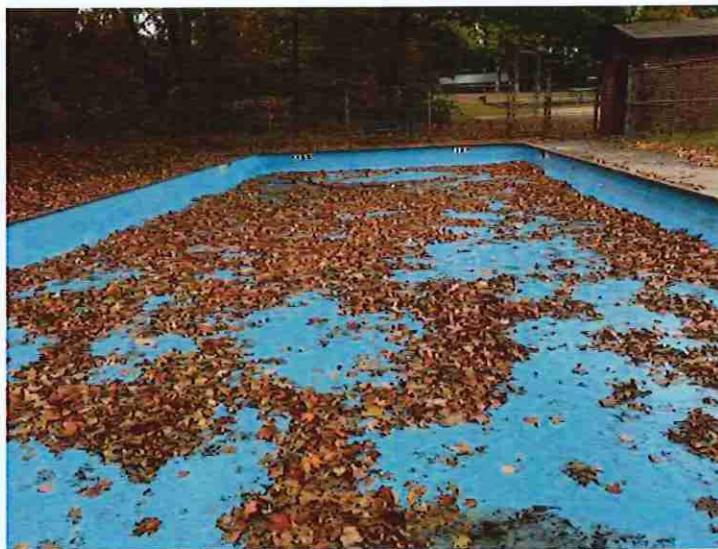
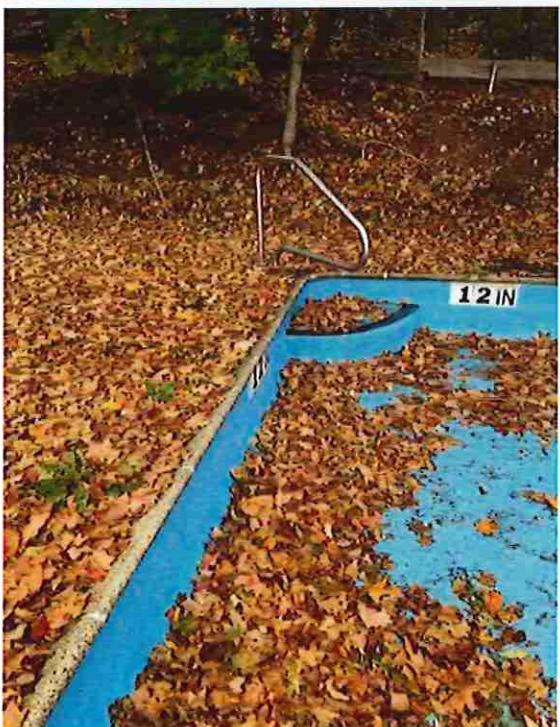
The concrete at the Wading Pool was generally sound with only minor cracking. However, reports of significant water loss closed the pool for the season, and as such, there are likely pipe leaks below the pool. As with any pipe leak below ground, there is concern for washout of sub-slab soils and eventual settlement of the pool, which could result in further cracking.

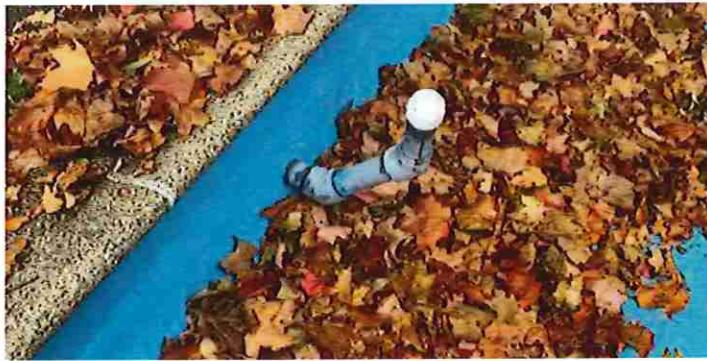
The spray nozzle and the coping overhang both protrude into the pool and may present a hazard (see below).

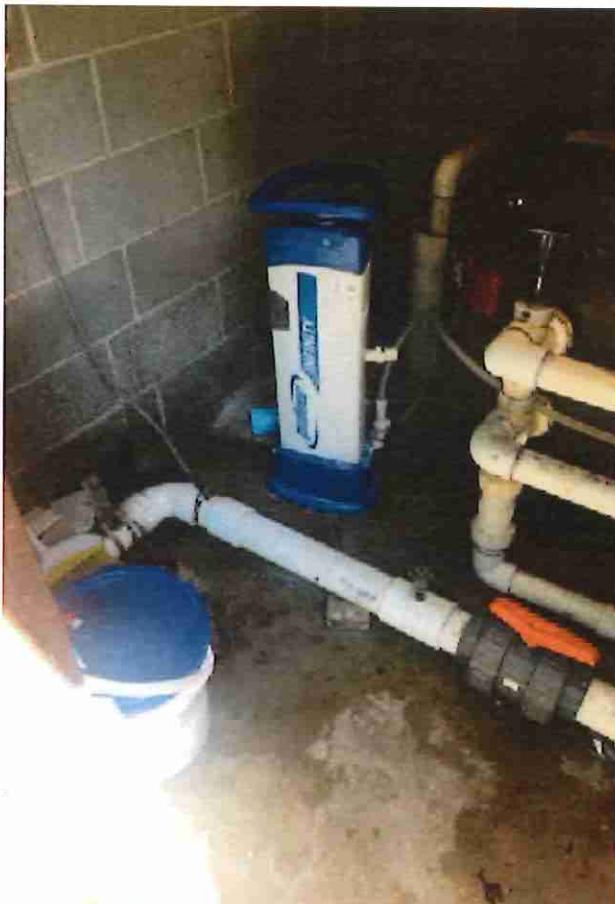
Above Left: Chemical Control System

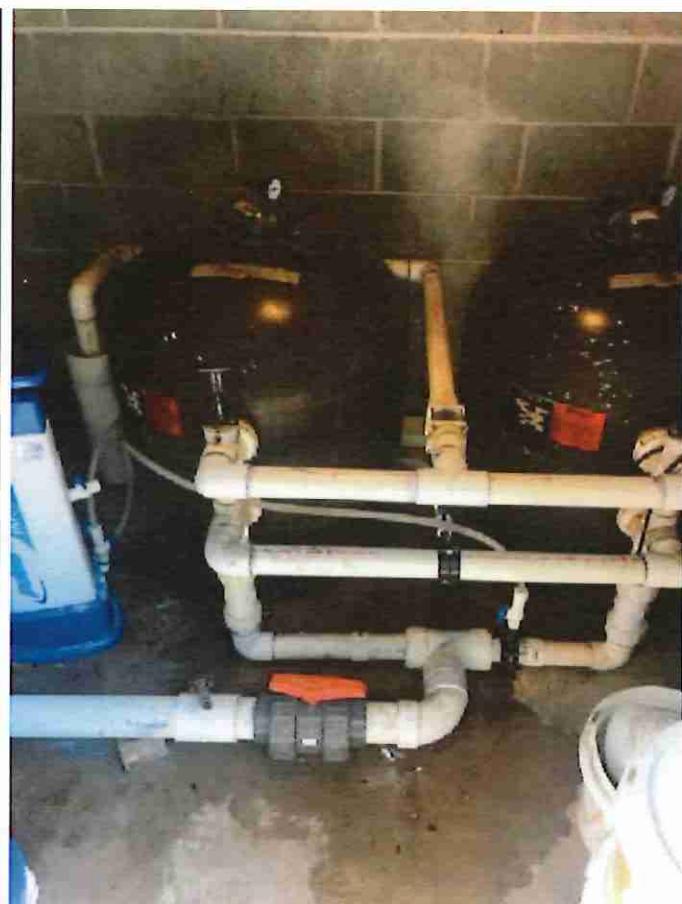
Above Right: High rate sand filters, not rated for commercial use.

Piping and equipment is sized properly for flow, but drains are not VGB compliant and a vacuum release system should be installed.

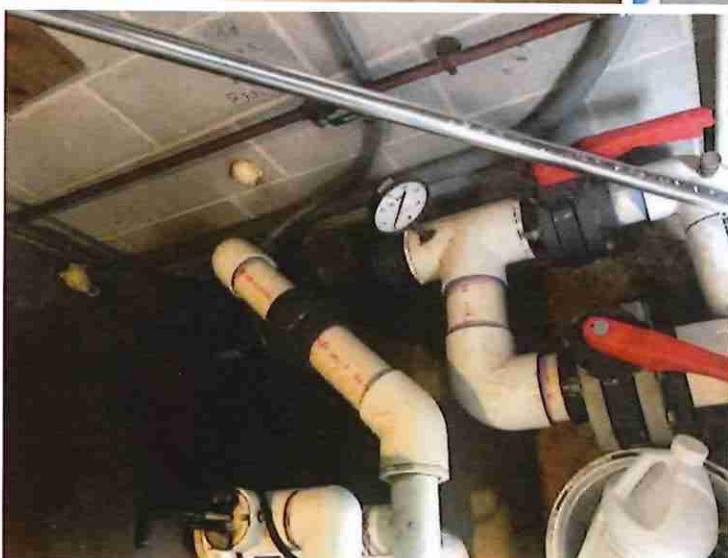
Left: Pump with main drains and skimmers in direct suction.

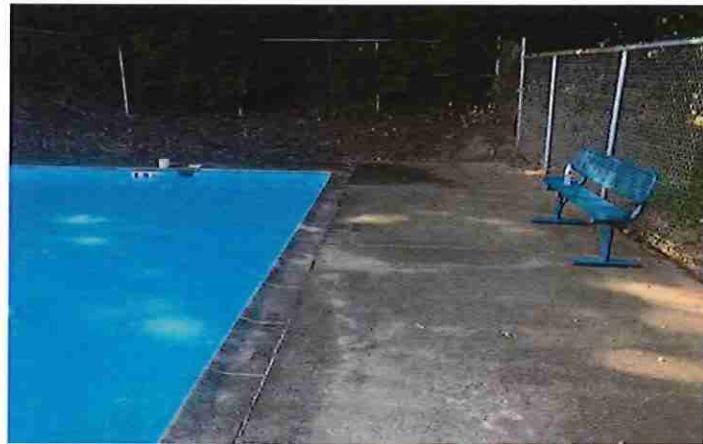
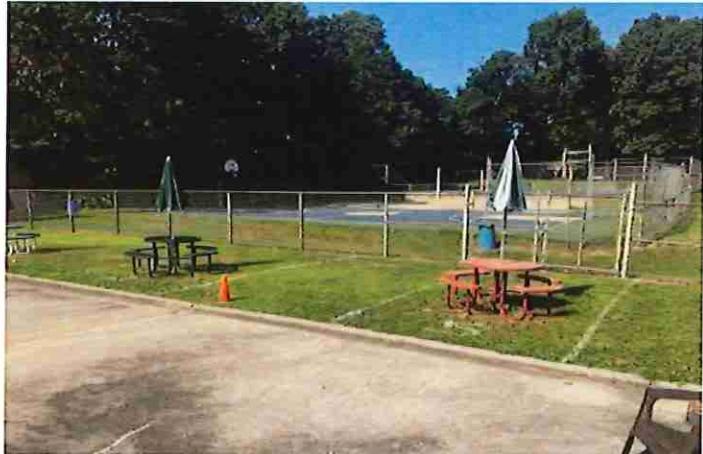
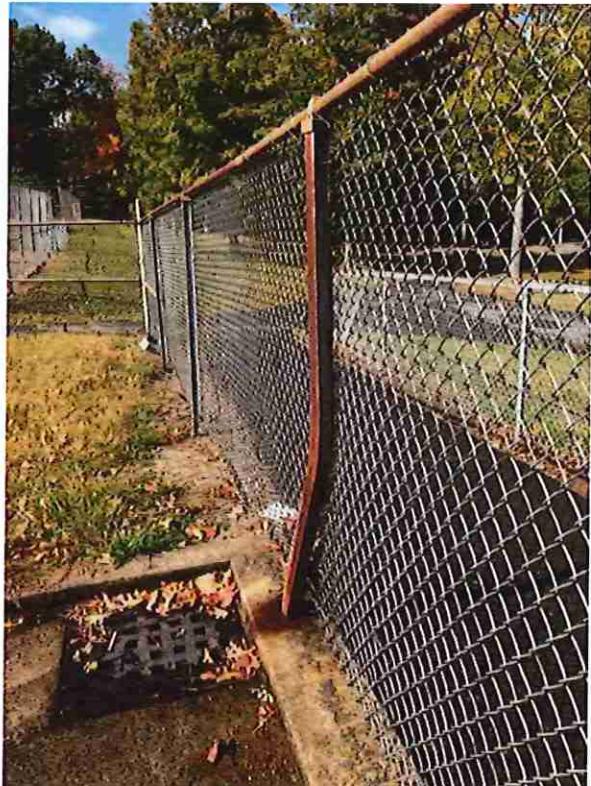
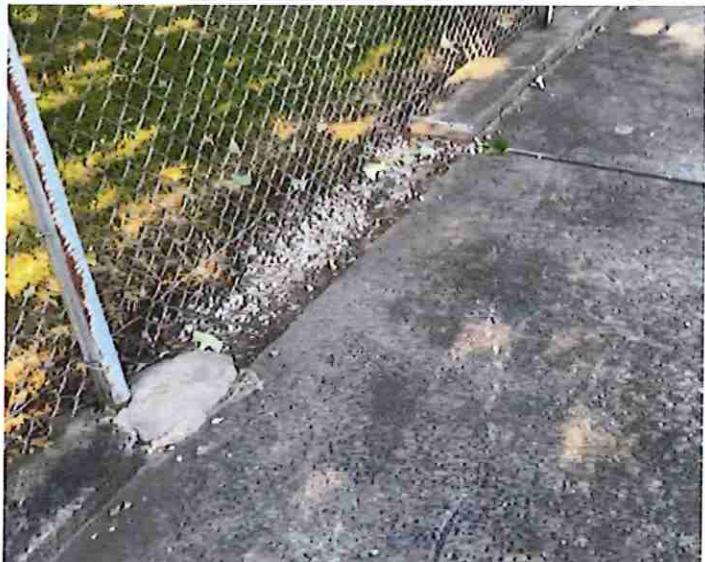
Fencing is in generally fair condition. Many areas need repair and select replacement of posts and fabric.

Areas of broken curbing at the perimeter of pool deck create gaps in the fencing that exceed allowable limits.
