Town of Newington  
Connecticut

# Aquatic Facility Assessment Report

Mill Pond Park and Churchill Park

December 2025

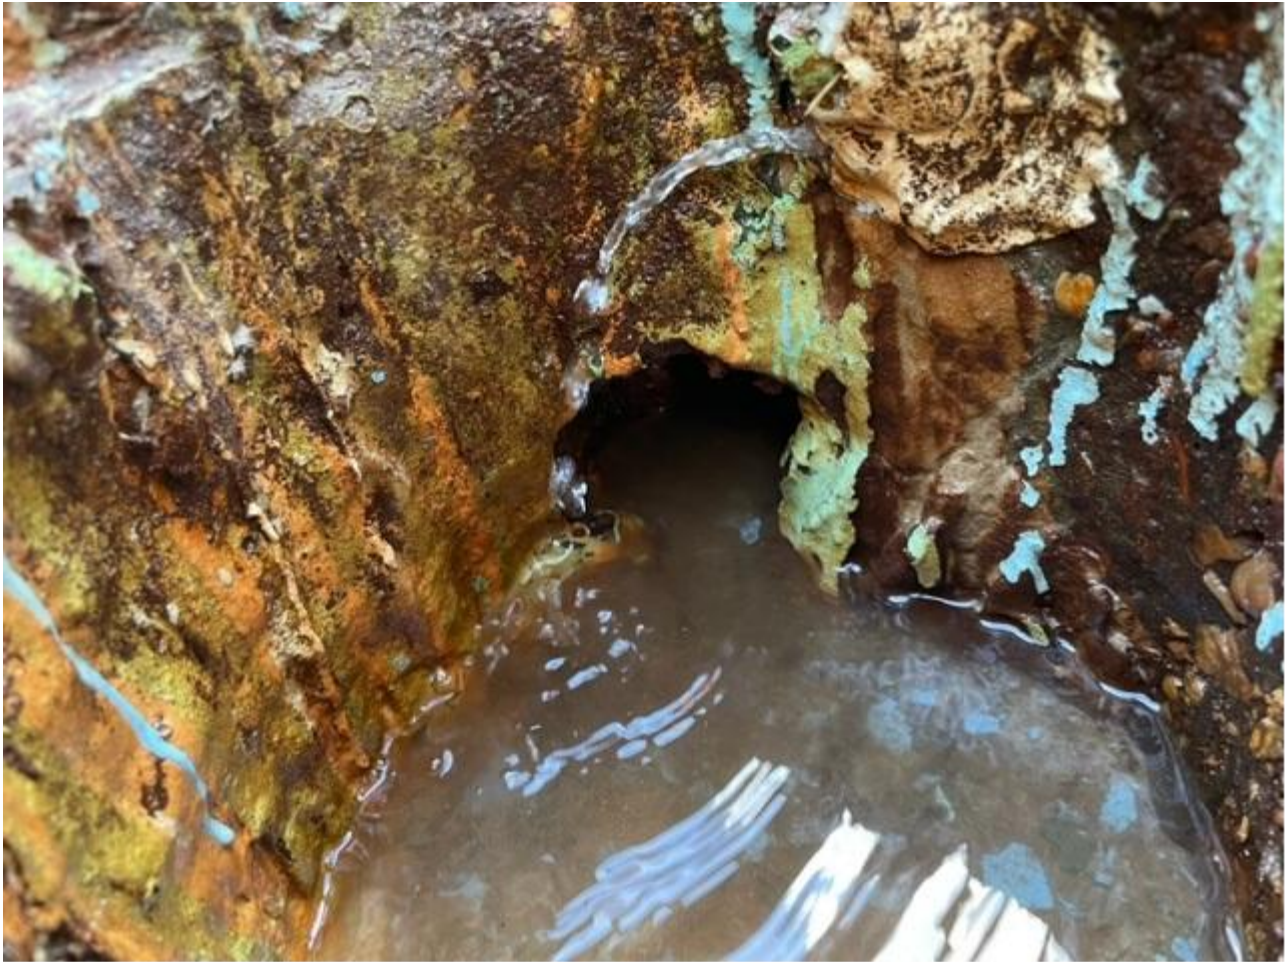
Mill Pond Leaking Sump:

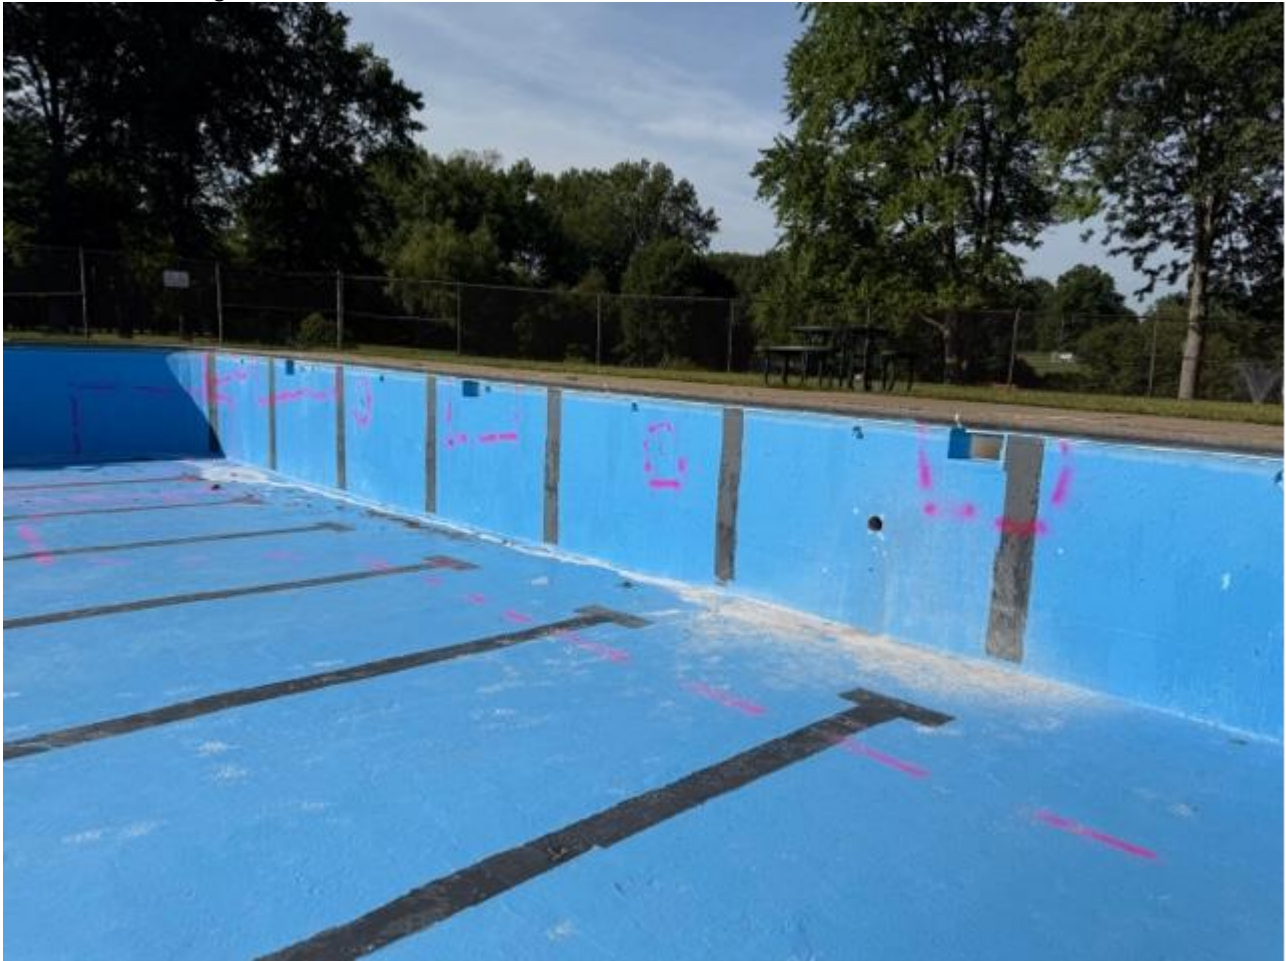
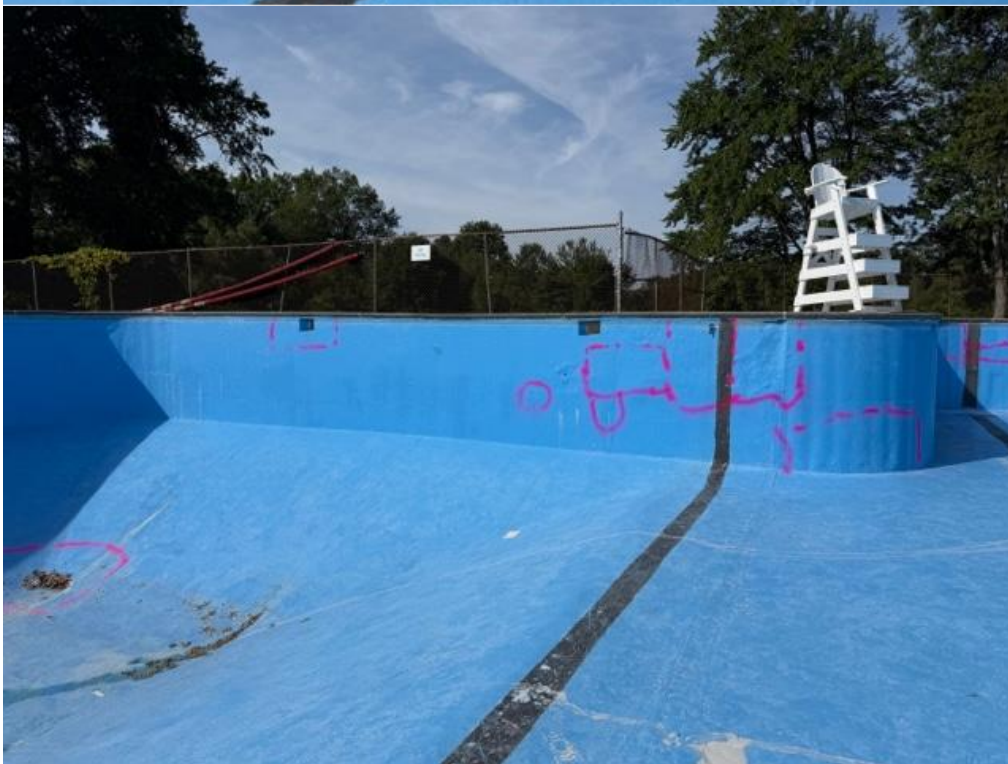
Mill Pond Sounding Results, Pond Side:

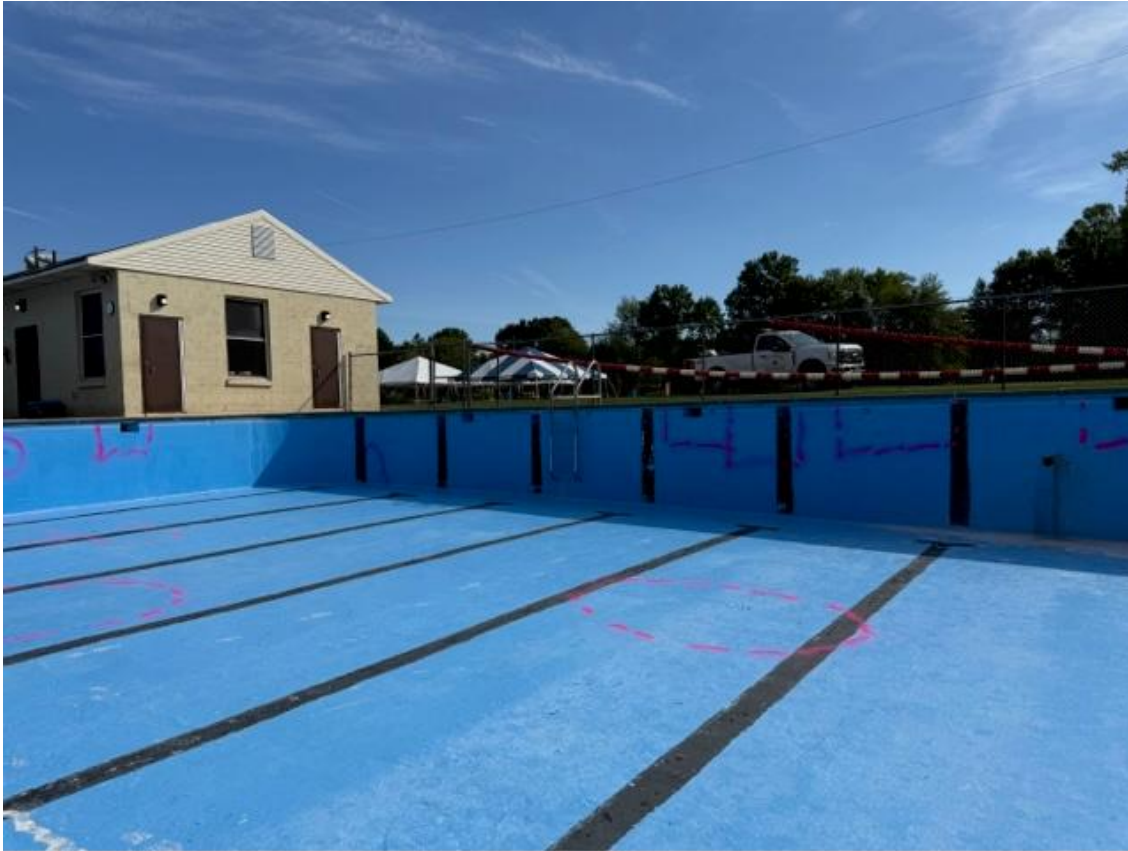
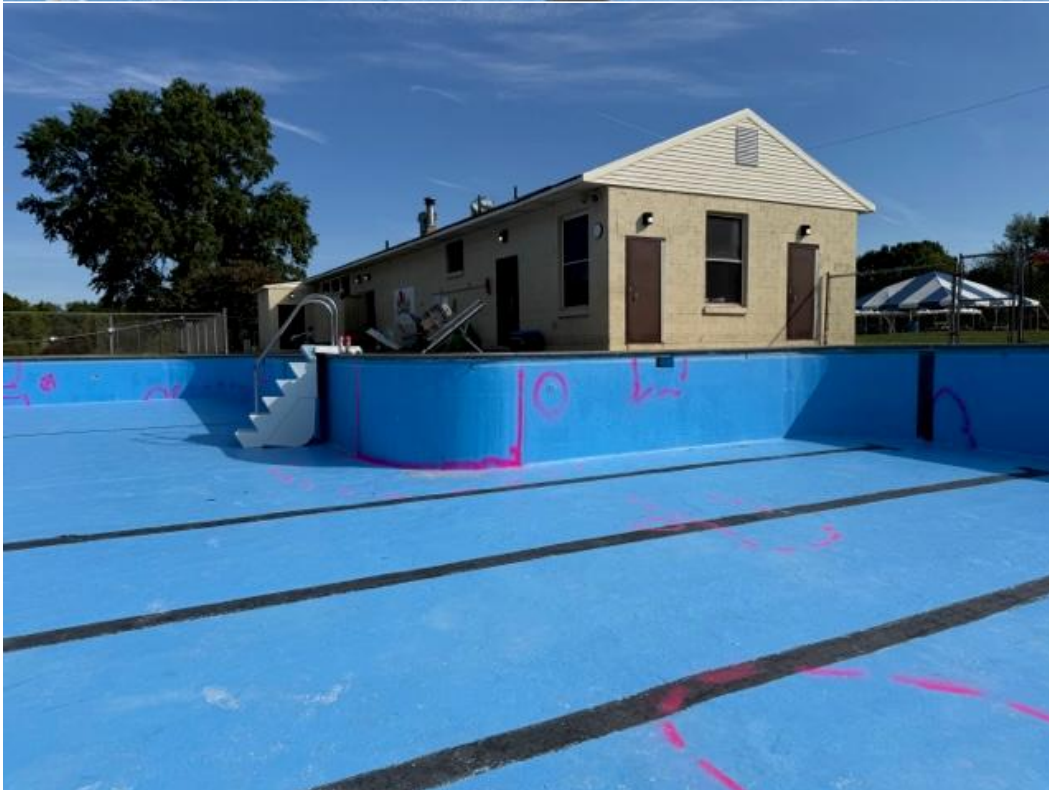
Mill Pond Park Side:

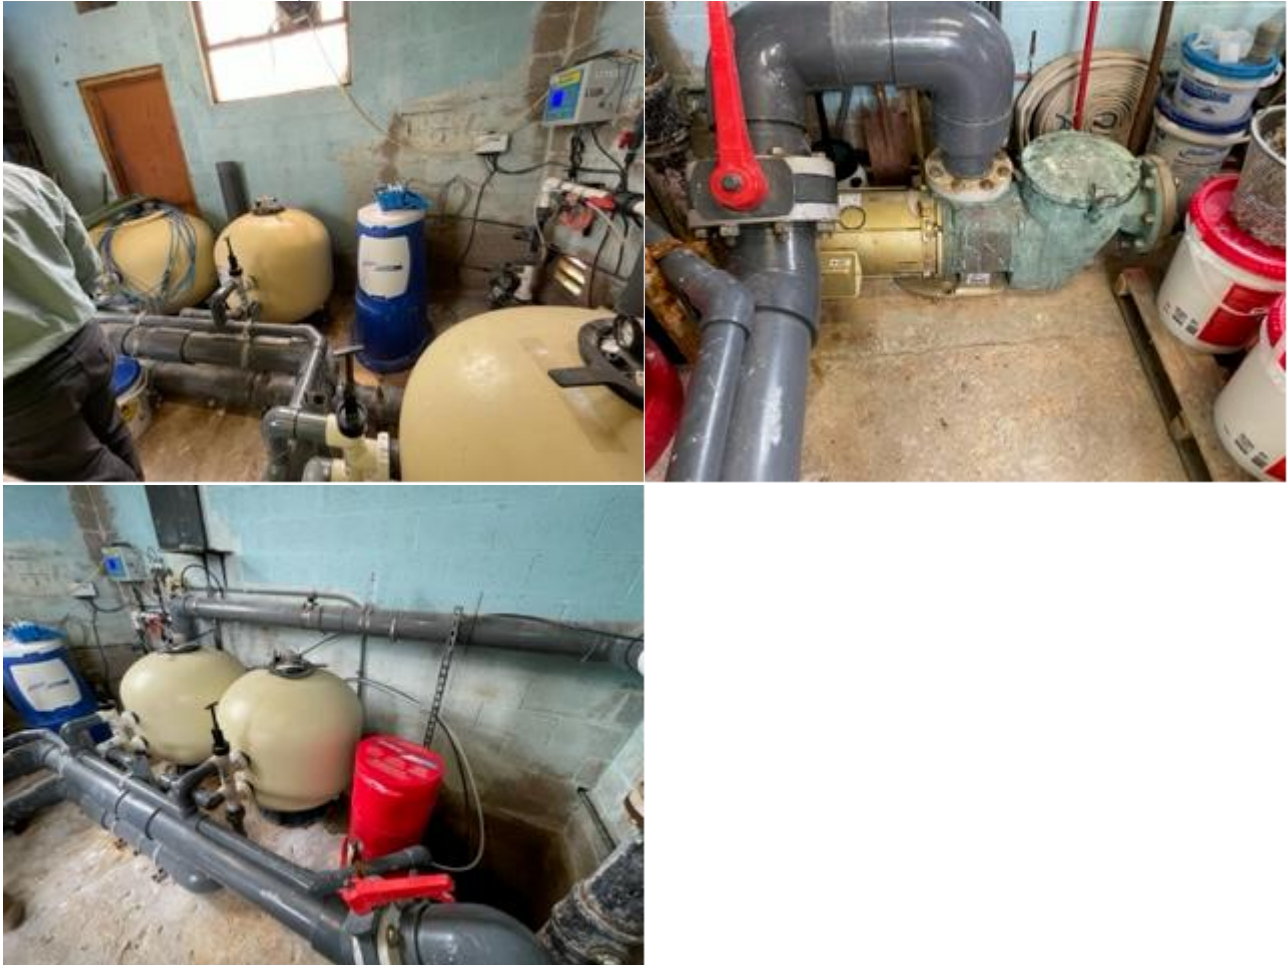
Mill Pond Filters and Pump:

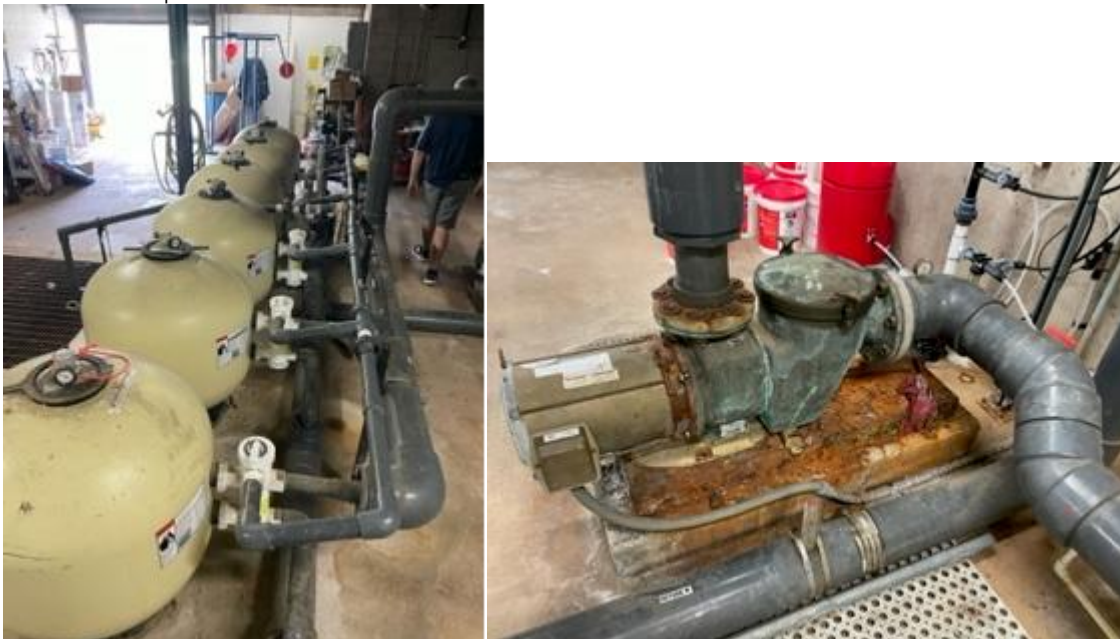
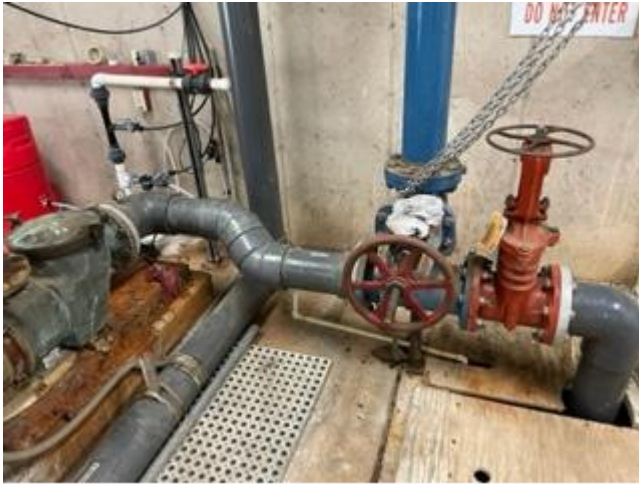
Churchill Pump and Filters:

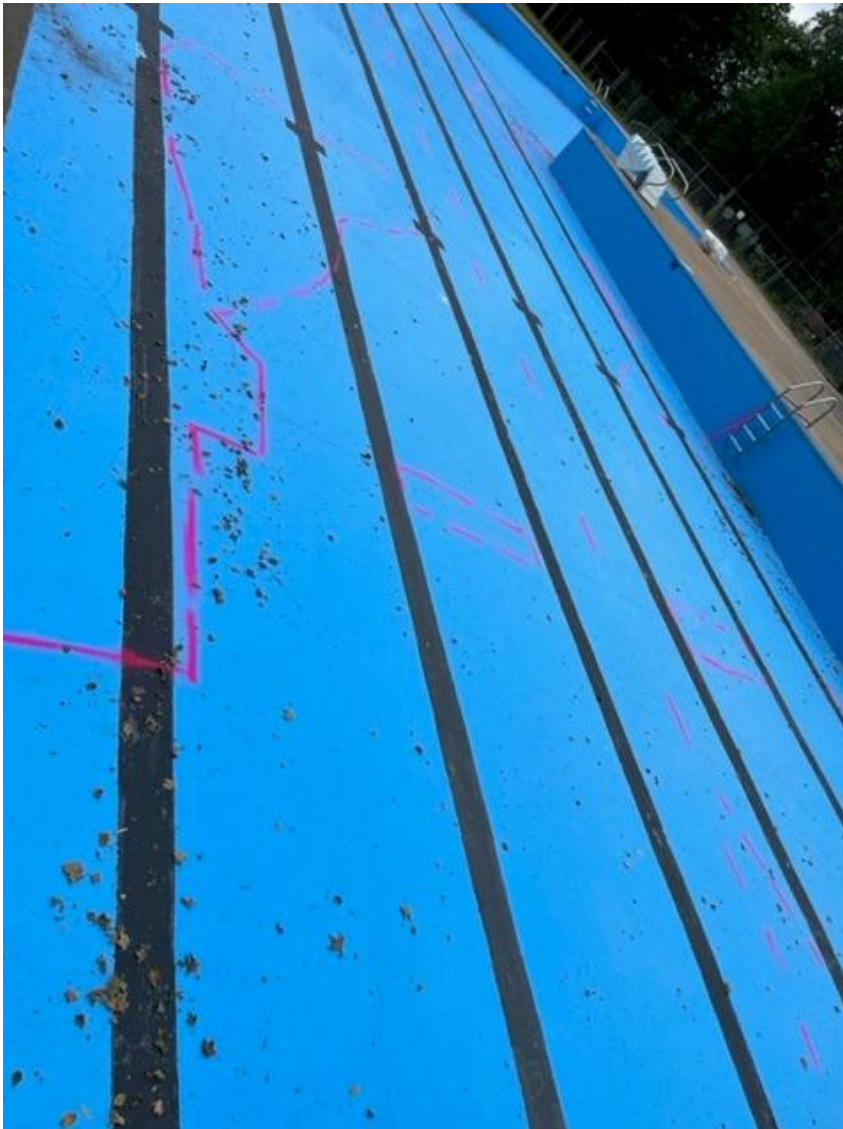
Churchill Hollow concrete taken from Hill side:

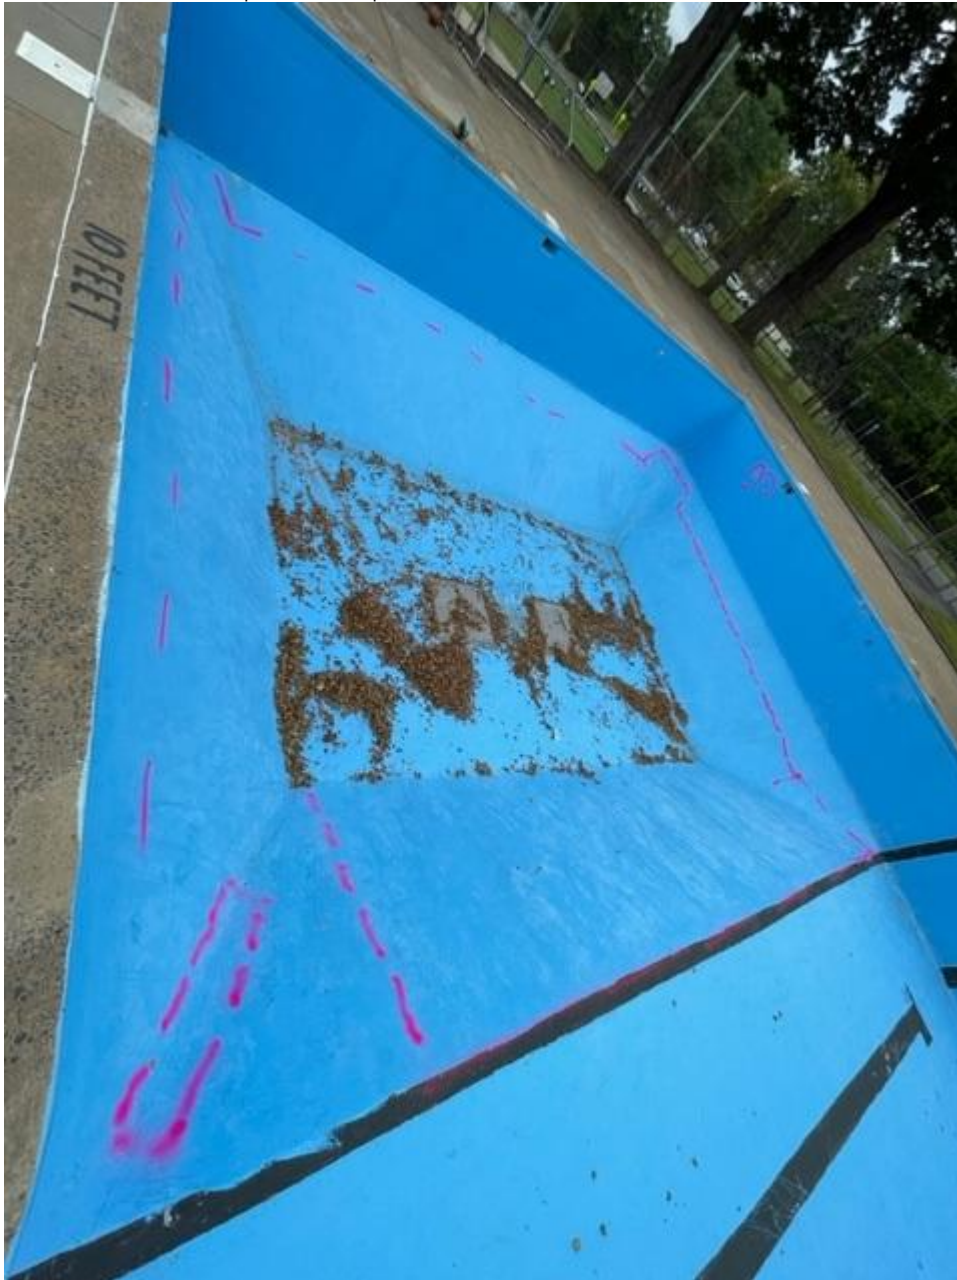
Churchill Hollow Deep End Sump:

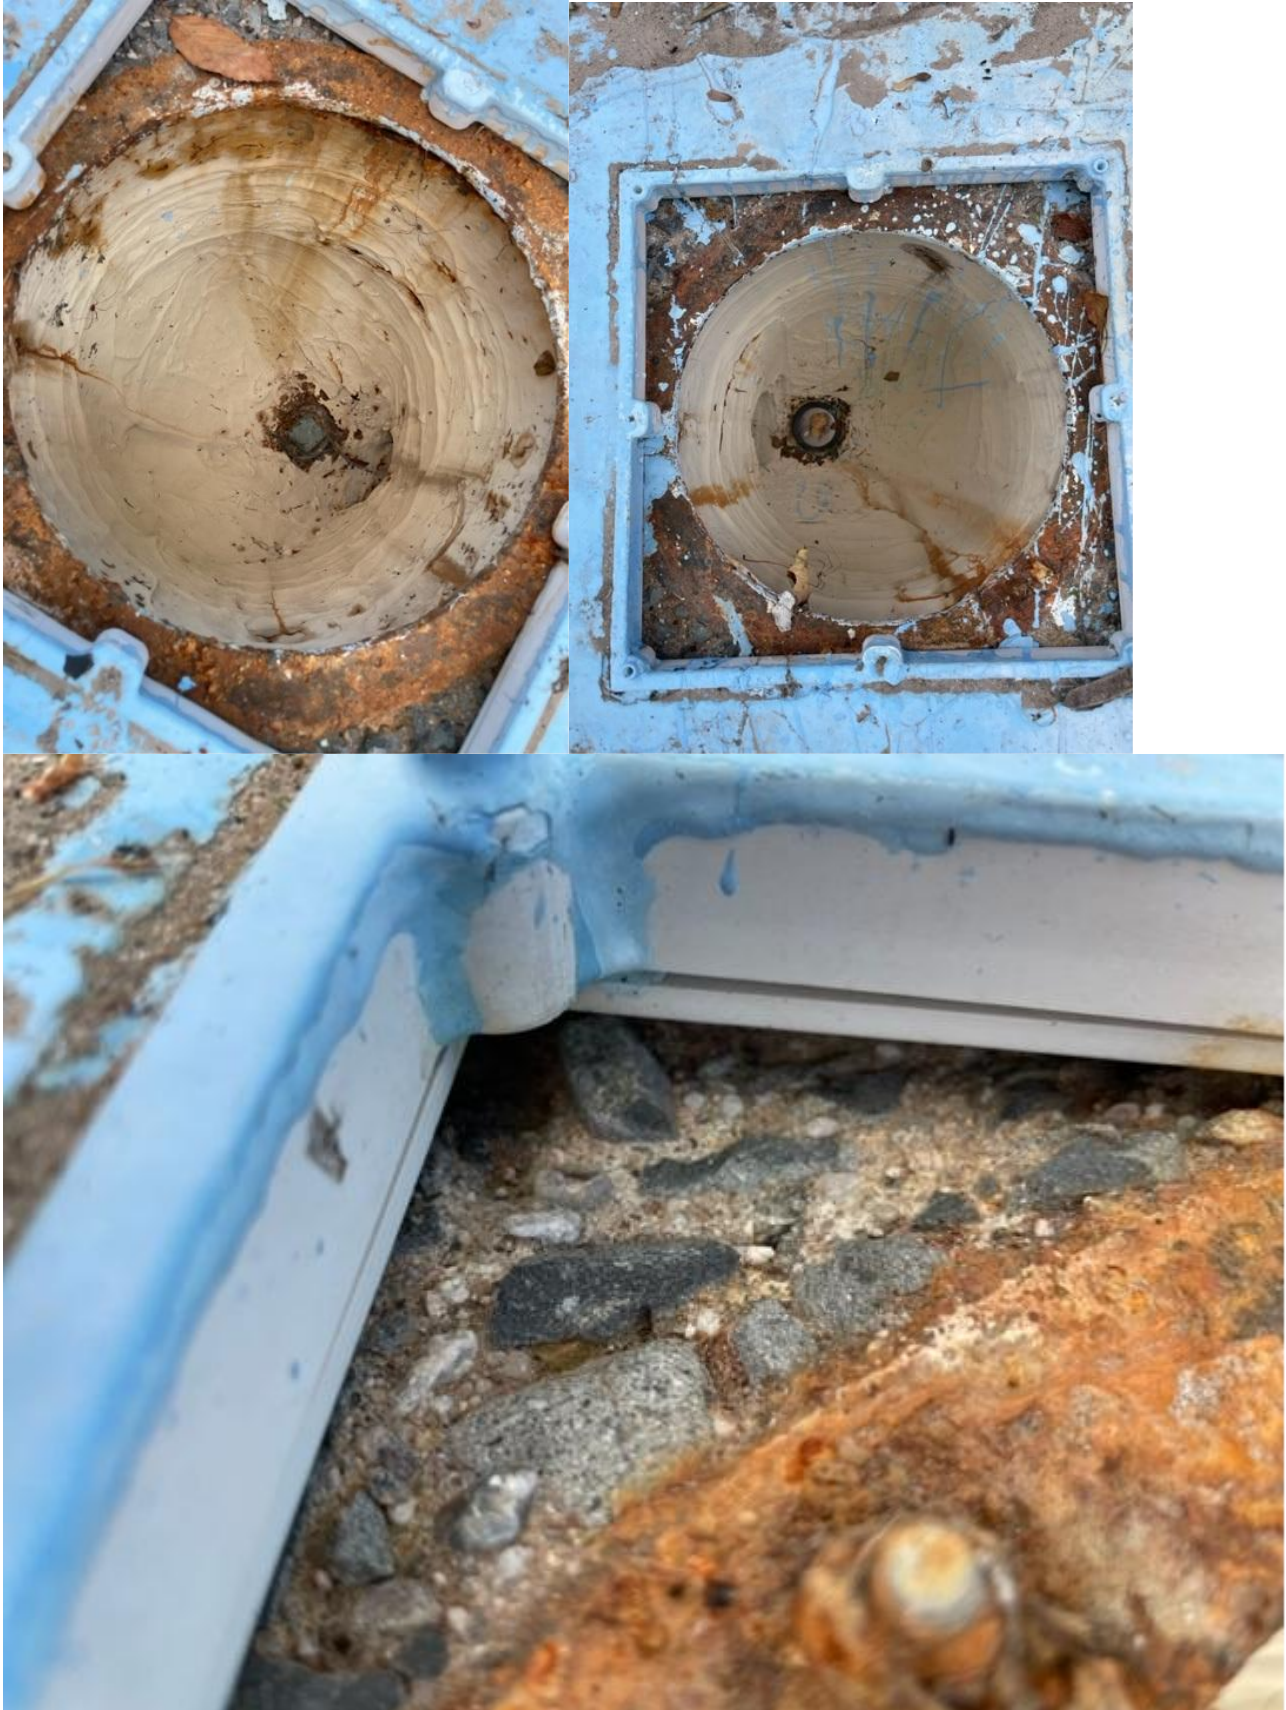
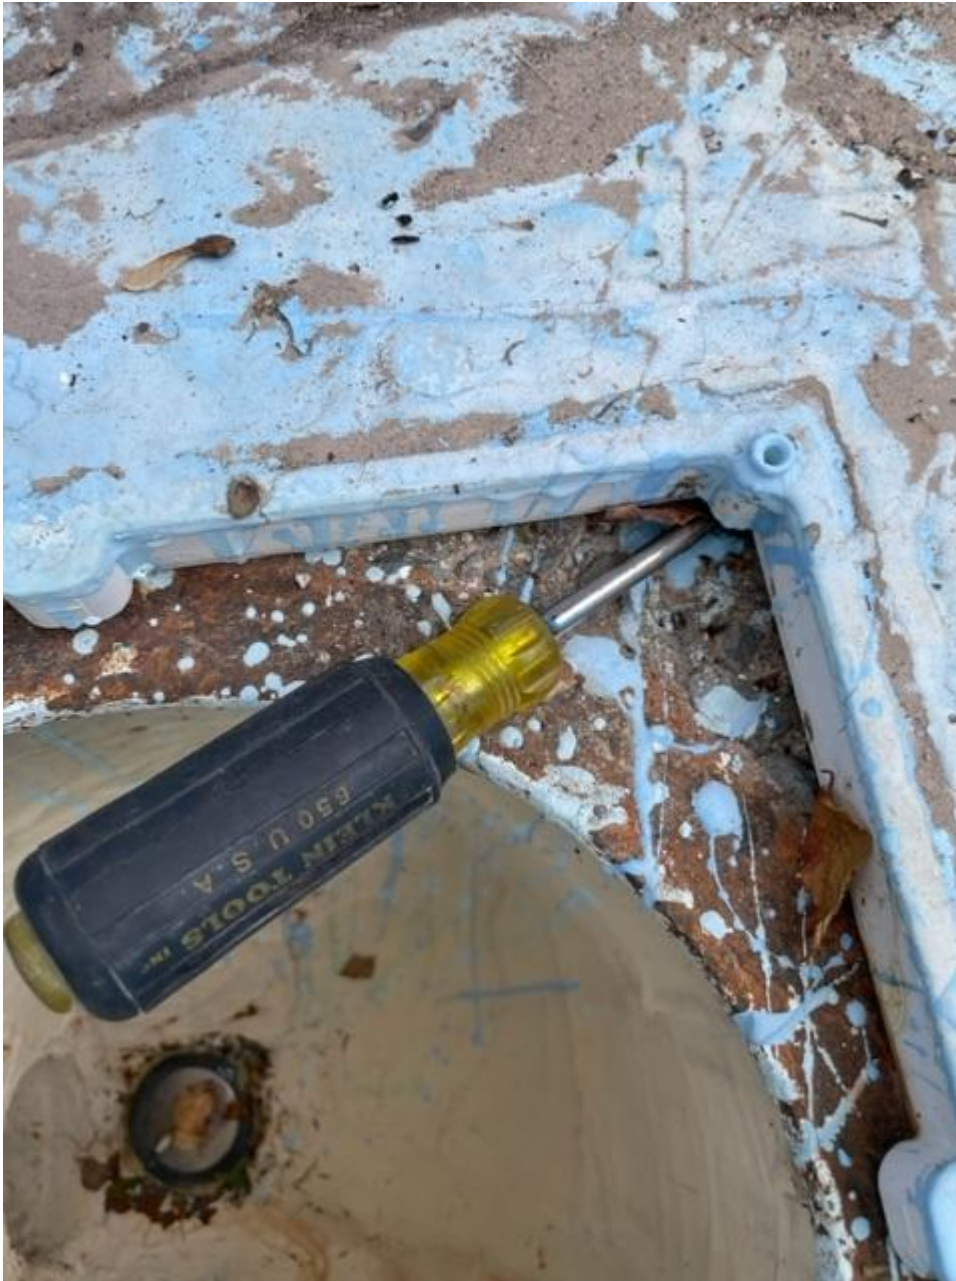
Churchill Failing Fiberglass Coating in Sump and water loss locations:

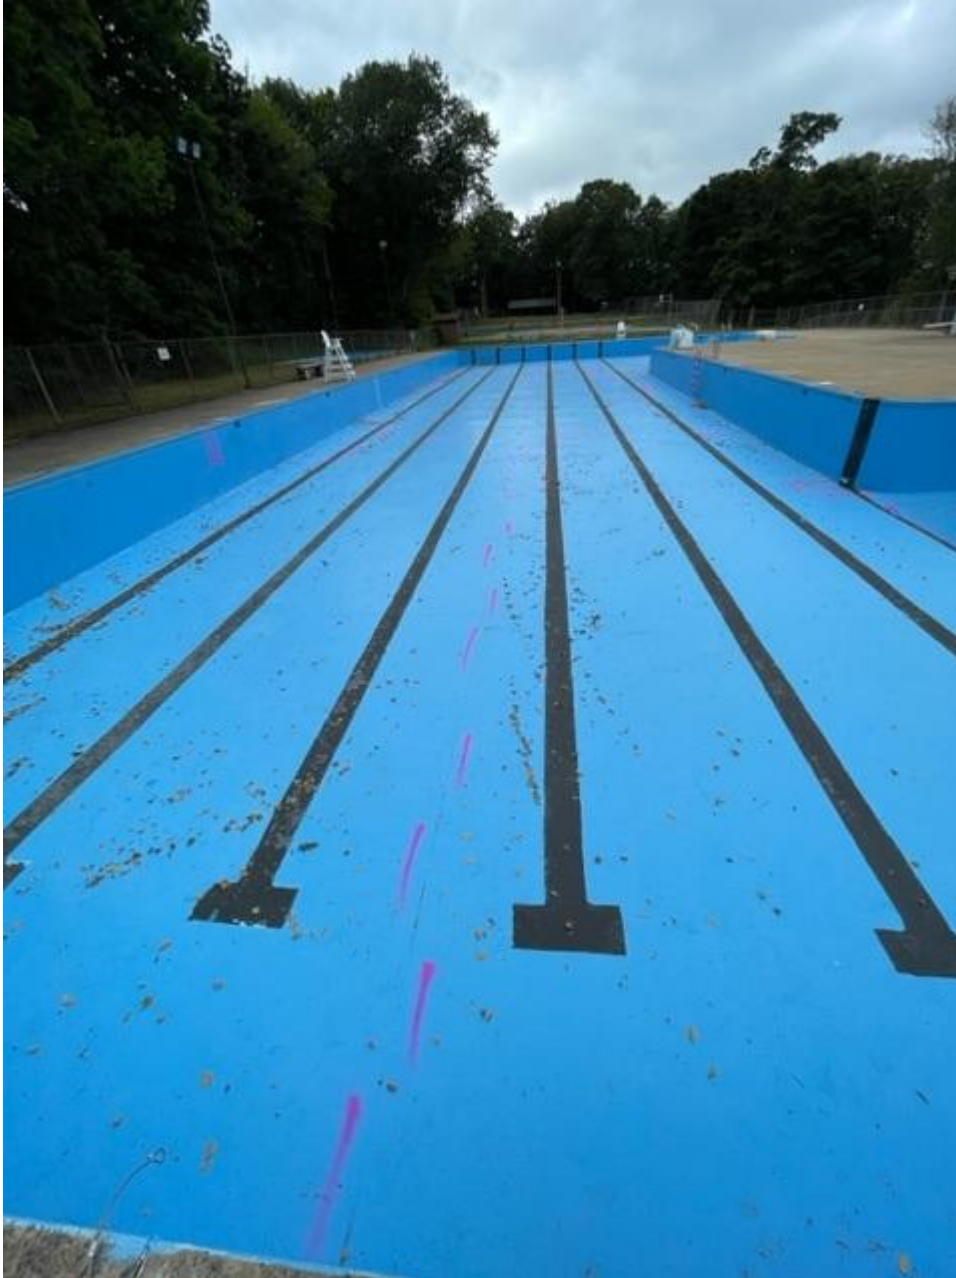
Churchill Hollow Expansion Joint:

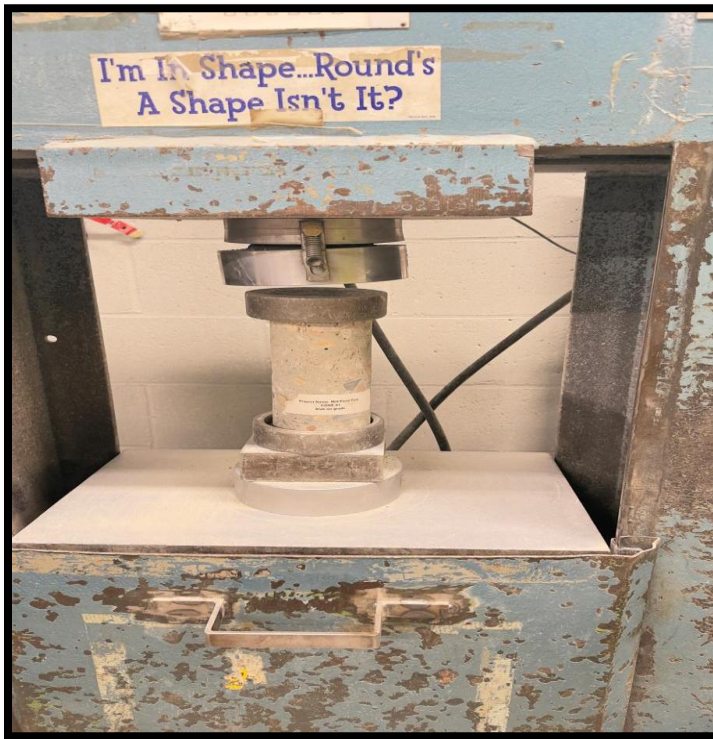
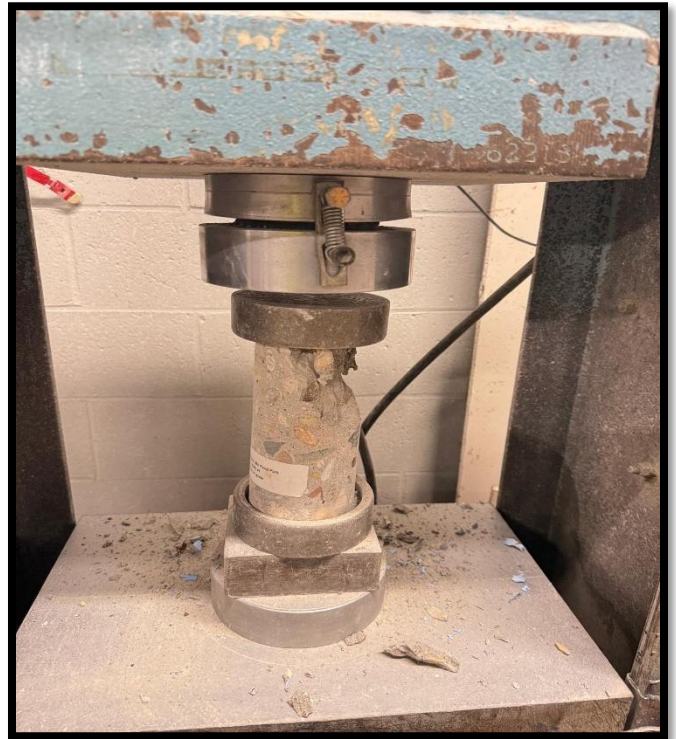
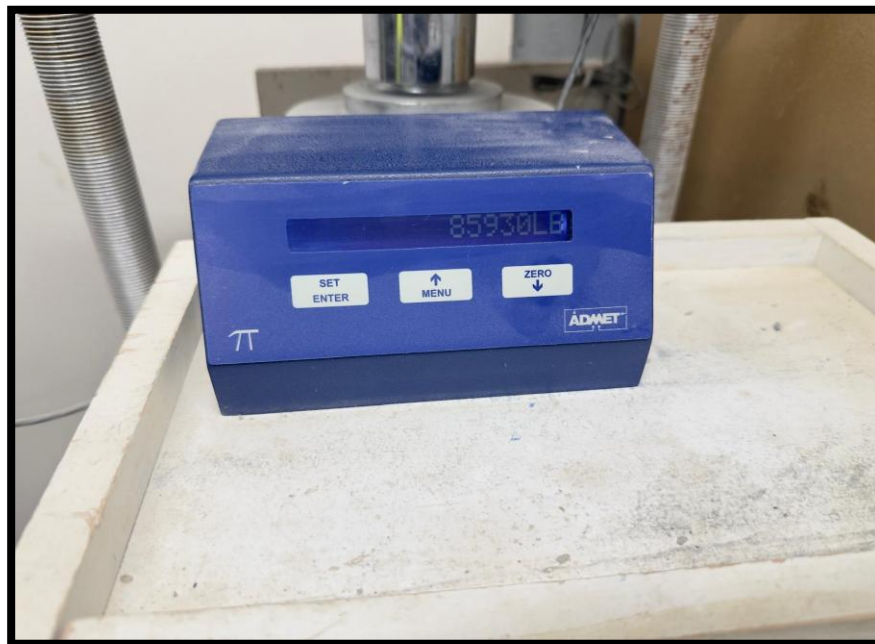
### Core #1

There were no visible cracks on the cores. The cores came out perfect that is also shown in the pictures attached above.

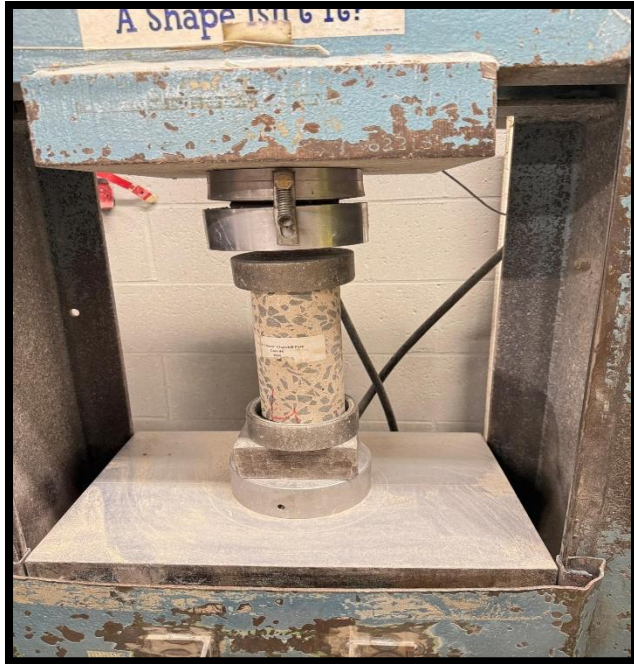
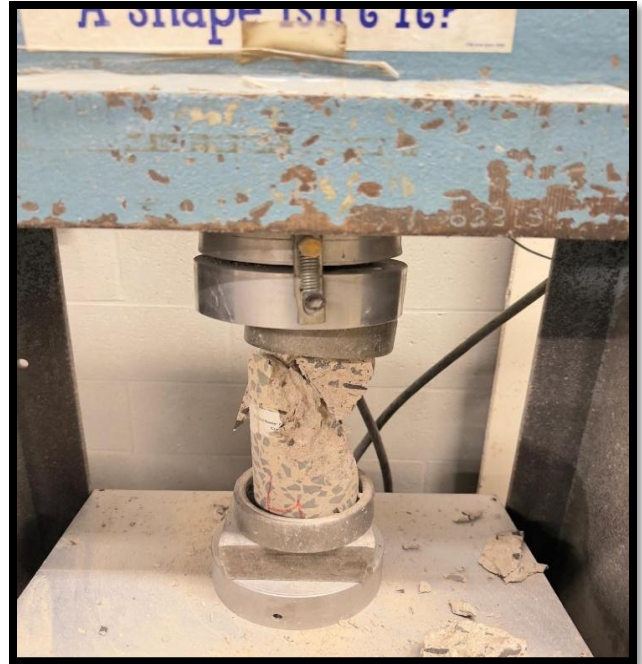
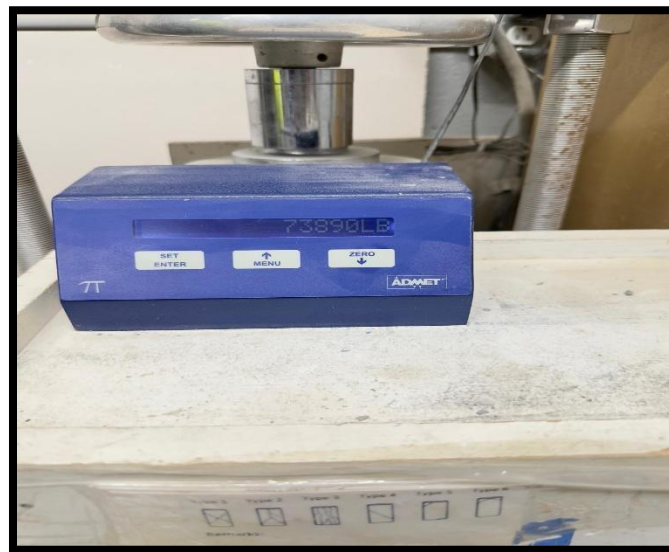
### Core #4

There were no visible cracks on the cores. The cores came out perfect that is also shown in the pictures attached above.

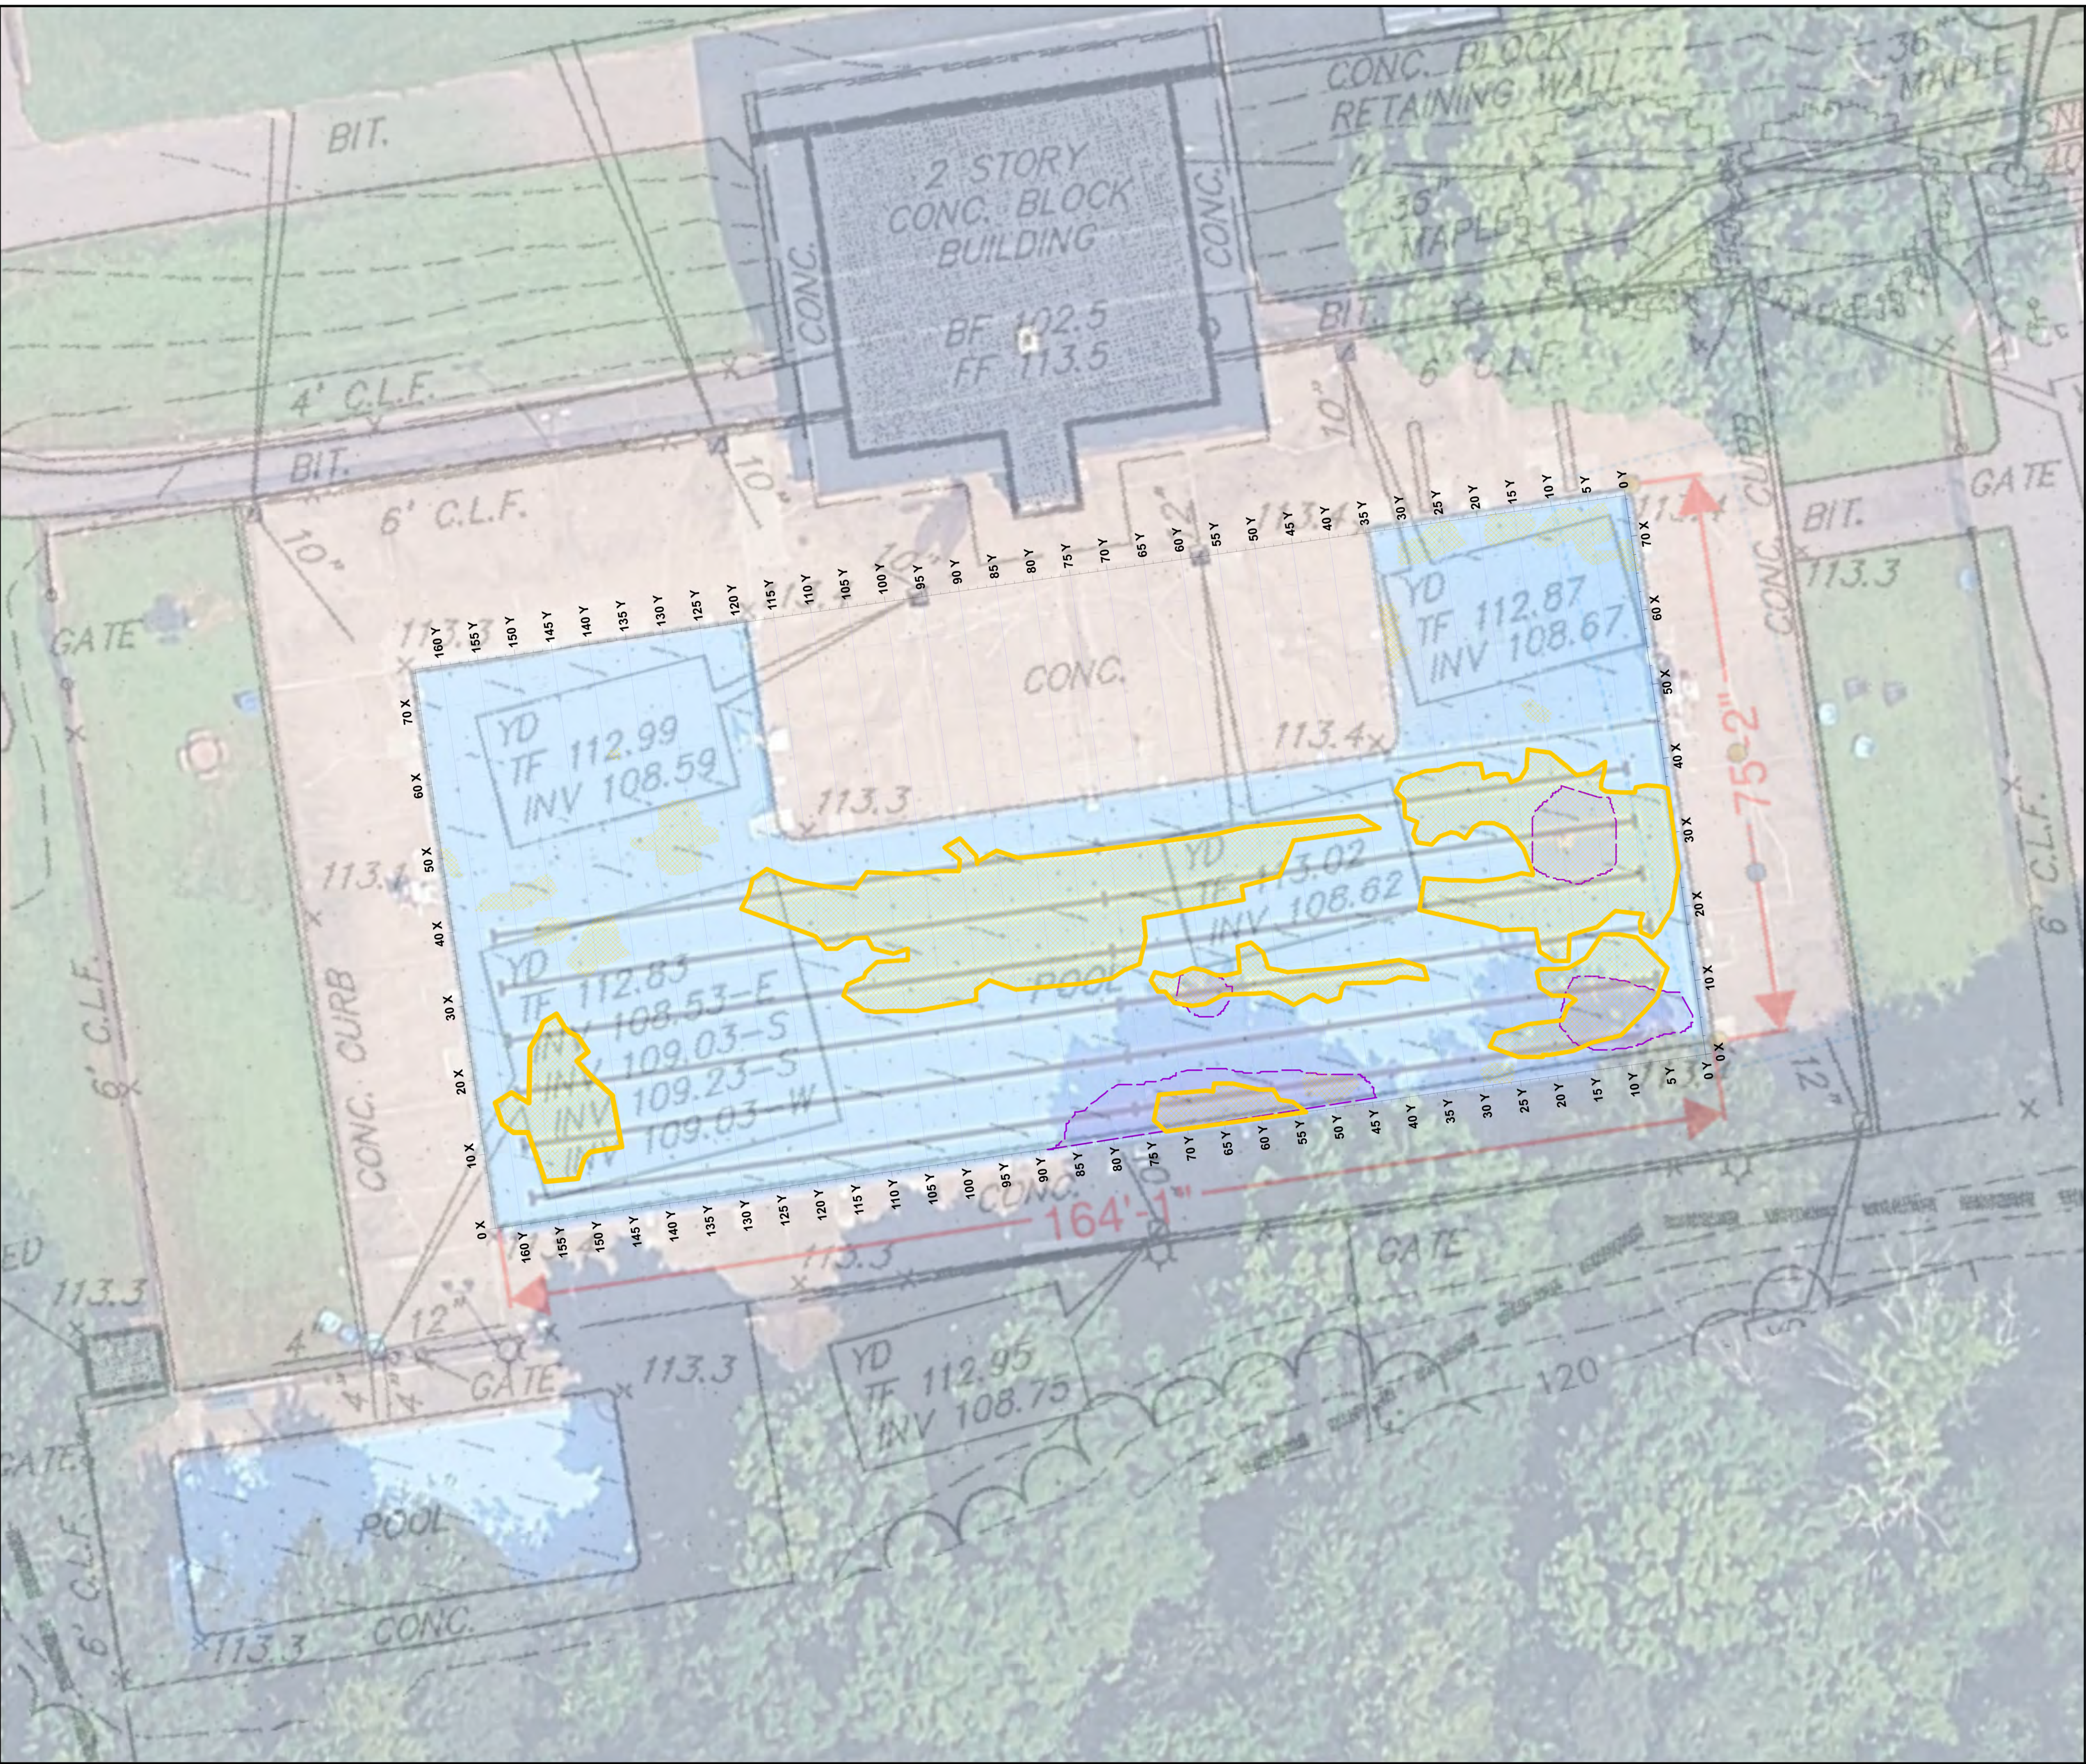
Interpreted areas of potential concrete  
delamination and cracking
