## Mill Pond Park Pool Evaluation

Town of Newington  
131 Cedar Street  
Newington, CT 06111

March 2013

## **ENGINEERS REPORT**

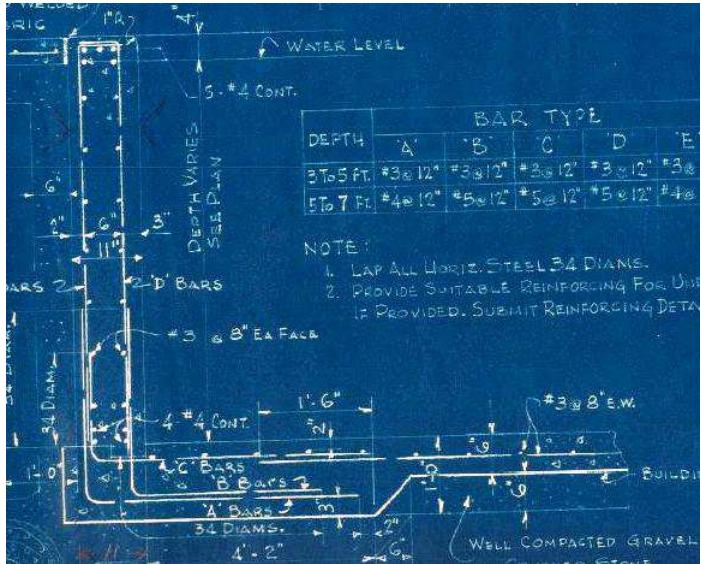
Figure 4 – Pool wall detail

called out are keyway joints with 9-inch pvc waterstop. The plans also show a French perimeter drainage system at the base of the pool floor.

Mill Pond is located very close to the pool and water comes through cracks in the wall when the pool is drained. The static water pressure relief valve in the deep end has been cemented over. The static valve should be working correctly to allow water to enter the pool if the ground water table rises. The concrete pool floor is lightly reinforced and not designed to handle upward pressures due high ground water. The pool floors and walls have numerous cracks, and have been patched in various locations. (Figure 5) The expansion joints in the pool appear to be properly caulked.

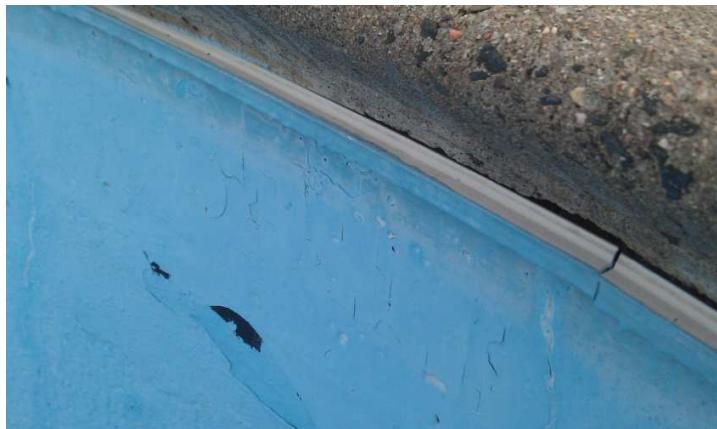
Figure 6 – Peeling paint and PVC joint separation

strip at the top of the pool walls is coming out in places and may be a source of water loss. (Figure 6)

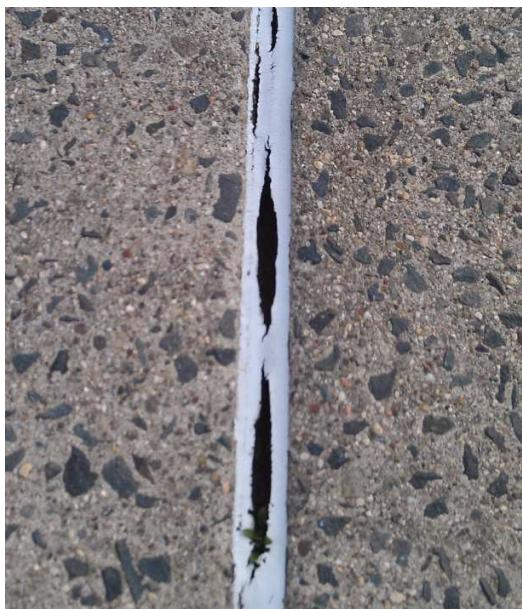
Figure 7 – Failed expansion joint caulking

The deck shows signs of settling and cracking in some areas that creates potential tripping hazard and can be uncomfortable and possibly cause an injury to bare feet. (Figure 8) Areas of the deck are discolored and some areas have been repaired. Overall the deck is not in too bad of shape for its age. Most of the caulking in the expansion joints on the decks is old brittle and cracked allowing for water to get beneath the deck and increase settling of the deck and the possibility of frost heaves. (Figure 7) Some of the expansion joints in the middle of the deck and the expansion joints between the deck and bathhouse are not sealed.

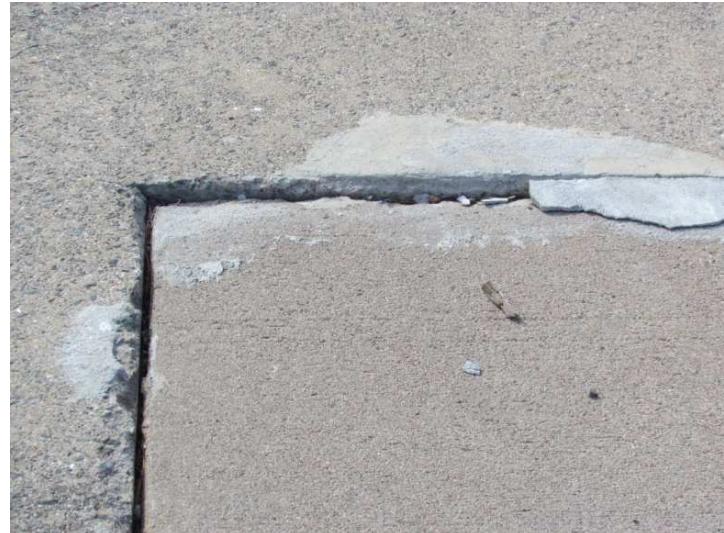
Figure 8 – Frost heave or settling concrete deck

The lack of a gutter or drain in the low spot between the bathhouse building and the pool has

caused concrete deck separation. All water in this area is

draining through cracks and is saturating the soil under the deck. Water saturated soil can also put pressure on pool and foundation walls. The perimeter of the deck closest to the pool is newer than the rest of the deck. This portion of the deck was removed in 1999 when the piping was replaced. Rust is showing through the concrete deck in some areas. The welded wire mesh may have been installed too close to the surface.

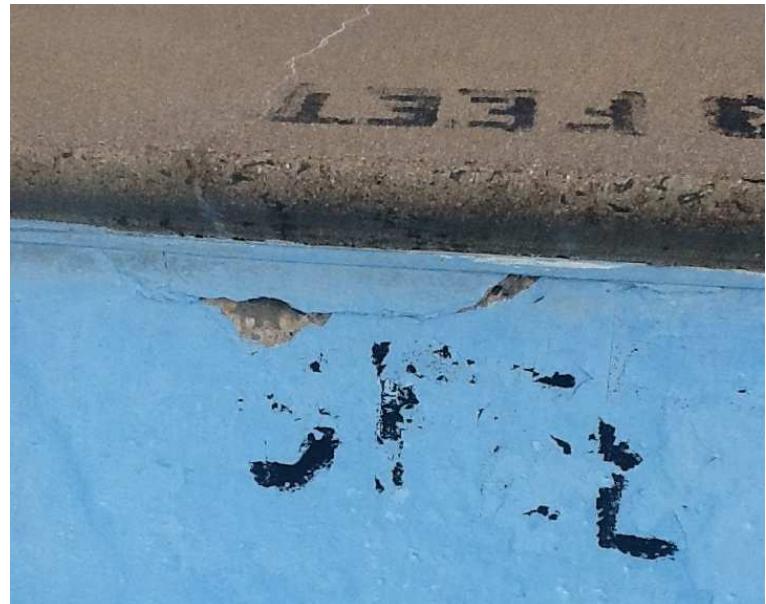
Figure 9 – Peeling depth markers

The depth markers on the pool walls and deck are hand painted or stickers. Most are faded or missing. (Figure 9) Some of the depth markers are incorrect. The depth must be measured from the floor of the pool to the water level.

Depth markers must be provided on the pool rim at points of minimum and maximum depths, at all points where the pool floor changes slope, and at appropriate points in between. Depth markers at these points must be visible from within the pool and while standing on the pool deck. Letters and numbers must be at least 4-inches tall.

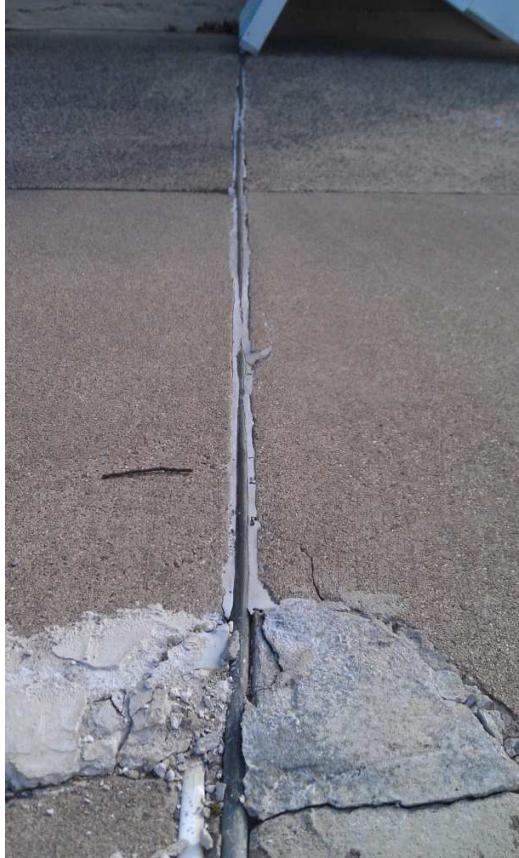
Figure 11 – Copper pipe for handicap lift

Pool staff reports new handicap lifts will be ordered for the upcoming season. The lifts will be hydraulic portable units, which need to be permanently anchored to meet ADA requirements (even though they are portable). This pool used to be equipped with a permanently mounted hydraulic (water powered) lift. The same connection can be used. The copper pipe connecting the lift was installed in an expansion joint in the concrete. The copper pipe is above the caulk and sticking out of the ground in areas. (Figure 11)

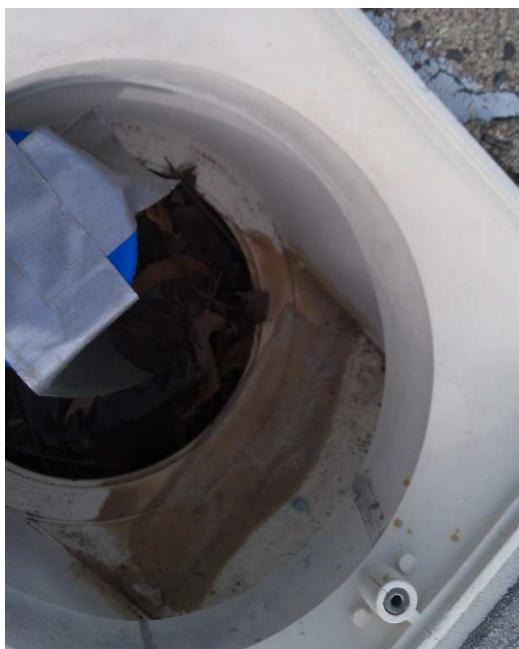
Figure 12 – Repaired skimmer

Many of the skimmers have stress cracks on the inside but have been repaired with fiberglass resin. (Figure 12) There are no skimmers along the deep end wall closest to

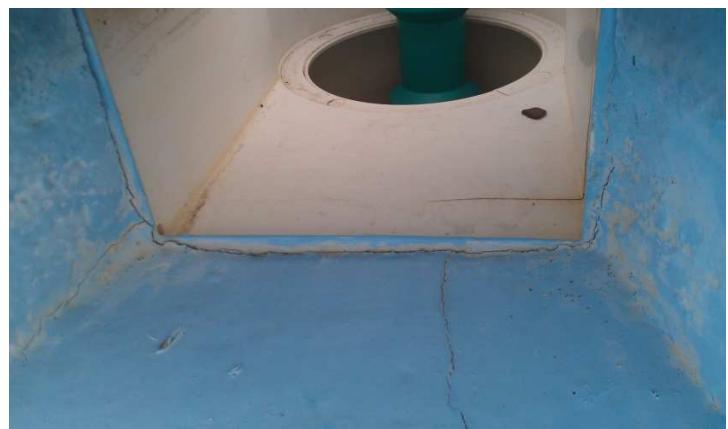
Figure 13 – Cracked joint between concrete and skimmer

the diving board. Skimmers are recommended in the deep end. The skimmers do not have equalization ports which are recommended by CT pool design guidelines. The skimmers appear to be cast in concrete with no caulking around the mouth of the skimmers. (Figure 13) The shrinkage between the skimmers and the concrete should be caulked to prevent water loss.

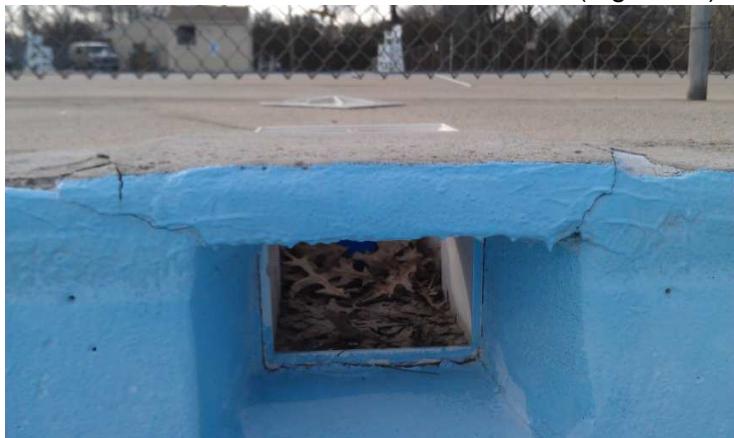
Figure 14 – Wading pool cracked coping above skimmer

The concrete coping is cracked in areas and has heaved around one of the skimmers. (Figure 14) The

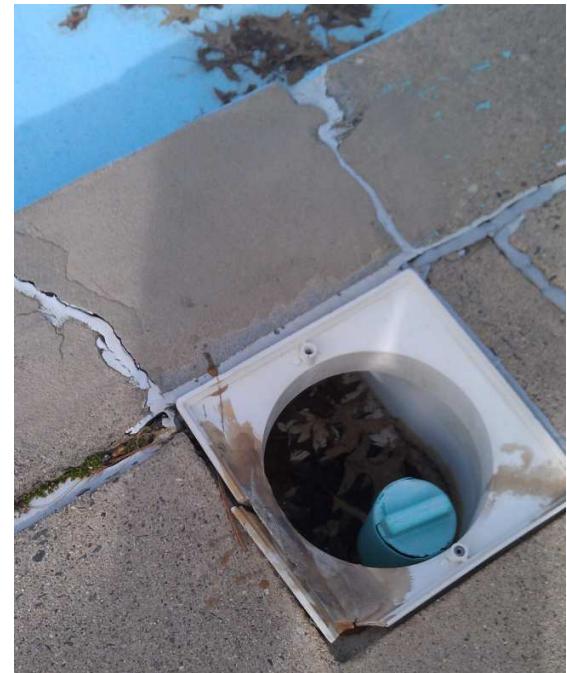
Figure 15 – Cracked skimmer and coping concrete

skimmers appear to be cast in concrete with no caulking around the mouth of the skimmers. The shrinkage between the skimmers and the concrete should be caulked. Some skimmers have cracked and have been repaired with fiberglass. (Figure 15)

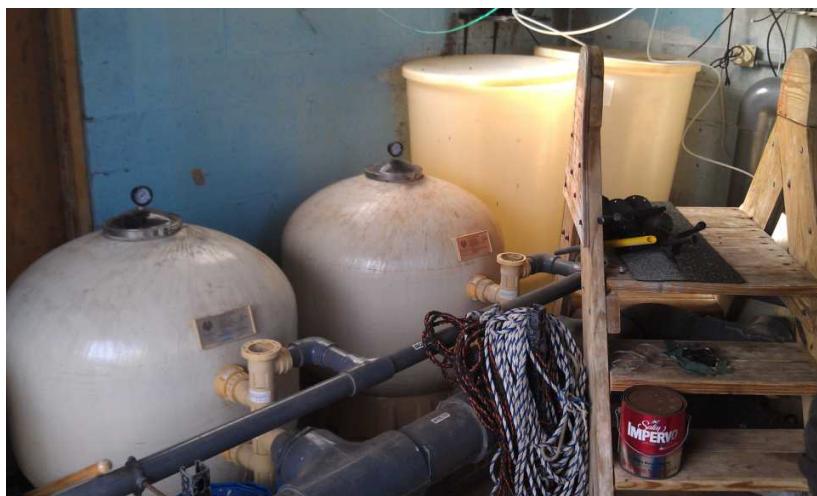
Figure 17 – Main pool filters, chemical storage, and stairs

An emergency eyewash station was present. Acid is used to lower pH. Carbon Dioxide (CO<sub>2</sub>) is much more commonly used than acid because it is less hazardous and is commonly available. Chemical tanks should have secondary containment in case of a leak. (Figure 17)

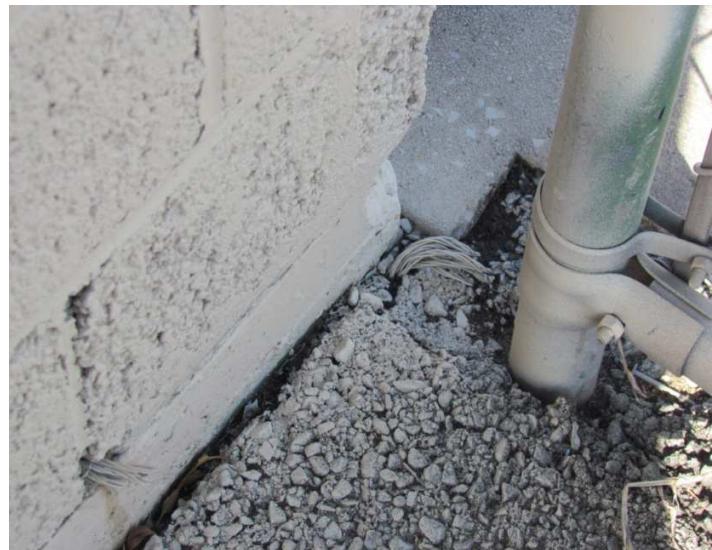
Figure 18 – Cut bonding or grounding wire

The existence of an electrical bonding grid around the pool is unknown, and probably non-existent. If major repairs are made metal deck equipment in the pool area and concrete reinforcement will need to be connected to a bonding grid. The bonding grid must connect to the pool pump. The pump is not bonded, and no bonding is shown on the plans. A wire just outside of the equipment room has been cut after it exits the building and before it enters the ground. (Figure 18) This wire may be either a ground wire or bonding wire.

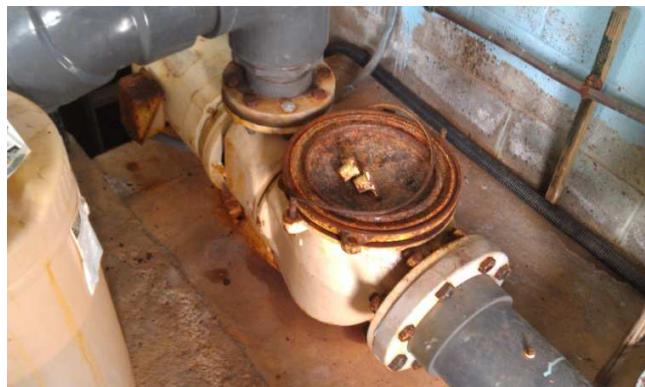
Figure 19 – Main pool pump

General corrosion inside the equipment room is apparent. Electrical panels, the pump, pipe flanges, and flange hardware are corroded. The paint on the cement block walls is delaminating (either from cement deterioration, moisture, or chemical exposure). Improved ventilation will reduce corrosion. A copper water pipe is not securely attached to the wall and is free to vibrate.

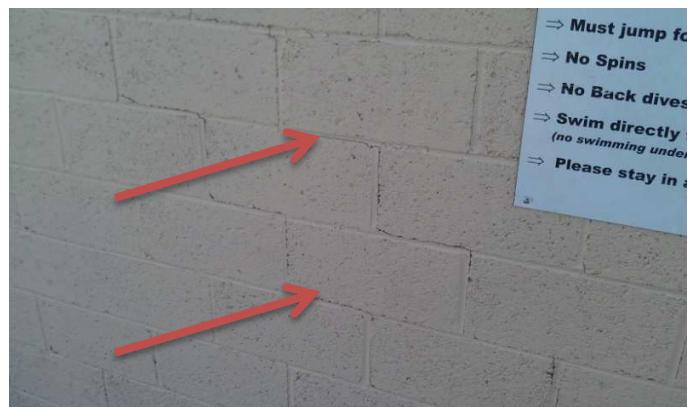
Figure 22 – Traveling cracks on filter building

The exterior CMU block walls on both buildings are painted. The masonry joints need to be caulked or repointed in numerous areas. There are a handful of holes in the CMU block on the outside of the building that should be filled with mortar or caulk. The holes may be from old piping or conduit. Some of the joints on the filter building show traveling cracks. (Figure 22)

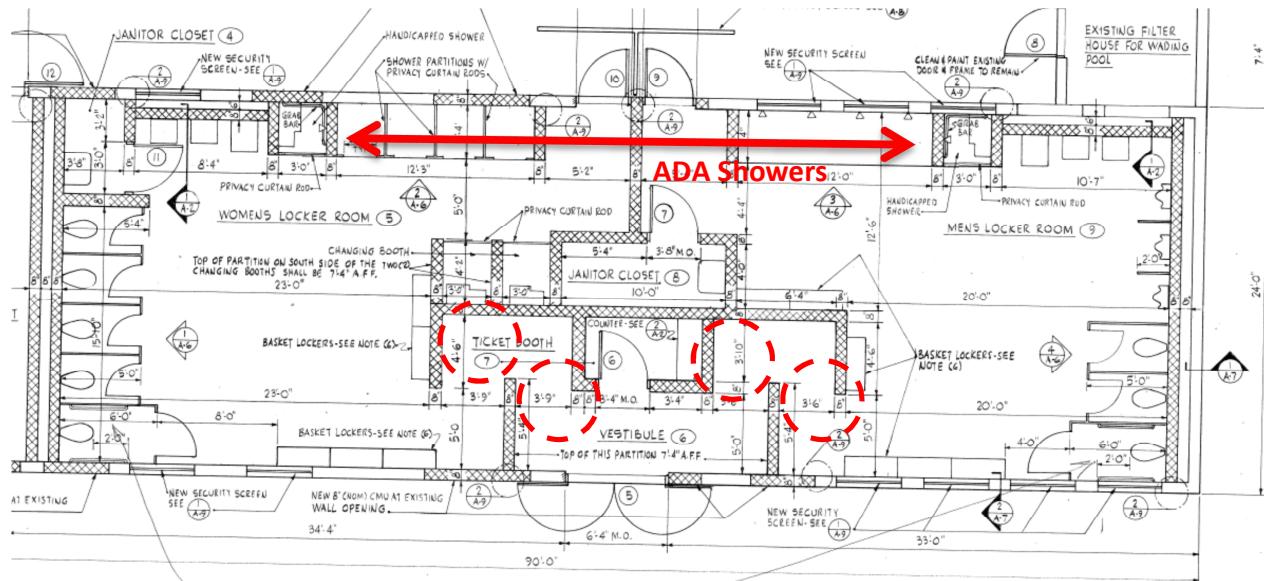
Figure 25 – ADA issue areas (showers and insufficient turning radiiuses)

A clear 5' of width is required at all turning points for wheelchairs. (Figure 25)

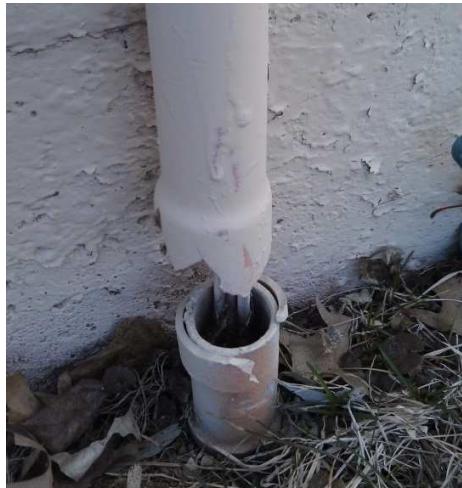
Figure 26 – Conduit at rear of filter building

The rear of the filter building has a snapped conduit with exposed wires (Figure 26). Conduit failure is common along foundation walls where conduit expansion joints are not installed, and the foundation has settled or heaved. The window glazing is cracked and in serious need of repair (Figure 27). The metal fascia and soffit on the bathhouse is falling out and missing in areas (Figure 28).

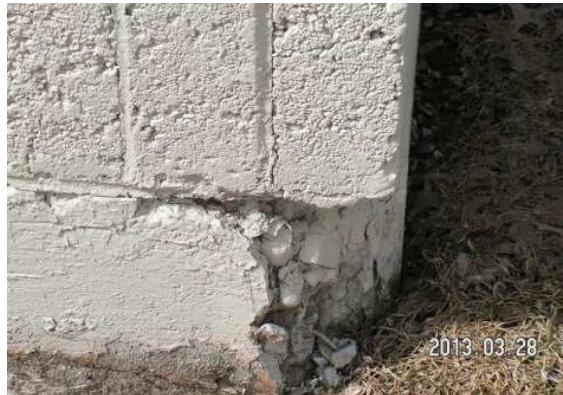
Figure 31 – Foundation spalling

The foundation is experiencing some cracking and spalling of concrete at the northeast corner of the building. (Figure 31) The threshold at the patron's entrance at the rear double door does not

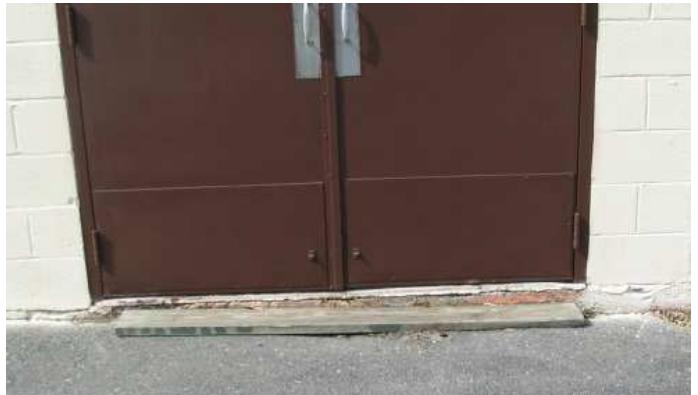
Figure 32 – Bathhouse entrance trip hazard

meet ADA due to the finish grade of the bituminous walkway. There is a loose 2x plank used to mitigate the change in elevation, which poses a tripping hazard. (Figure 32)
