Mill Pond Park Newington, Connecticut

PRELIMINARY MASTER PLAN

TLB Architecture

01—2013 and 2020 Mill Pond Pool Evaluations

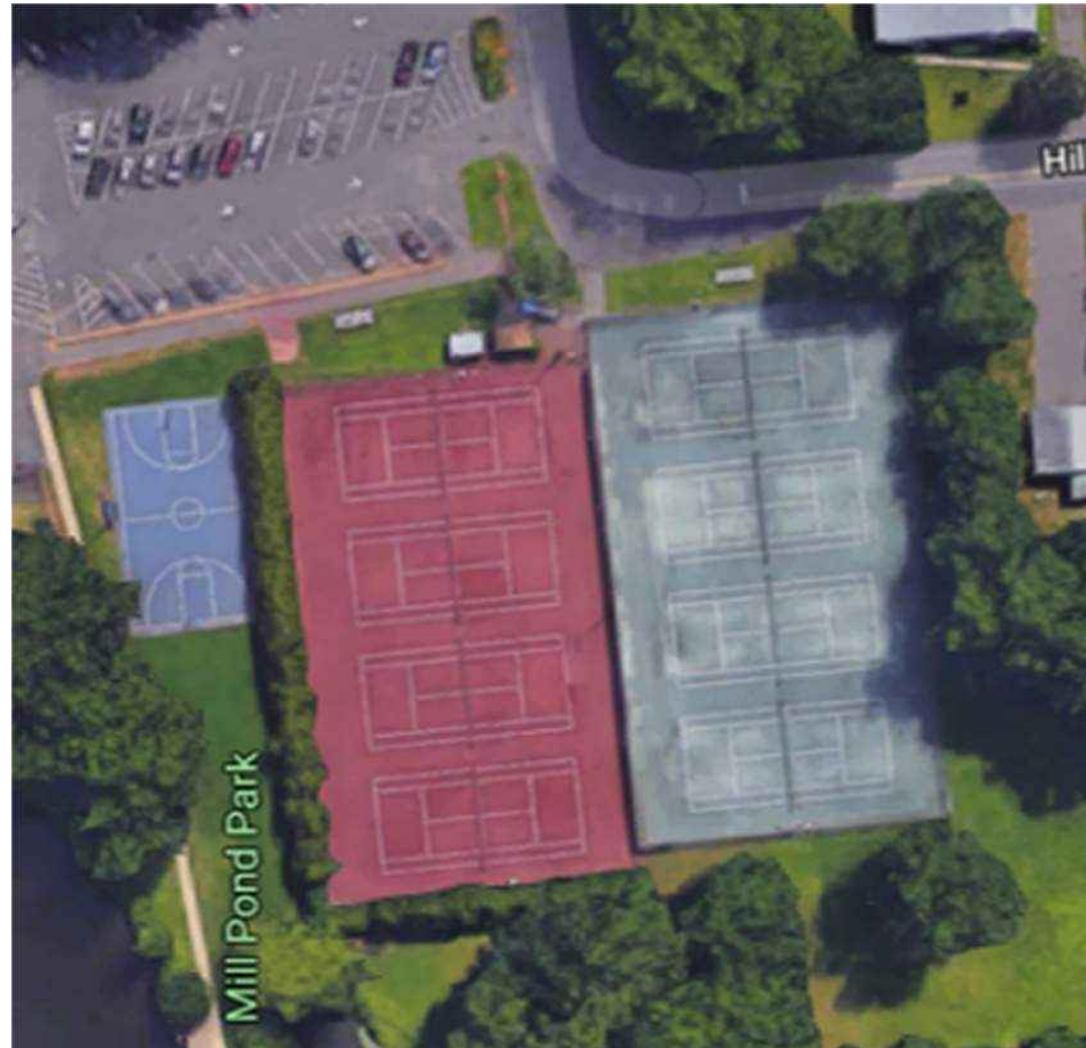
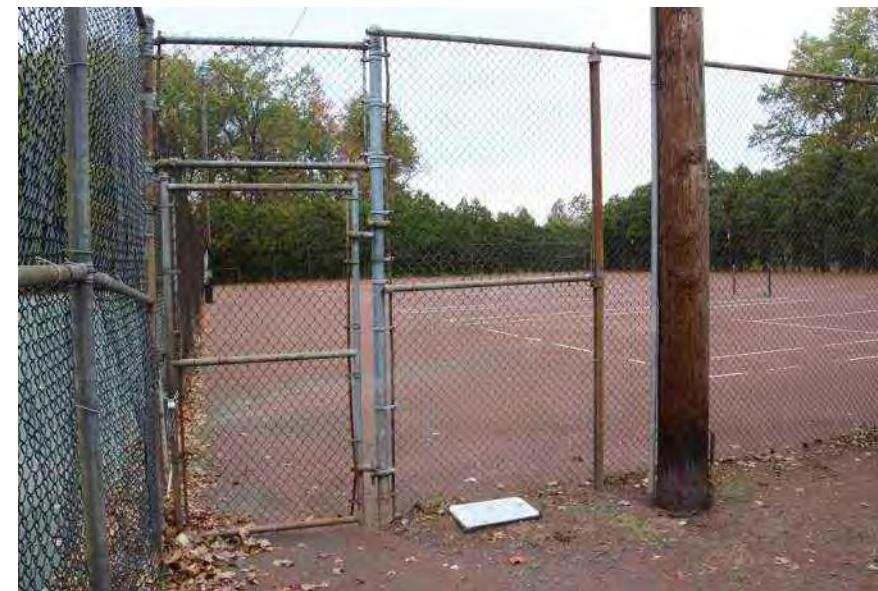
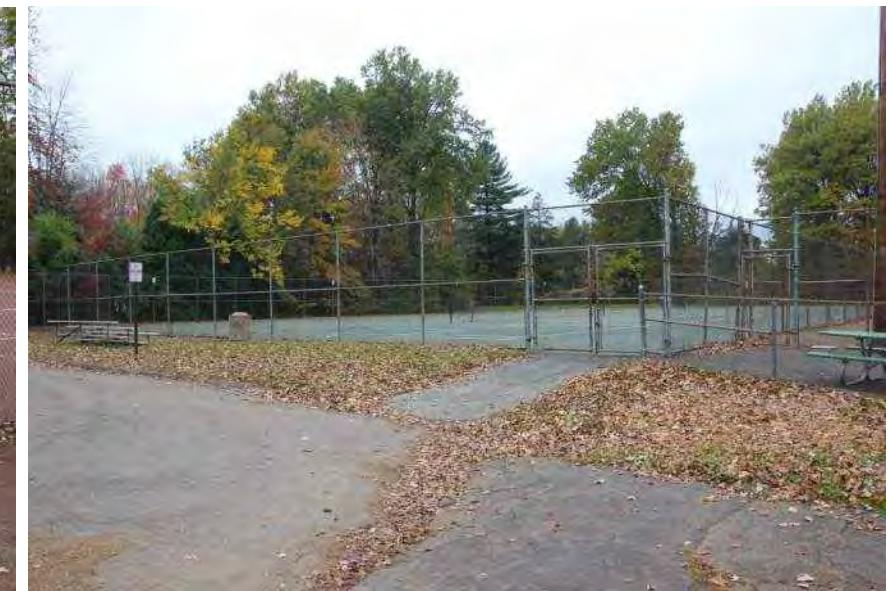
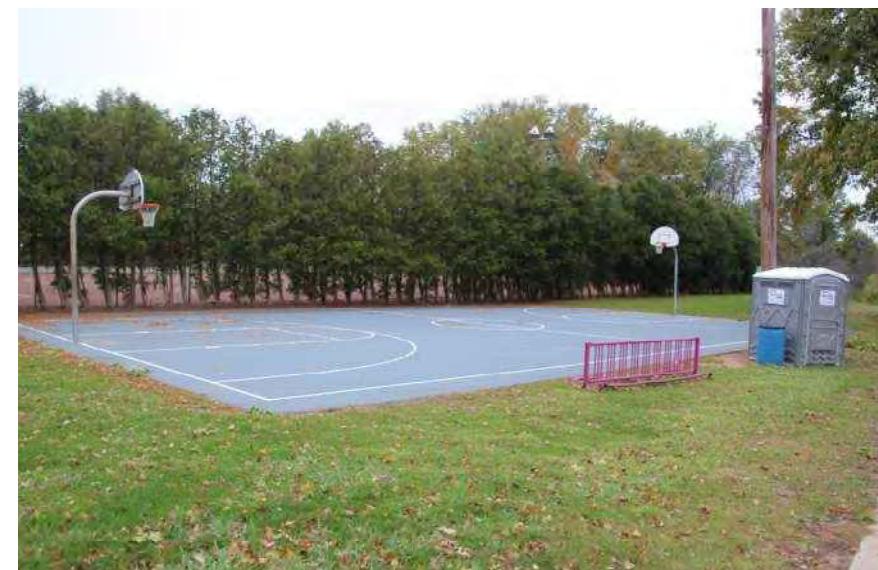
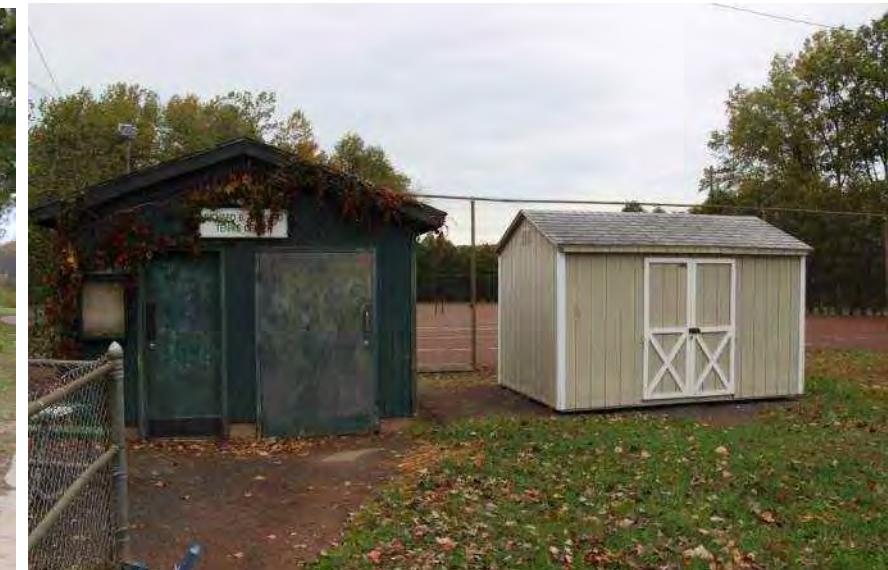
Tennis Courts and Basketball Court

The tennis facility, inclusive of the courts, fencing and storage buildings is in very poor condition and in need of complete replacement.

The basketball court suffers from cracks, broken edges and uneven pavement and is also in need of replacement.

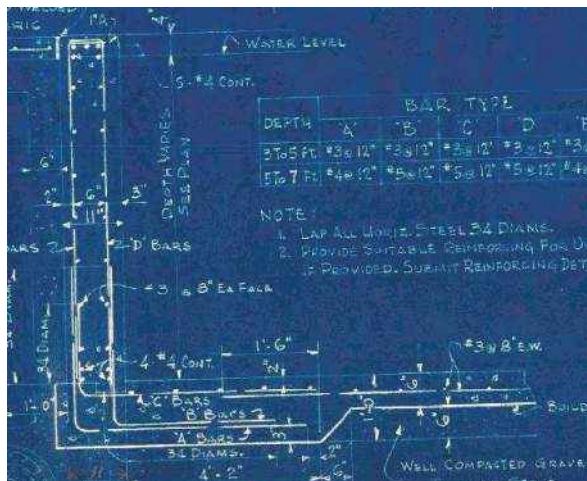
Figure 4 – Pool wall detail

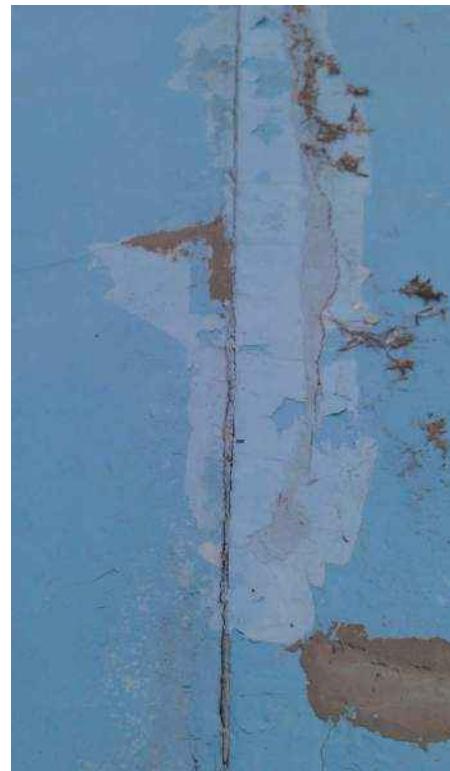
Mill Pond is located very close to the pool and water comes through cracks in the wall when the pool is drained. The static water pressure relief valve in the deep end has been cemented over. The static valve should be working correctly to allow water to enter the pool if the ground water table rises. The concrete pool floor is lightly reinforced and not designed to handle upward pressures due high ground water. The pool floors and walls have numerous cracks, and have been patched in various locations. (Figure 5) The expansion joints in the pool appear to be properly caulked.

Figure 5 – Expansion joint, cracks, and patches

- Option 1: Repair cracks in the pool walls with hydrophobic polyurethane grout crack injection. Replace all caulking and backer rod in expansion joints.
- Option 2: Install a new gunite pool inside the shell of the existing pool.
- Option 3: Remove the existing pool shell and install a completely new pool.
- Replace corroded valves, fittings, main pool pump, and corroded hardware.
- Replace the acid injection system with a CO₂ system.
- Install new chemical control equipment.
- Epoxy paint entire pool
- Replace depth markings.
- Replace concrete pool deck and sub base. Incorporate deck drains where needed.
- Replace diving board & stand.

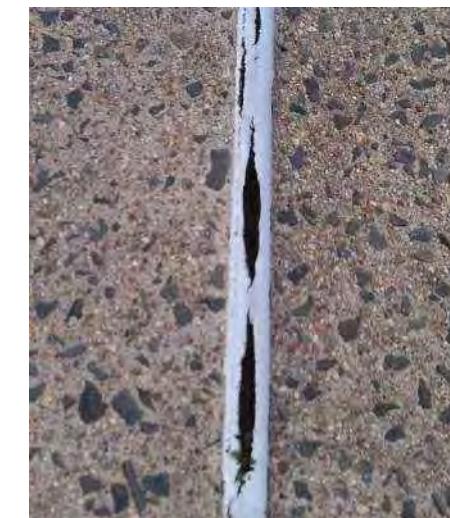
Figure 7 – Failed expansion joint caulking

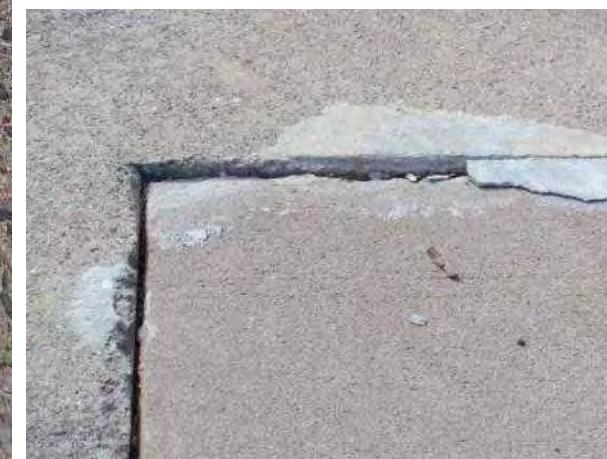
The deck shows signs of settling and cracking in some areas that creates potential tripping hazard and can be uncomfortable and possibly cause an injury to bare feet. (Figure 8) Areas of the deck are discolored and some areas have been repaired. Overall the deck is not in too bad of shape for its age. Most of the caulking in the expansion joints on the decks is old brittle and cracked allowing for water to get beneath the deck and increase settling of the deck and the possibility of frost heaves. (Figure 7) Some of the expansion joints in the middle of the deck and the expansion joints between the deck and bathhouse are not sealed.

The lack of a gutter or drain in the low spot between the bathhouse building and the pool has caused concrete deck separation. All water in this area is

Figure 8 – Frost heave or settling concrete deck

draining through cracks and is saturating the soil under the deck. Water saturated soil can also put pressure on pool and foundation walls. The perimeter of the deck closest to the pool is newer than the rest of the deck. This portion of the deck was removed in 1999 when the piping was replaced. Rust is showing through the concrete deck in some areas. The welded wire mesh may have been installed too close to the surface.

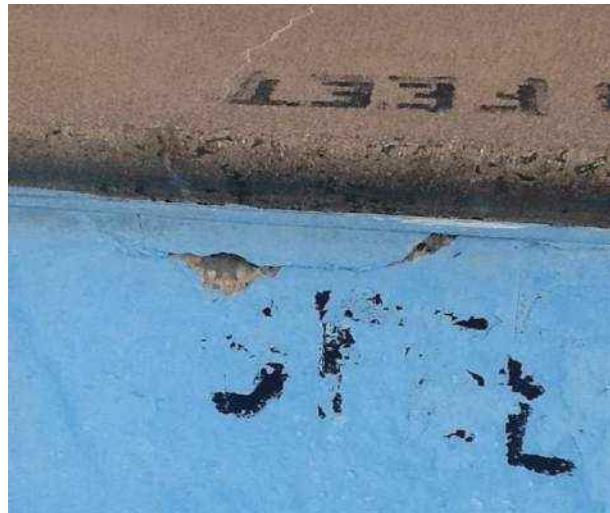
The depth markers on the pool walls and deck are hand painted or stickers. Most are faded or missing. (Figure 9) Some of the depth markers are incorrect. The depth must be measured from the floor of the pool to the water level.

Figure 9 – Peeling depth markers

- Repair gaps in fence, and secure loose fence areas.
- Review the inventory of lifesaving equipment and replace or supplement as necessary.
- Modify the main drain piping to keep water velocity flow rates under the rating on the Virginia Graeme Baker covers. This may conflict with CT pool guidelines, but is the only short-term solution.
- Remove the existing diving boards, and install smaller up to date boards that are compliant with the deep end dimensions.
- Replace depth markings.

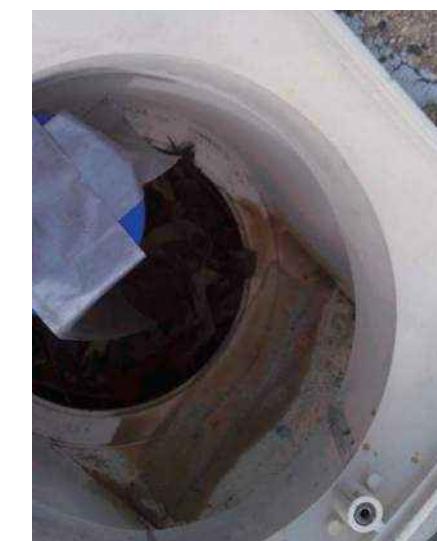
Figure 12 – Repaired skimmer

Many of the skimmers have stress cracks on the inside but have been repaired with fiberglass resin. (Figure 12) There are no skimmers along the deep end wall closest to

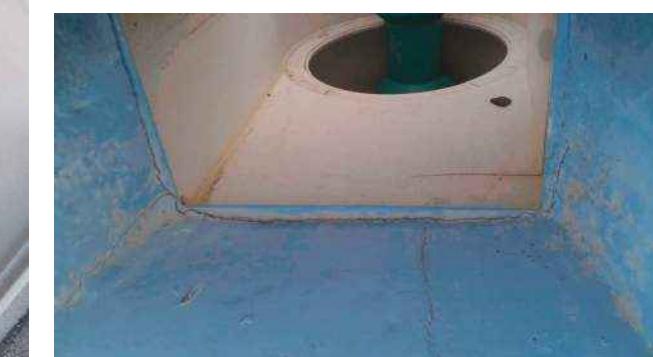
Figure 13 – Cracked joint between concrete and skimmer

the diving board. Skimmers are recommended in the deep end. The skimmers do not have equalization ports which are recommended by CT pool design guidelines. The skimmers appear to be cast in concrete with no caulking around the mouth of the skimmers. (Figure 13) The shrinkage between the skimmers and the concrete should be caulked to prevent water loss.

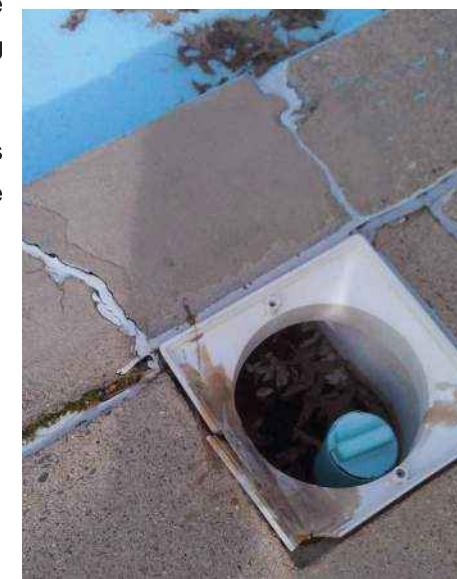
Figure 15 – Cracked skimmer and coping concrete

skimmers appear to be cast in concrete with no caulking around the mouth of the skimmers. The shrinkage between the skimmers and the concrete should be caulked. Some skimmers have cracked and have been repaired with fiberglass. (Figure 15)

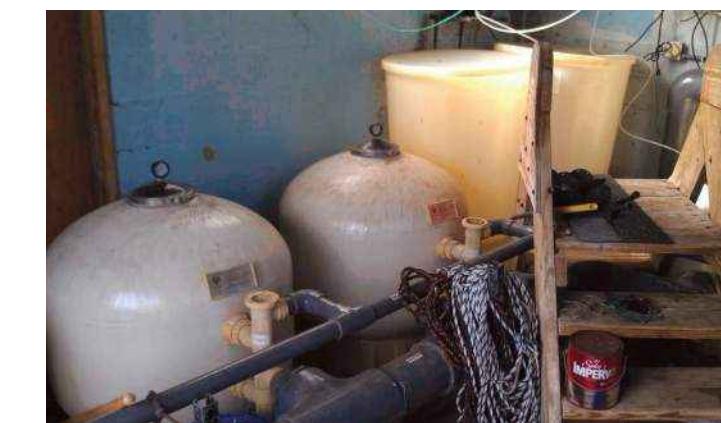
Figure 17 – Main pool filters, chemical storage, and stairs

An emergency eyewash station was present. Acid is used to lower pH. Carbon Dioxide (CO₂) is much more commonly used than acid because it is less hazardous and is commonly available. Chemical tanks should have secondary containment in case of a leak. (Figure 17)

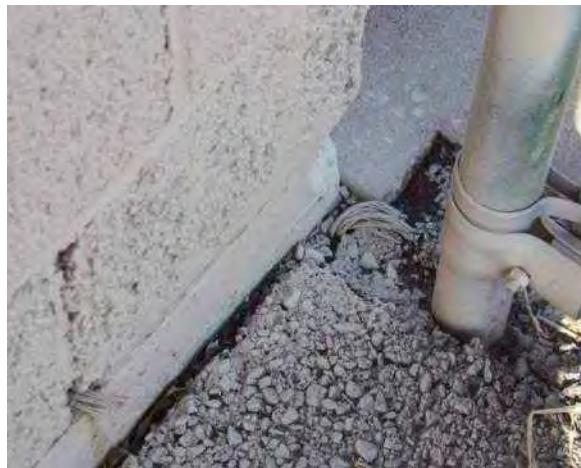
The existence of an electrical bonding grid around the pool is unknown, and probably non-existent. If major repairs are made metal deck equipment in the pool area and concrete reinforcement will need to be connected to a bonding grid. The bonding grid must connect to the pool pump. The pump is not bonded, and no bonding is shown on the plans. A wire just outside of the equipment room has been cut after it exits the building and before it enters the ground. (Figure 18) This wire may be either a ground wire or bonding wire.

Figure 18 – Cut bonding or grounding wire

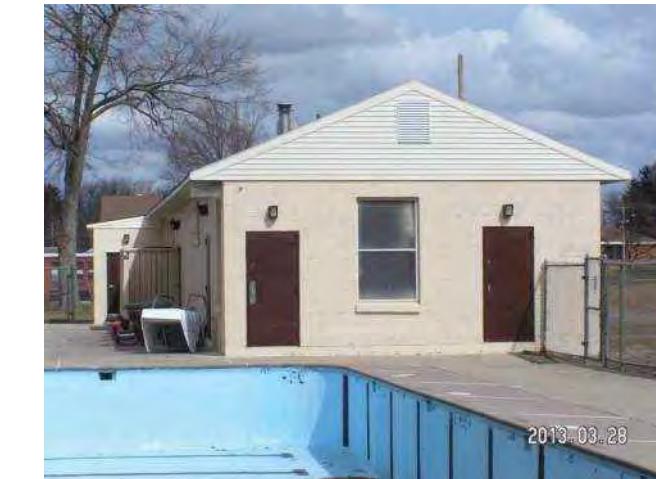
Figure 30 – Side of bathhouse

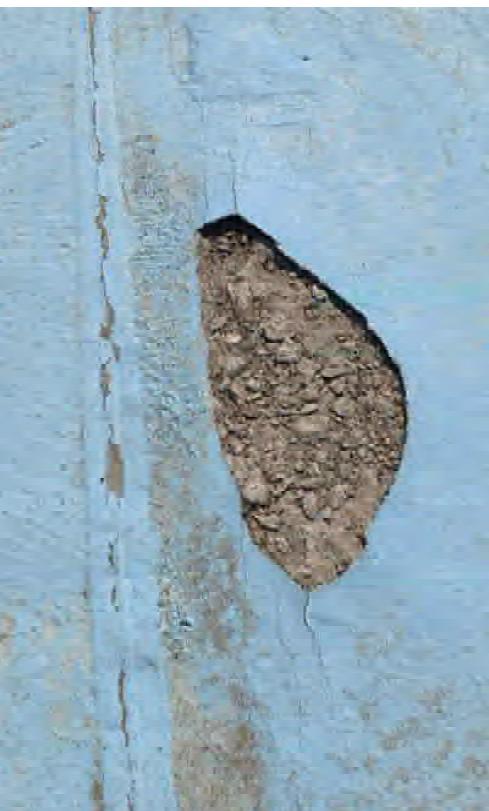
Pool concrete has numerous cracks, spalls and delaminated areas. The photos to the right and below and on the following pages depict typical conditions. Many of these have been patched and repaired with both cementitious repair materials and soft repair materials. As the pool shell is being impacted from hydrostatic pressure from behind the walls and below the floor, all patches will eventually fail and additional deterioration can be anticipated. Paint finish is worn and peeling throughout pool.

Delamination adjacent to construction joint

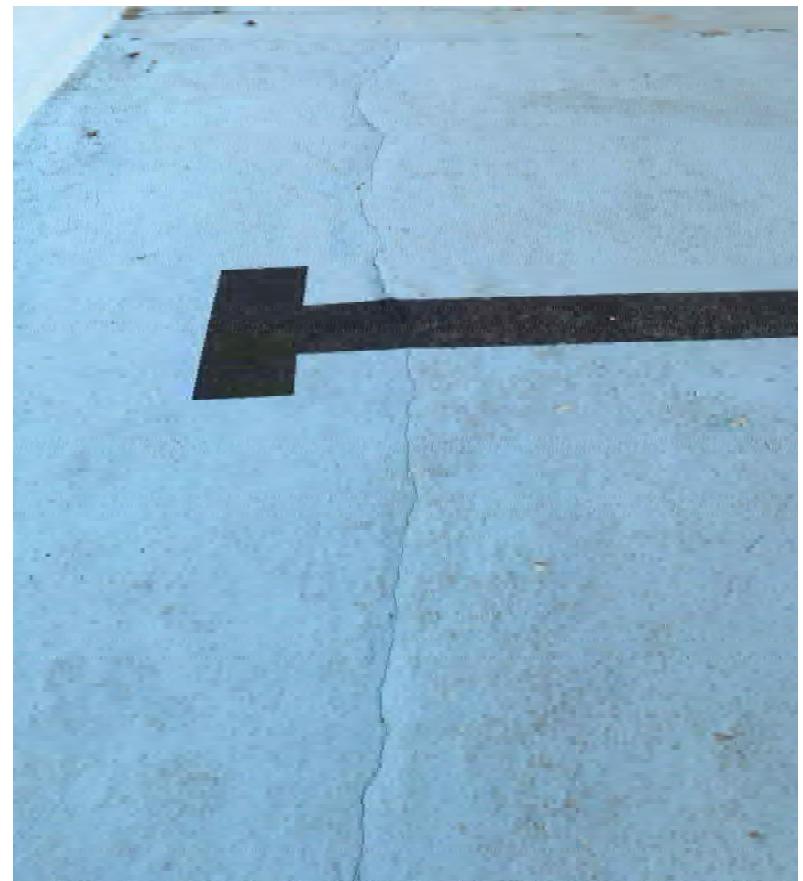
Typical crack in pool floor

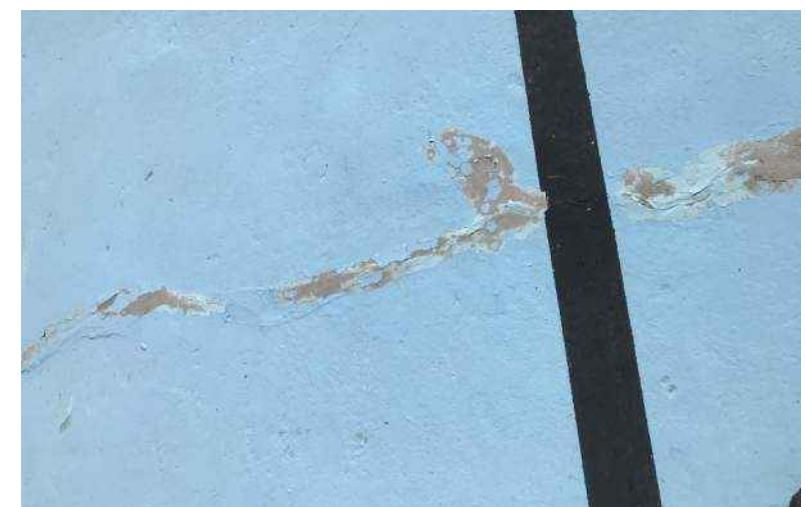
Previously repaired crack in pool floor with failure of repair materials

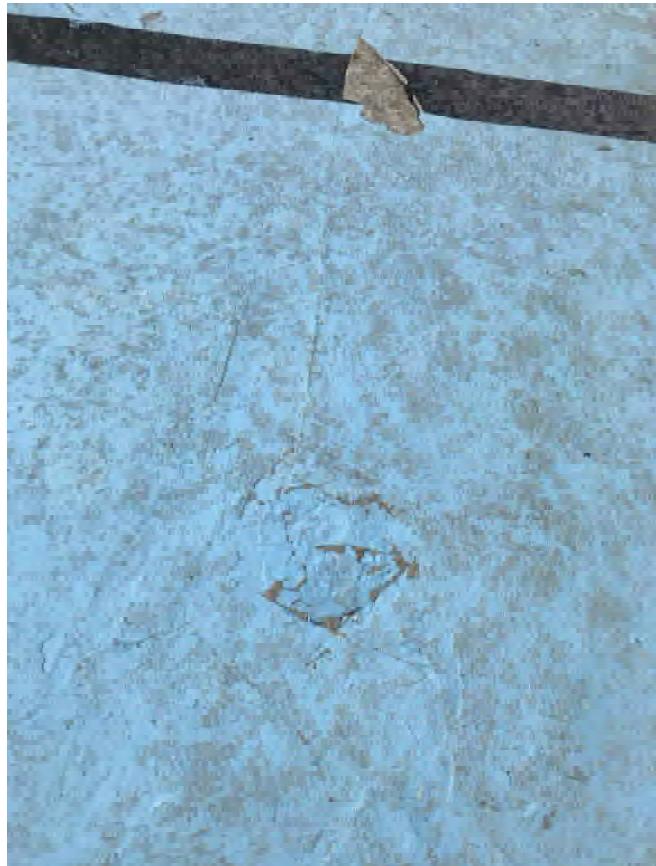
Multiple delaminations along the edge of crack

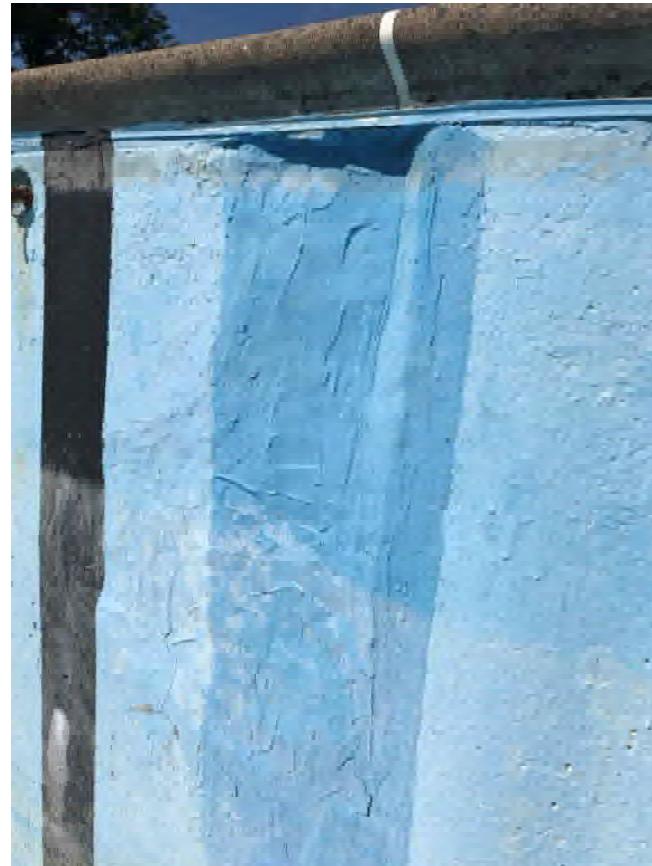
Significant spall of approximately 4-inches deep

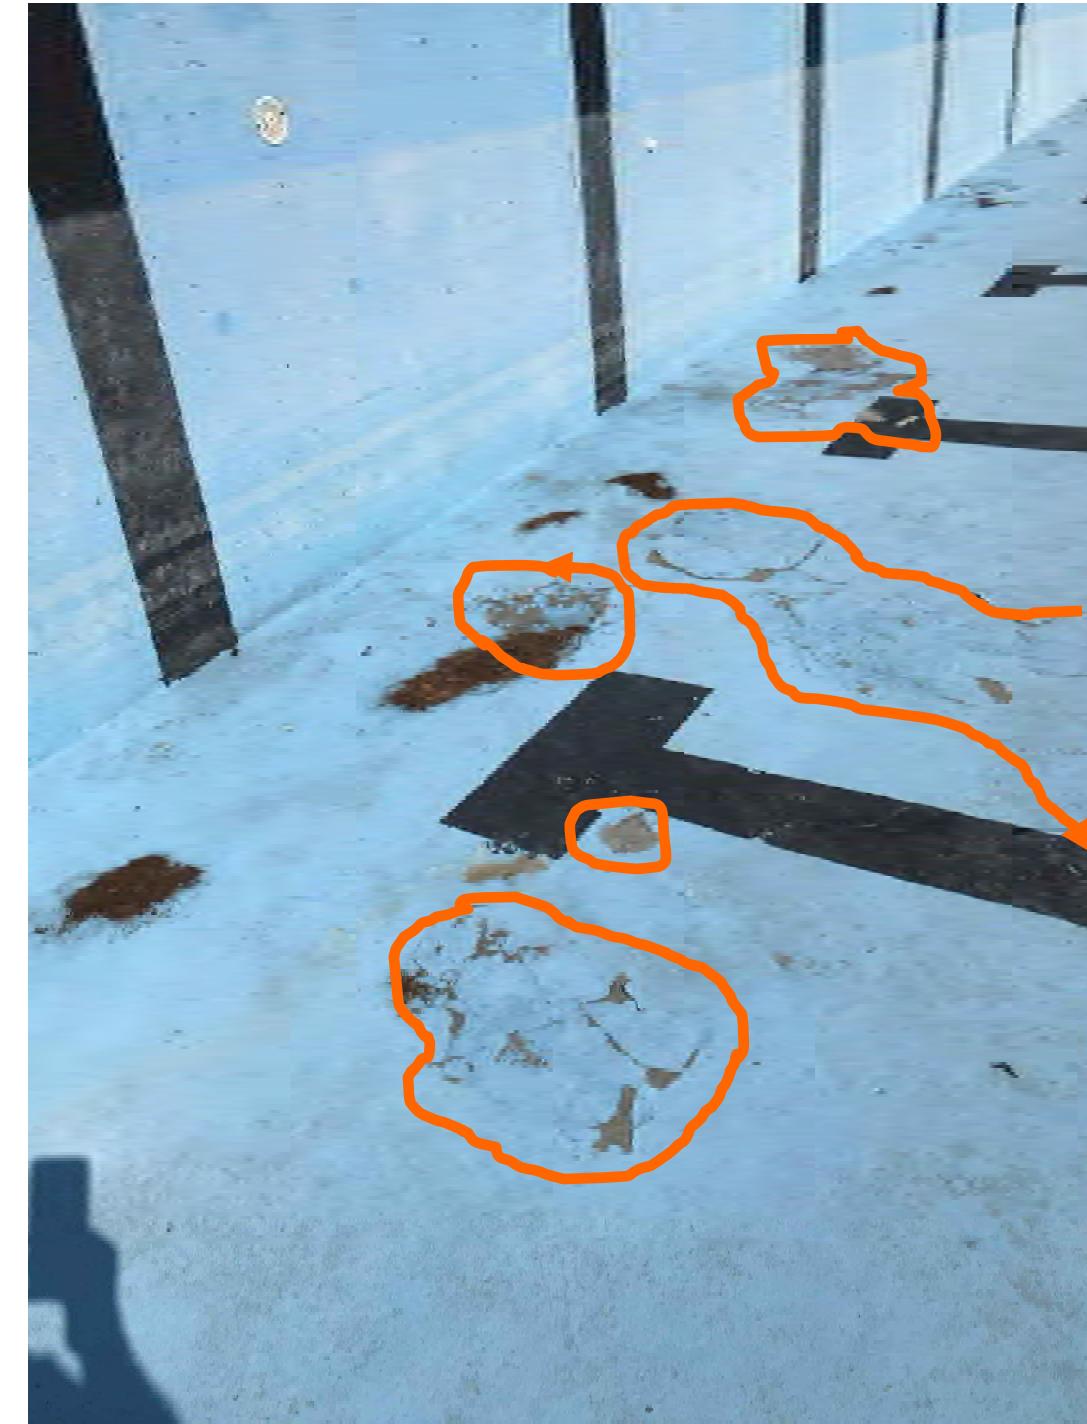
Broad areas of spalling and delamination

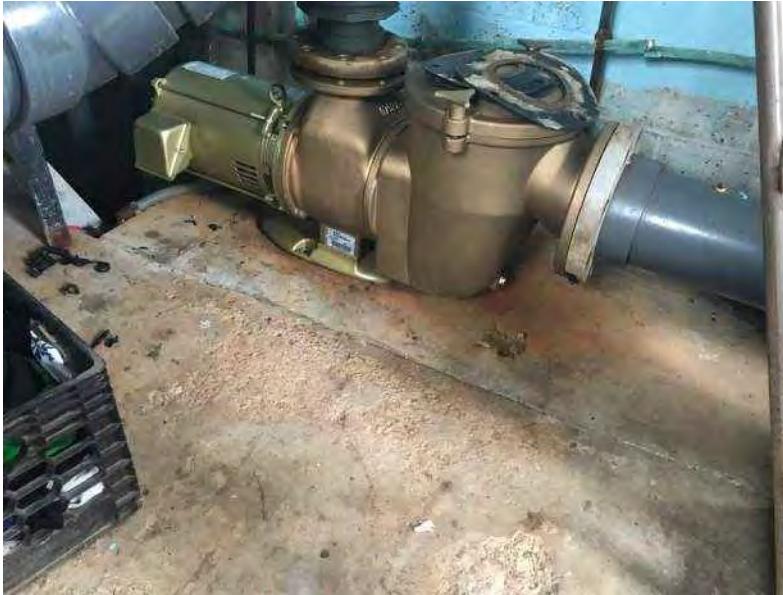
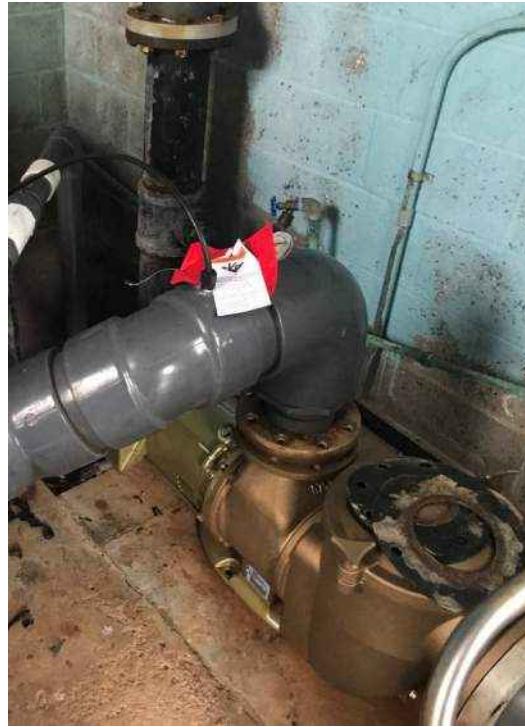
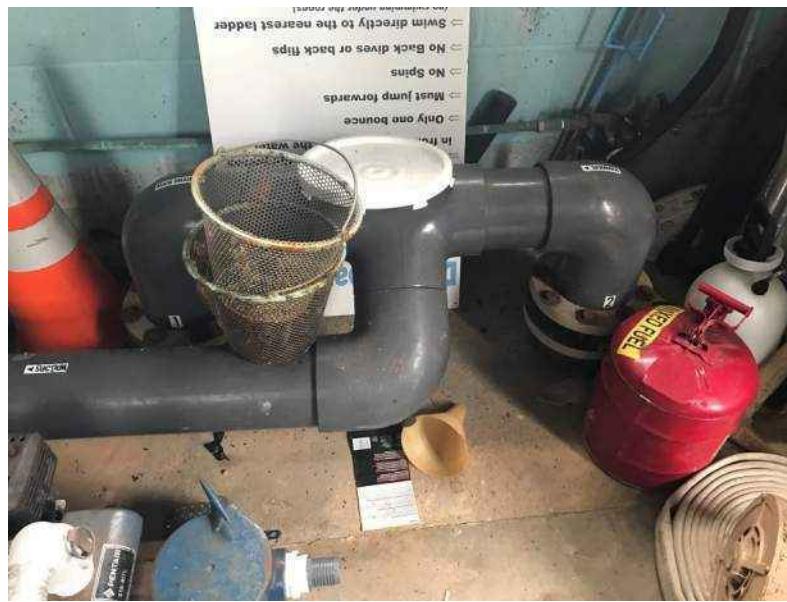
- Piping is undersized and not in compliance with DPH Regulations.
- Pump should be on housekeeping pad and bolted down to limit vibration that could break fittings and damage pump.
- System is in direct suction without an anti-entrapment device. At calculated velocities, the drains are not VGB compliant, even if covers are certified.

Above: 10 HP recirculation pump.
Below Right: Main drain and skimmer suction piping.
Below Left: Pump discharge to Filters

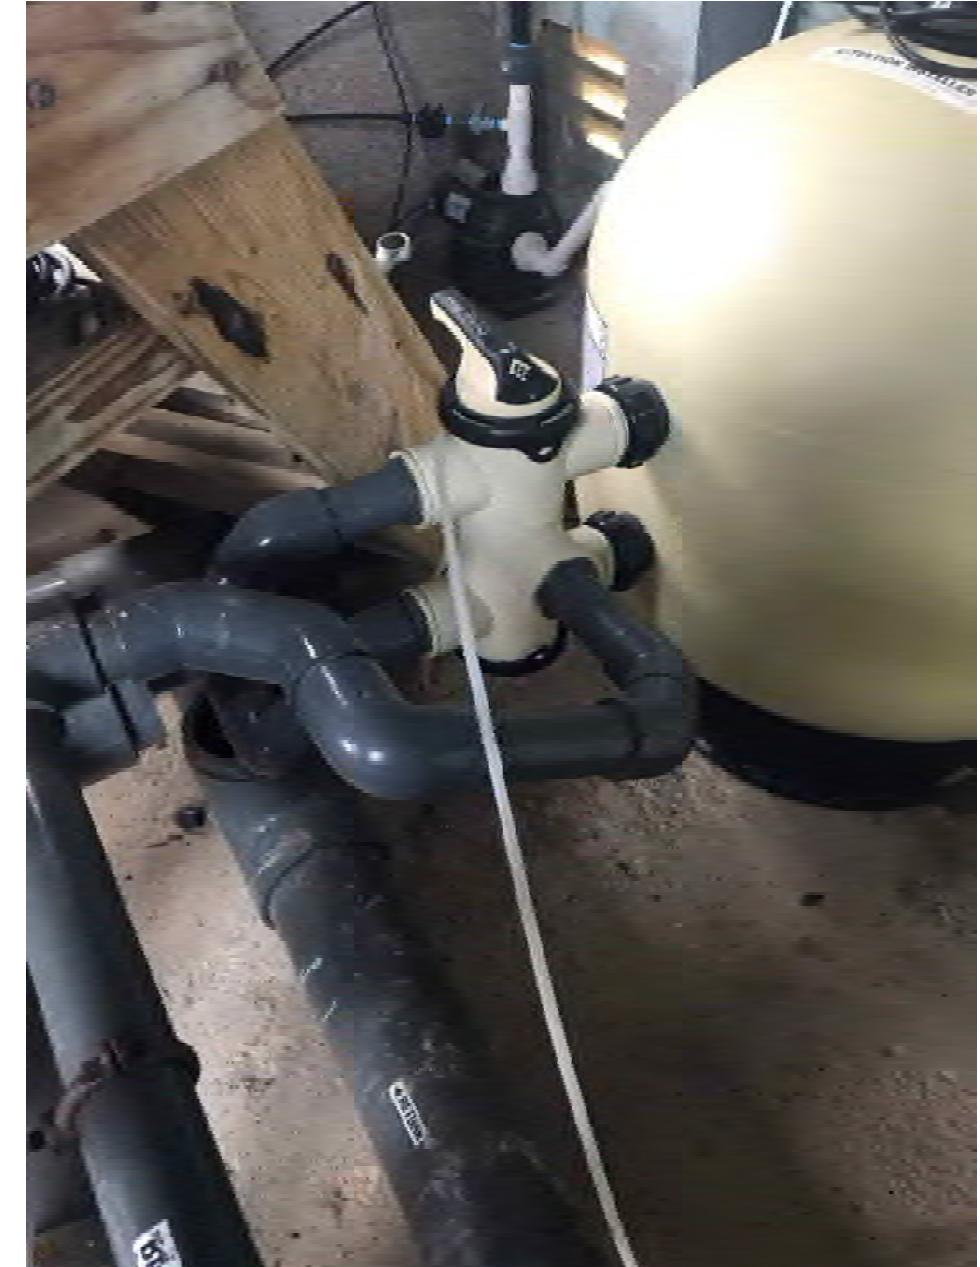
- Piping is undersized and not in compliance with DPH Regulations.
- There are no throttling valves or flow meters at each filter to confirm that each are flowing at the same rate.

Typical filter piping and multi-port valve. Position of the valve determines filter mode –vs– backwash mode.

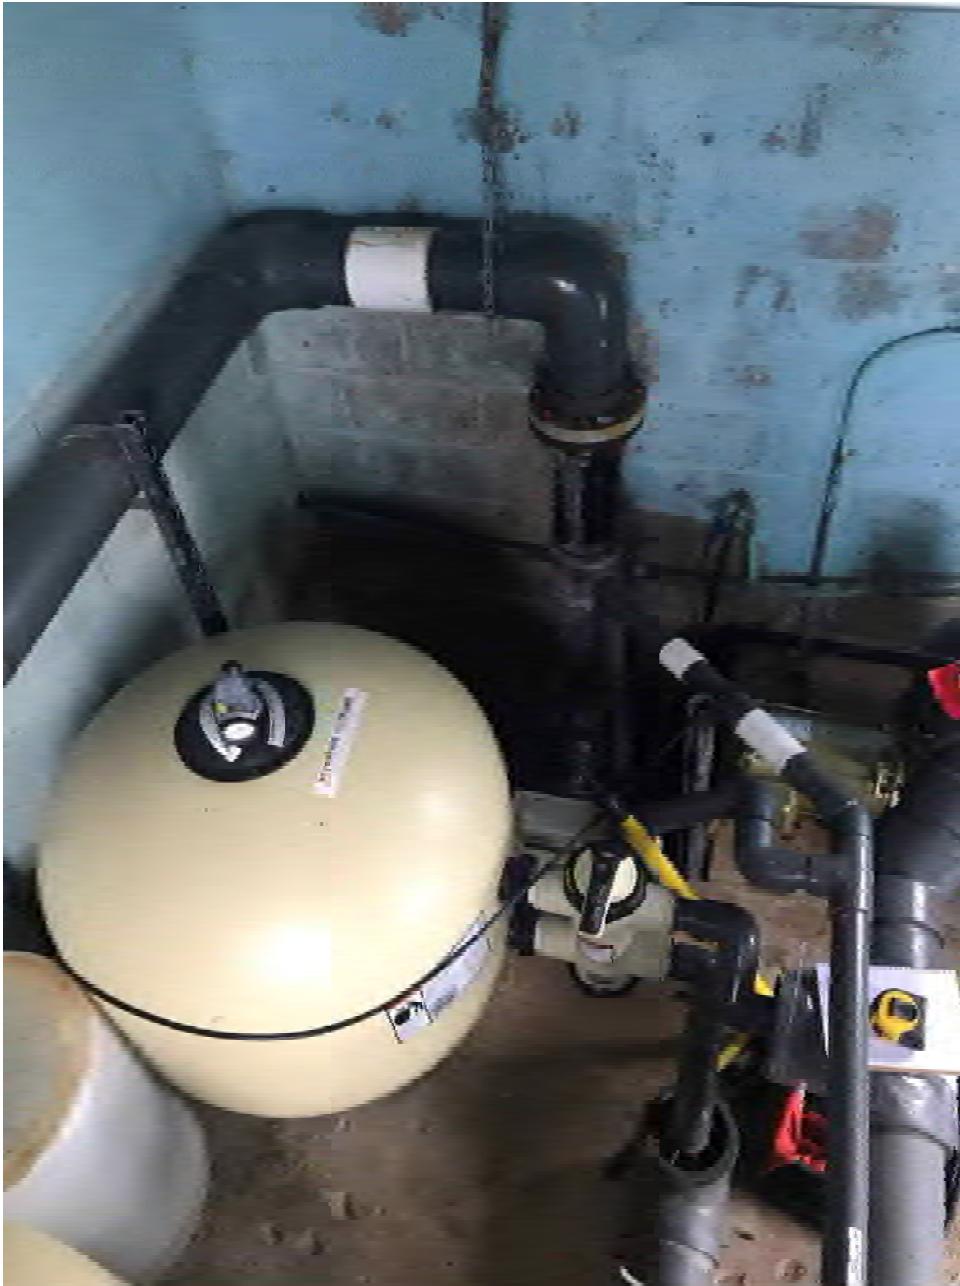
- It appears the backwash discharge is a direct connection to sewer, which is not DPH compliant, as an air-gap is required. The current arrangement could allow waste water to siphon back into the pool system.

Typical filter piping and multi-port valve. Position of the valve determines filter mode –vs– backwash mode.

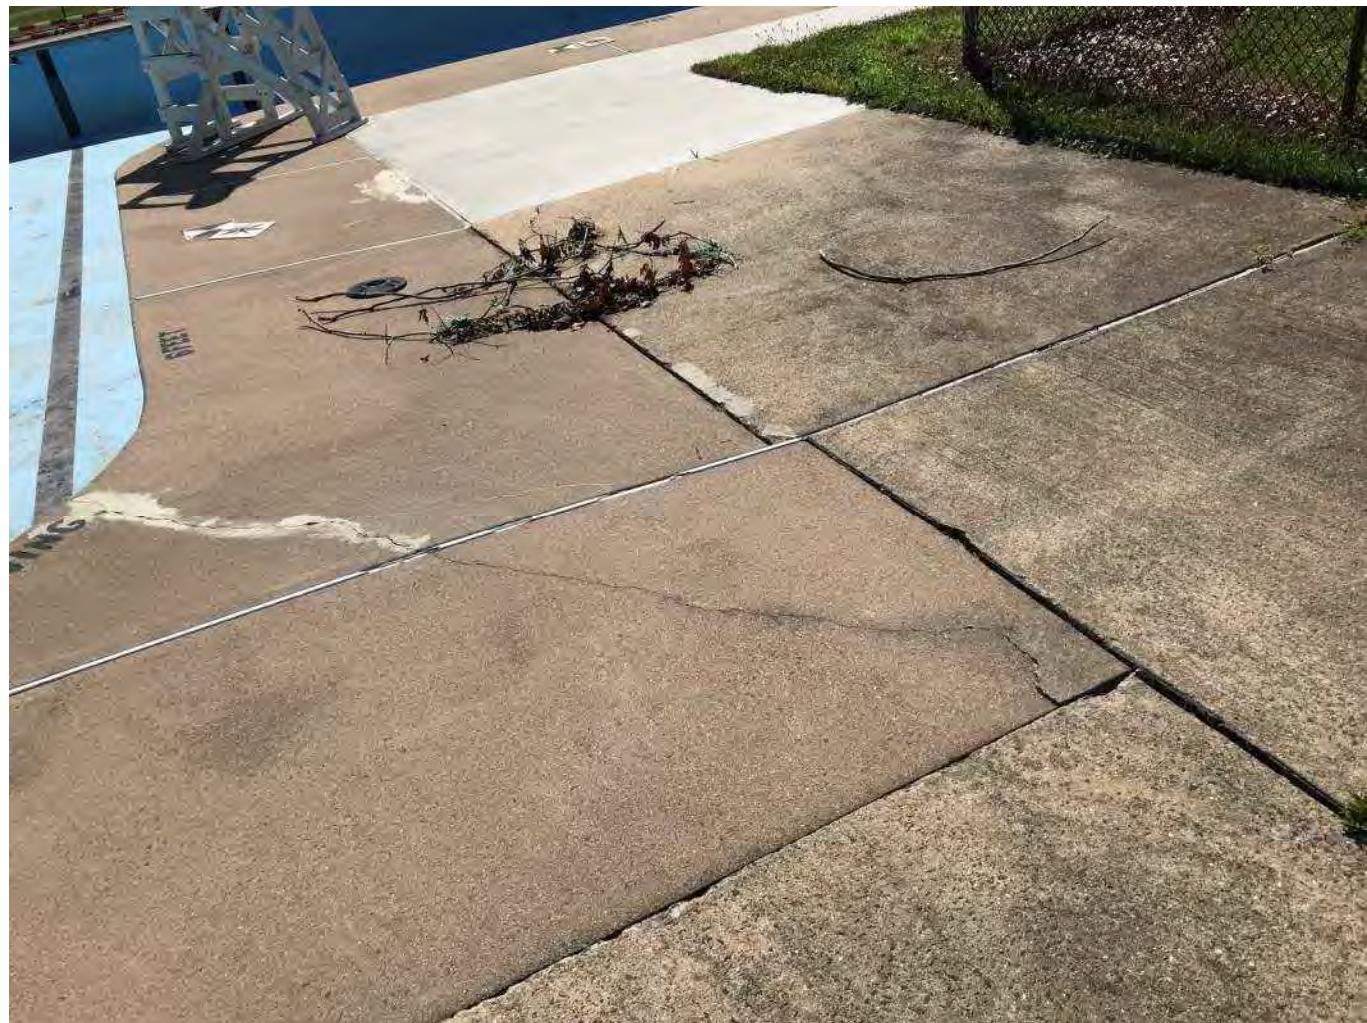
Typical deck conditions. Note 1990's vintage decking closest to pool, original decking in foreground and recently replaced decks toward the back of the photo.

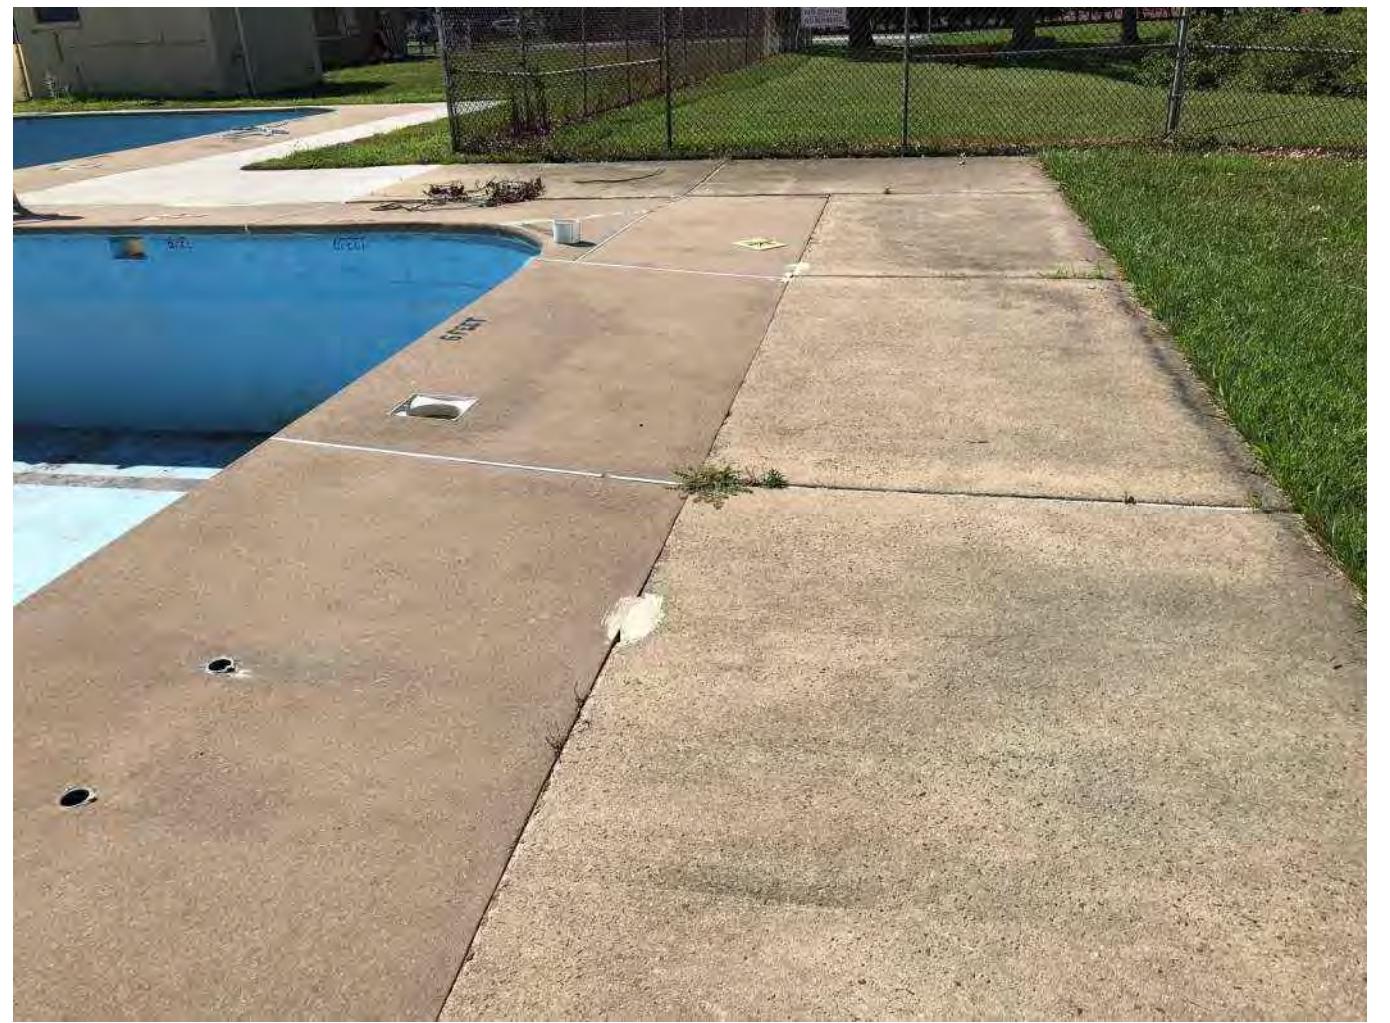
Deck pitch at the slab adjacent to the pool exceeds the ADA allowable cross pitch of 1:48. This maximum slope must be maintained for an accessible route from the bathhouse to the HCA Lift Chair and the Steps.

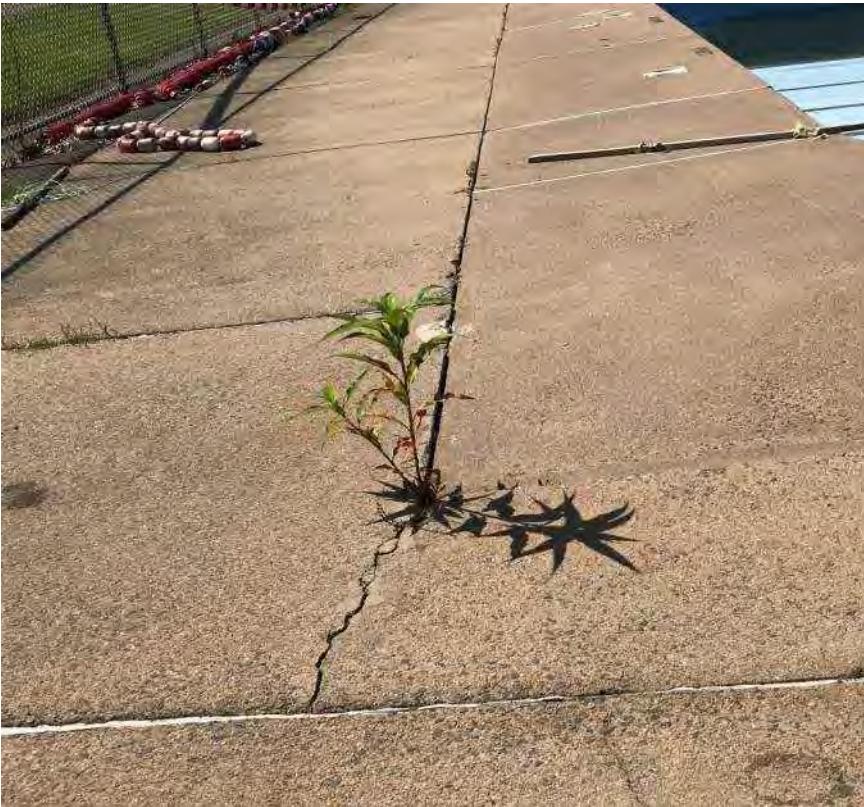
Miscellaneous cracking

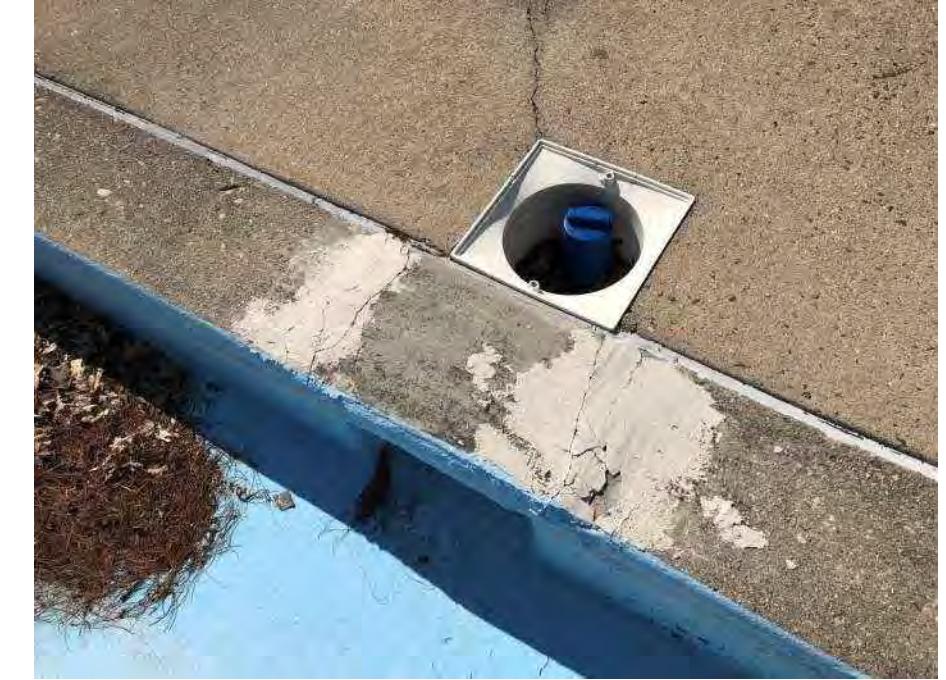
Right: Cracked and damaged concrete at skimmer boxes.

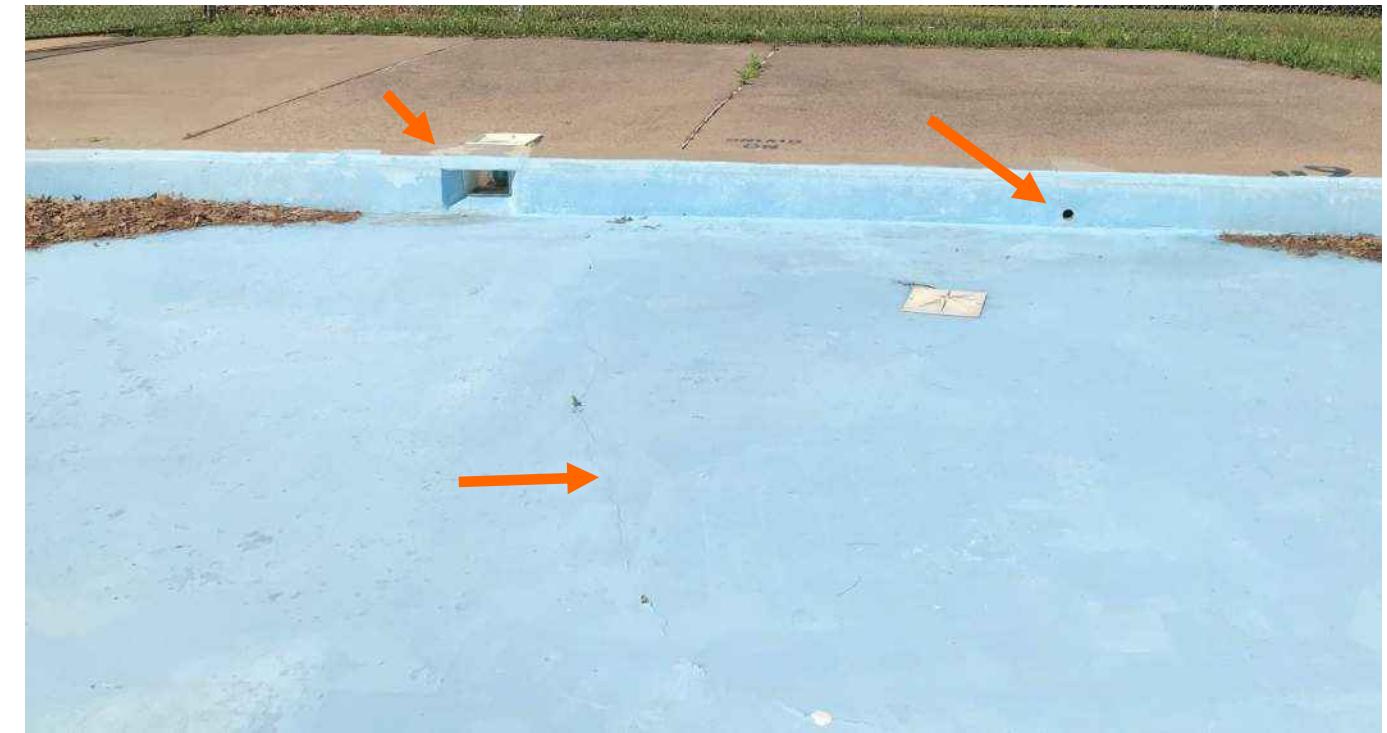
Below: Crack across pool, and vertically at inlet fitting and skimmer.

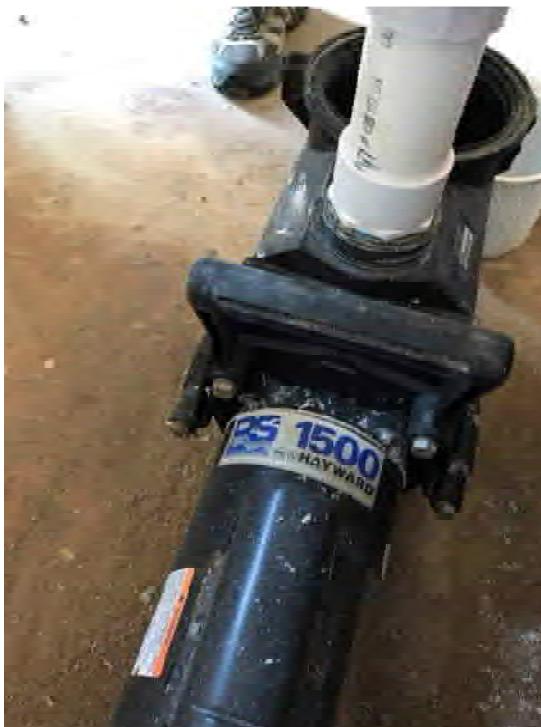
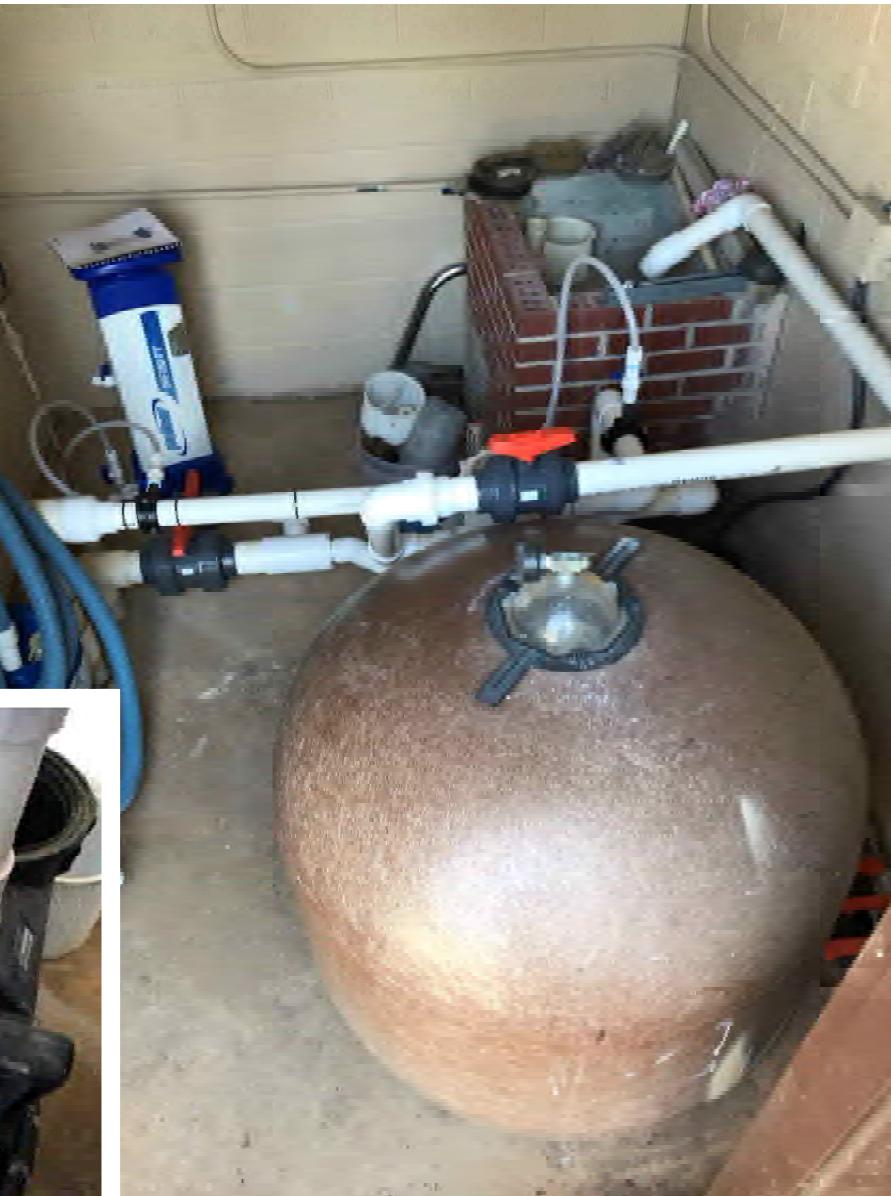
Below: 1 1/2 HP pool recirculation pump.
