Mill Pond Park Newington, Connecticut

PRELIMINARY MASTER PLAN

TLB Architecture

01—2013 and 2020 Mill Pond Pool Evaluations

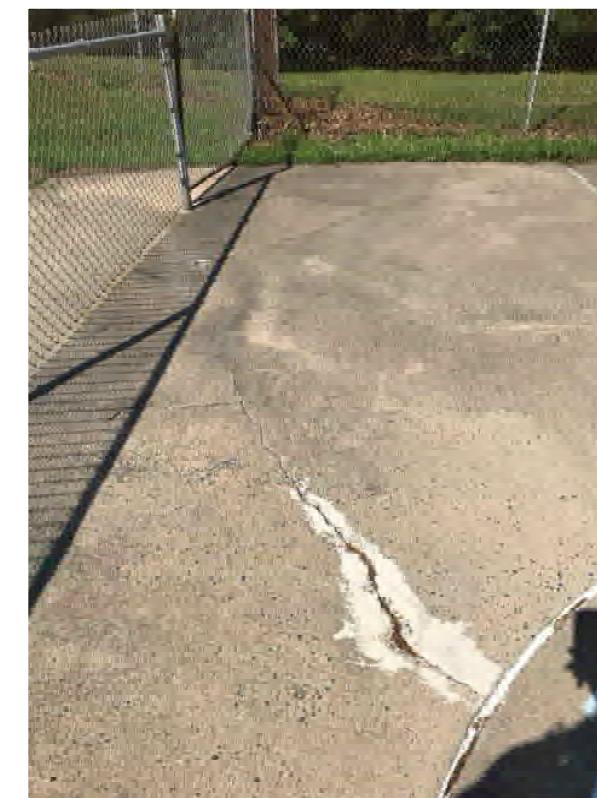
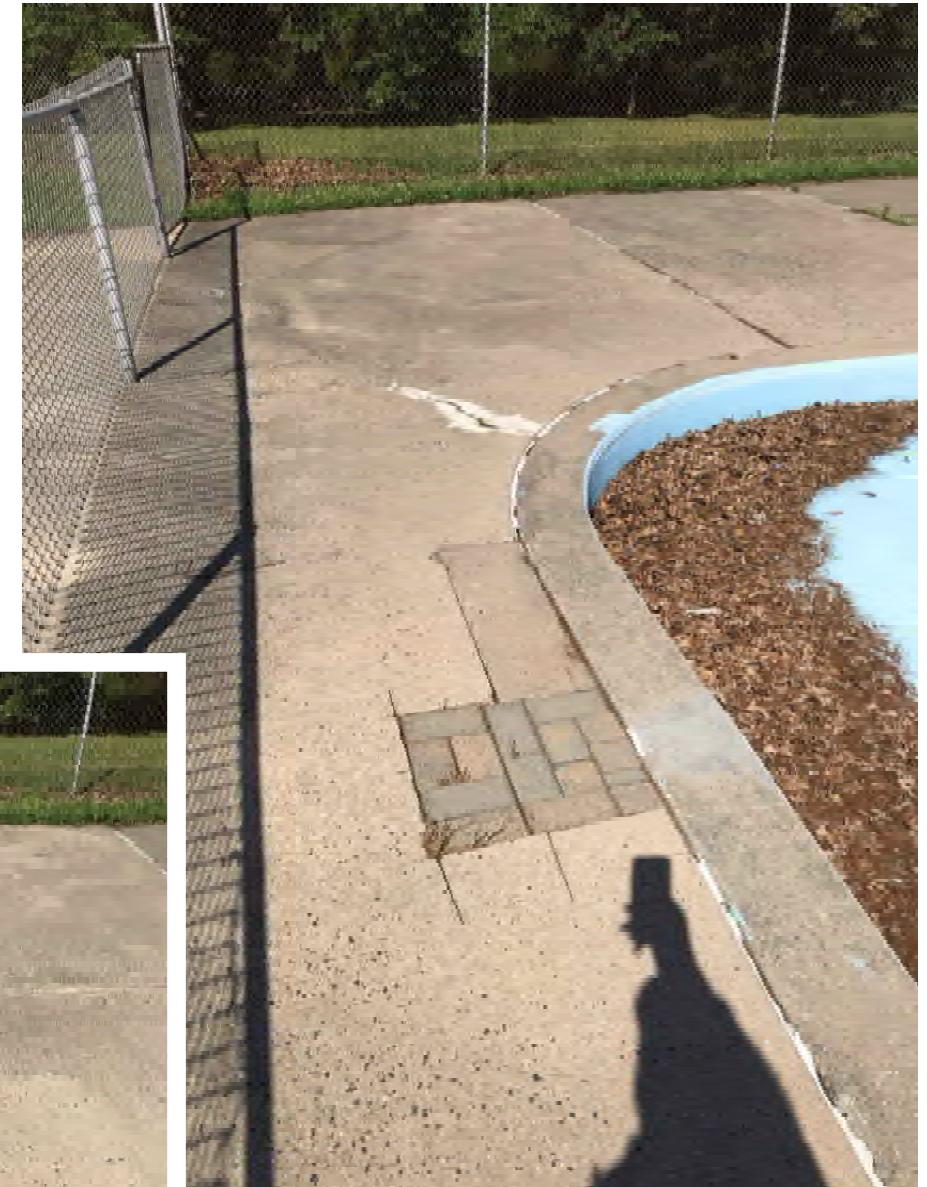
Cracked deck, repaired areas and failed sealant joints in deck allow water infiltration.

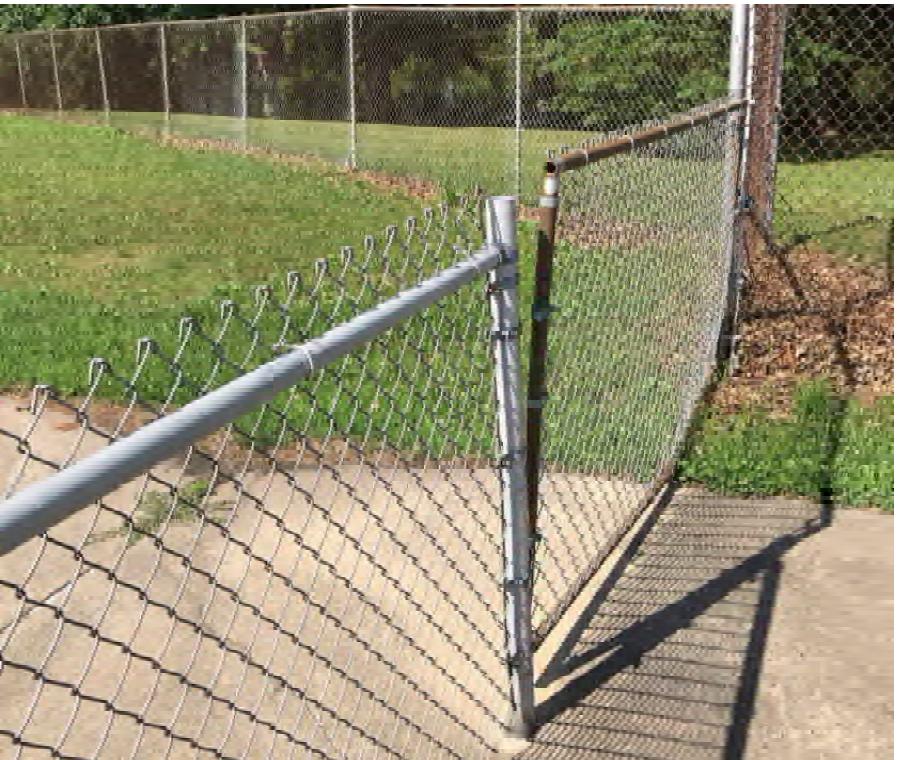
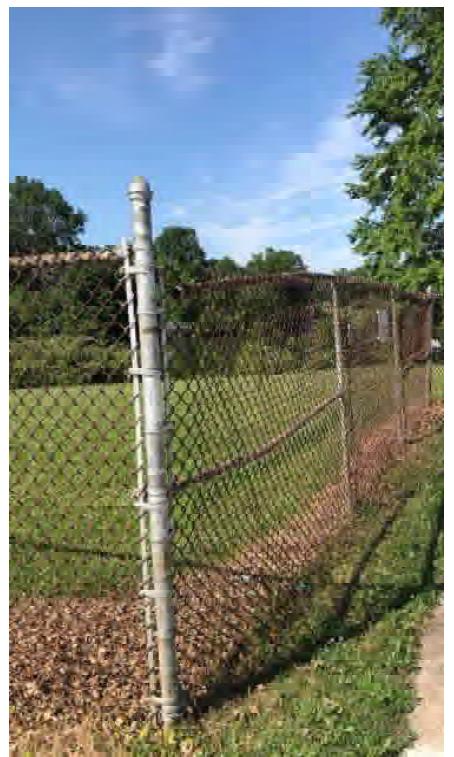
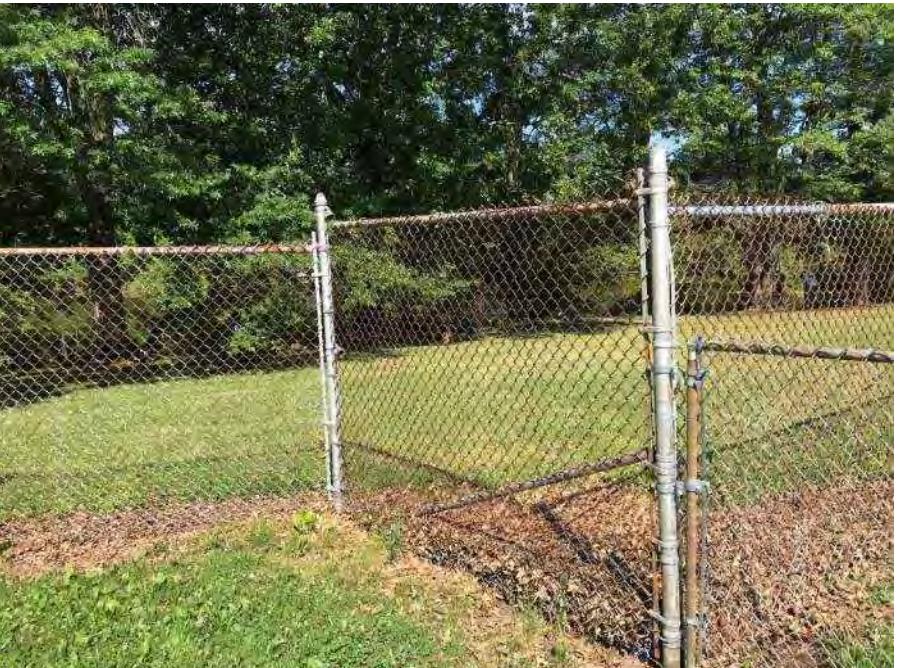
Missing caps and end plugs allow water infiltration leading to further rusting. It also allows wasps to nest, creating additional risk.
