Mill Pond Park Newington, Connecticut

PRELIMINARY MASTER PLAN

MARCH 2018

TLB Architecture

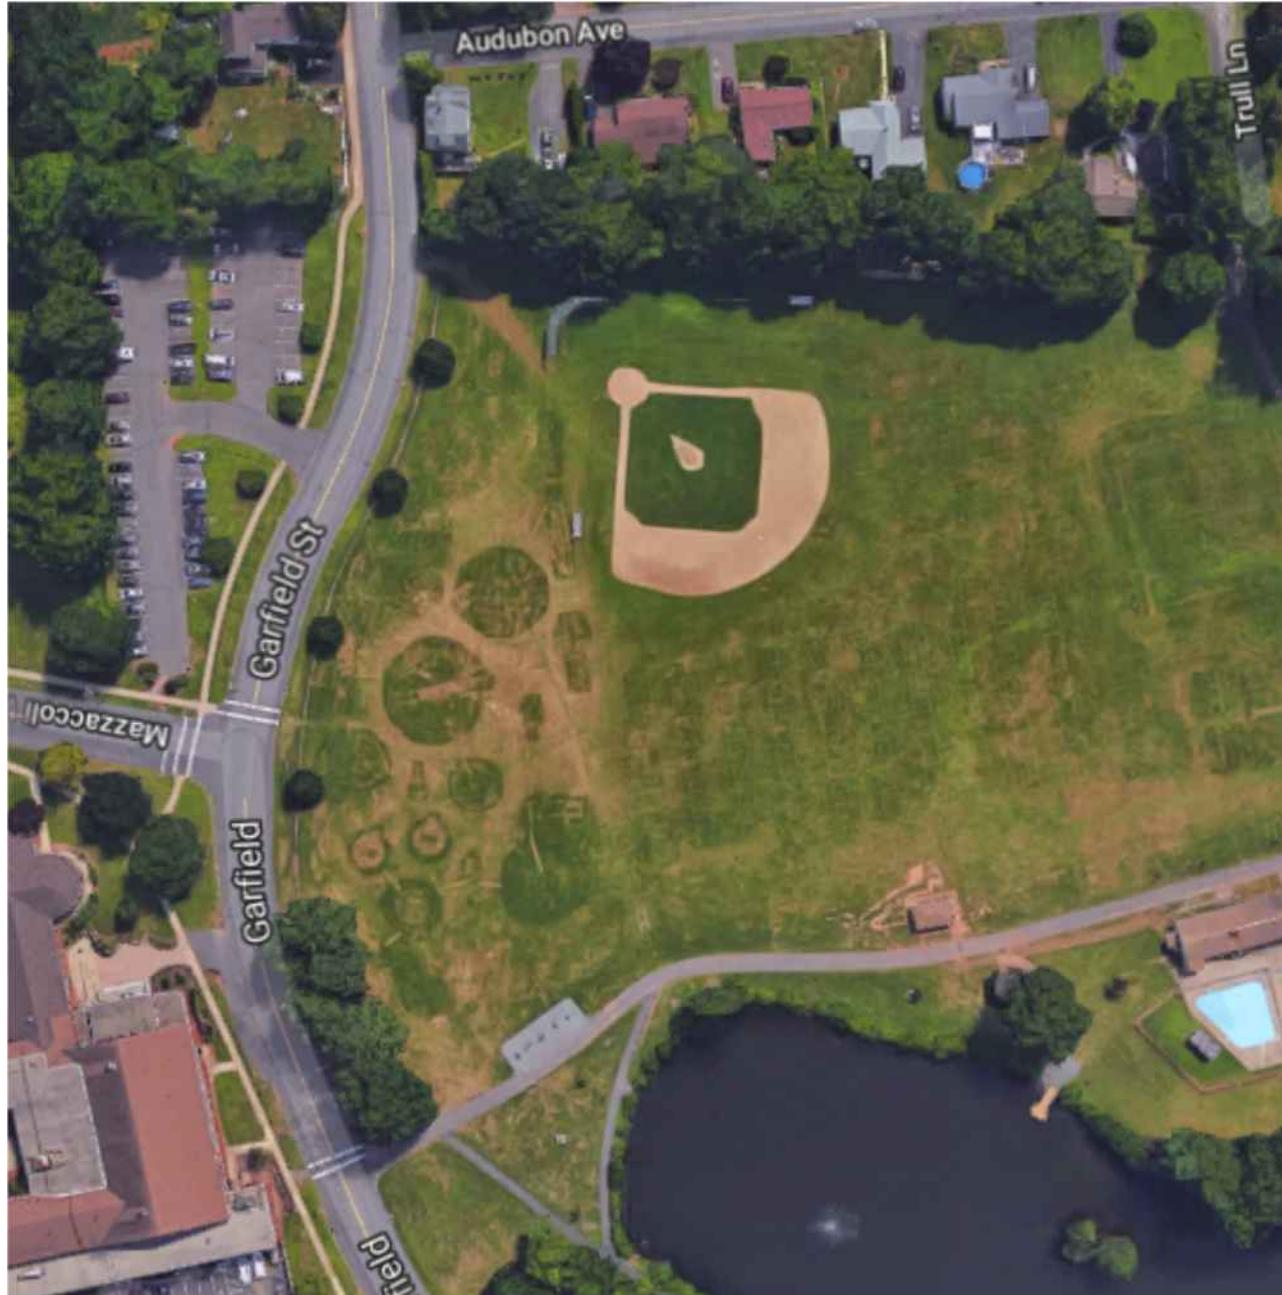
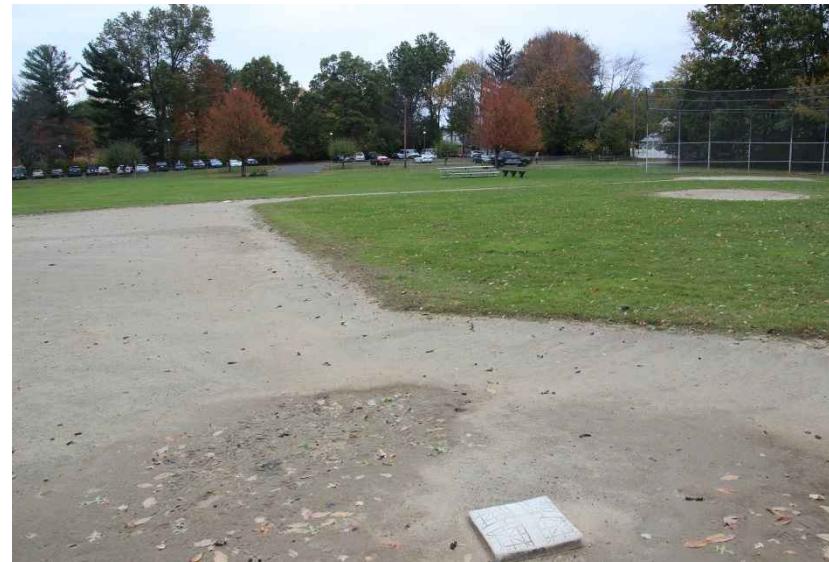
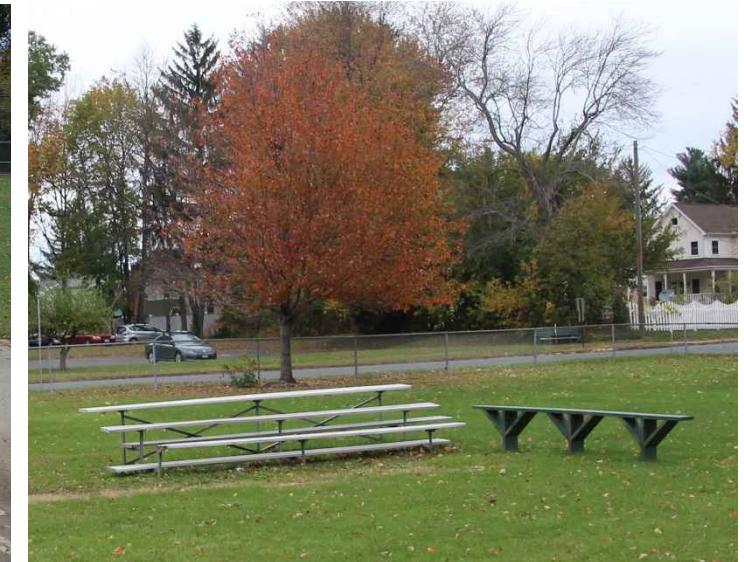
The baseball field currently occupies a significant portion of the Park's open space, north of the pond. It is used by Newington High School Baseball Team as well as other youth and adult recreational teams. The field is in generally good condition, requiring typical maintenance to the pitcher's mound and the lip between the in-field and outfield.

The backstop and team benches are reaching the end of their useful life and replacement should be planned for player safety and functionality.

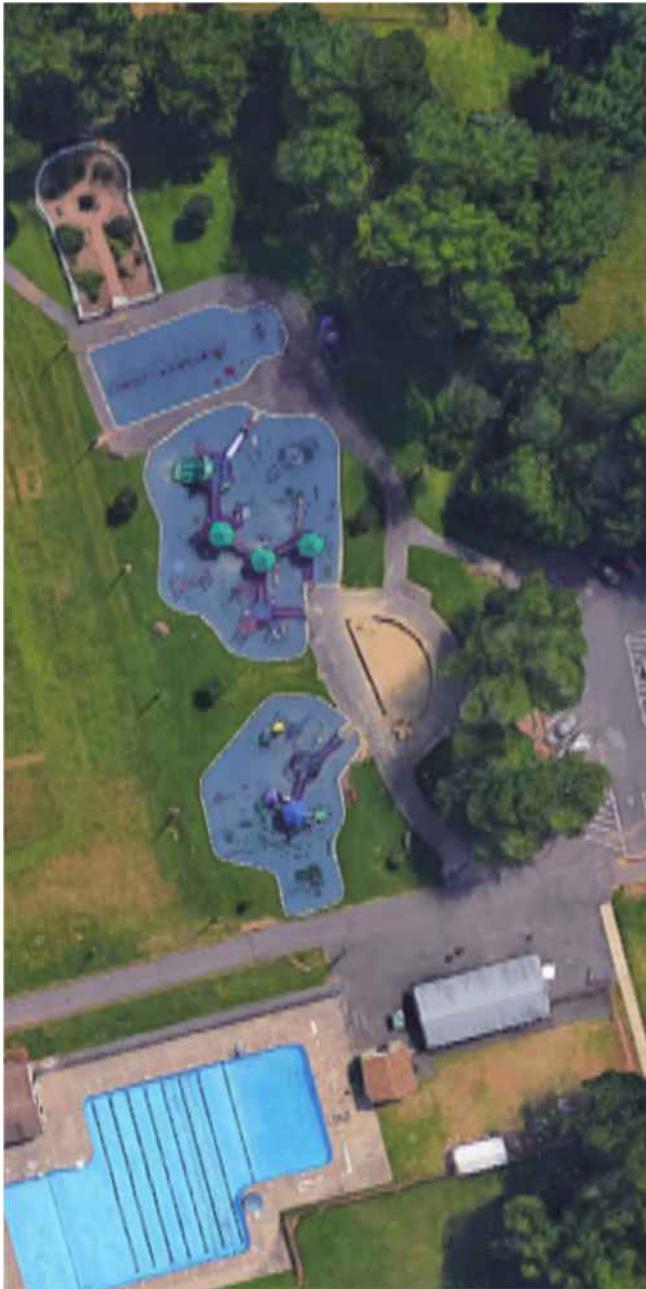
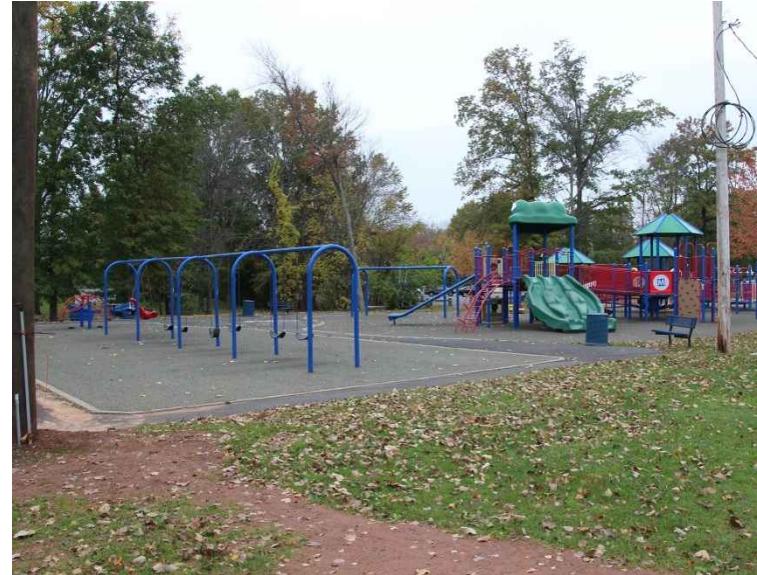
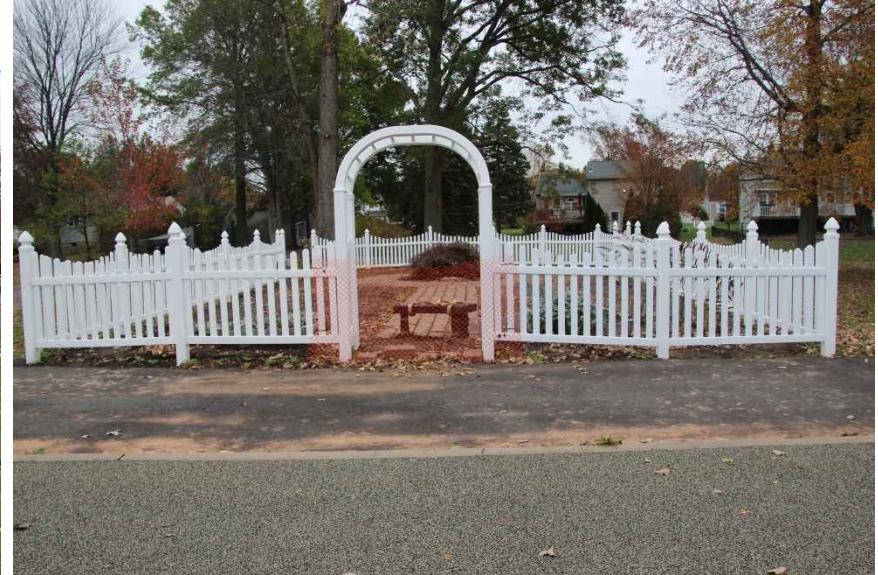
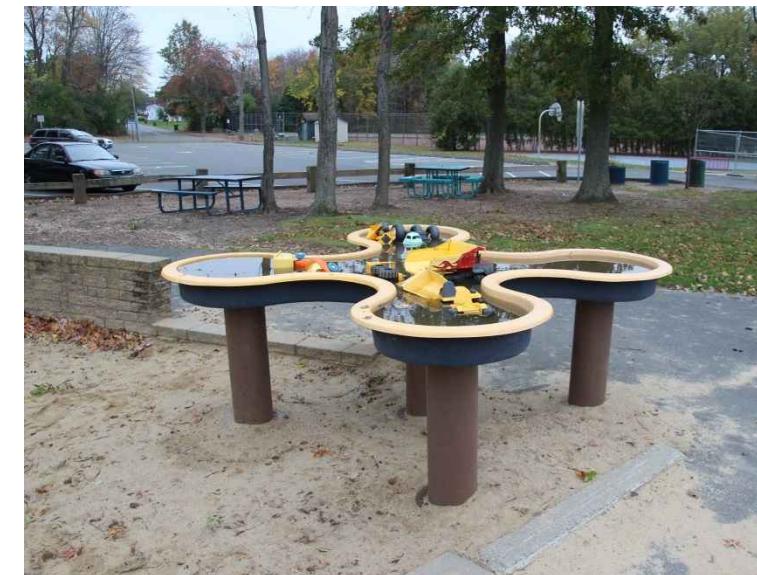
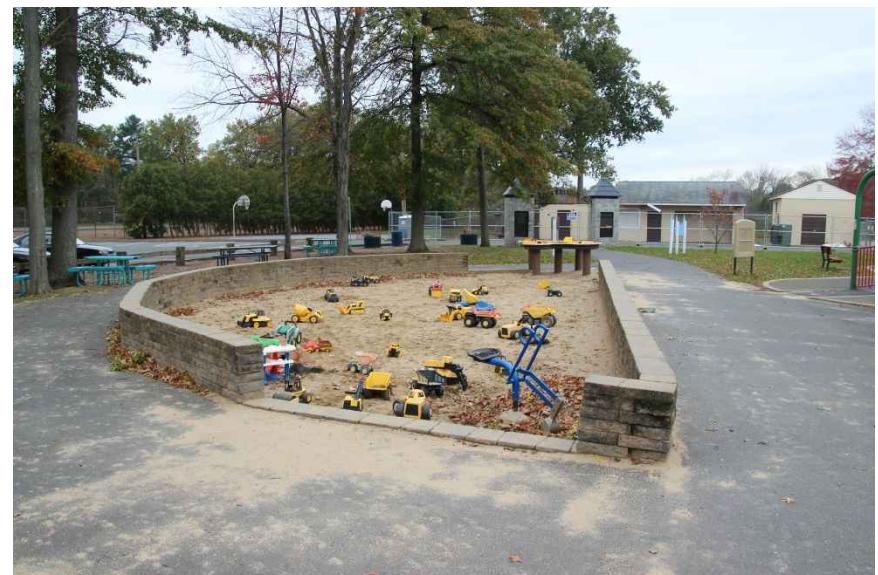
Playgrounds and Sensory Garden

These playgrounds are a heavily used asset within the Park, are in good condition and appear well-maintained. Qualified Town staff should perform safety inspection and make necessary repairs. The need to separate the toddler play area from visible water at the pond should be evaluated further, and fencing added as may be necessary. No work is required as part of this long-range planning effort, except as required for continued safety.

A sensory touch garden is provided to the north of the playgrounds. The Town has on-going improvements planned for this area.

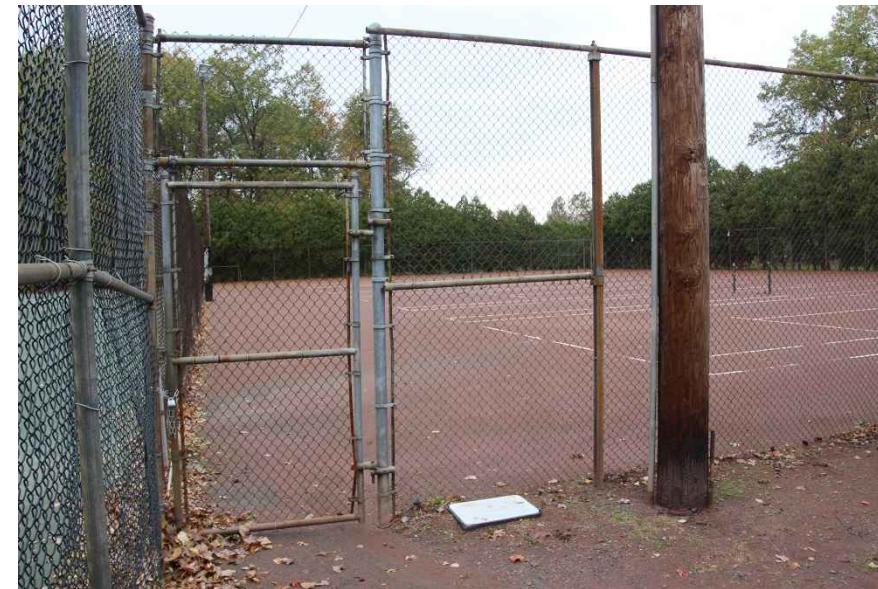
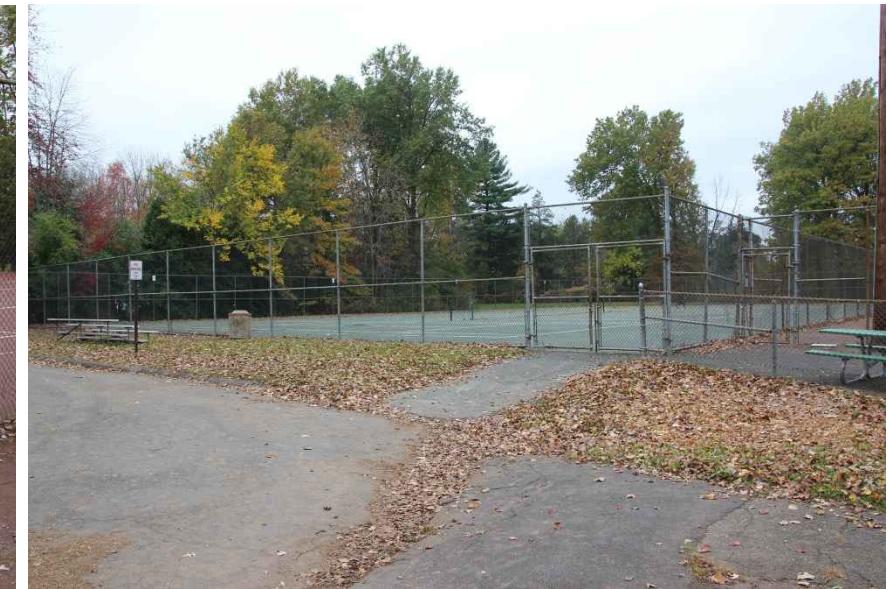
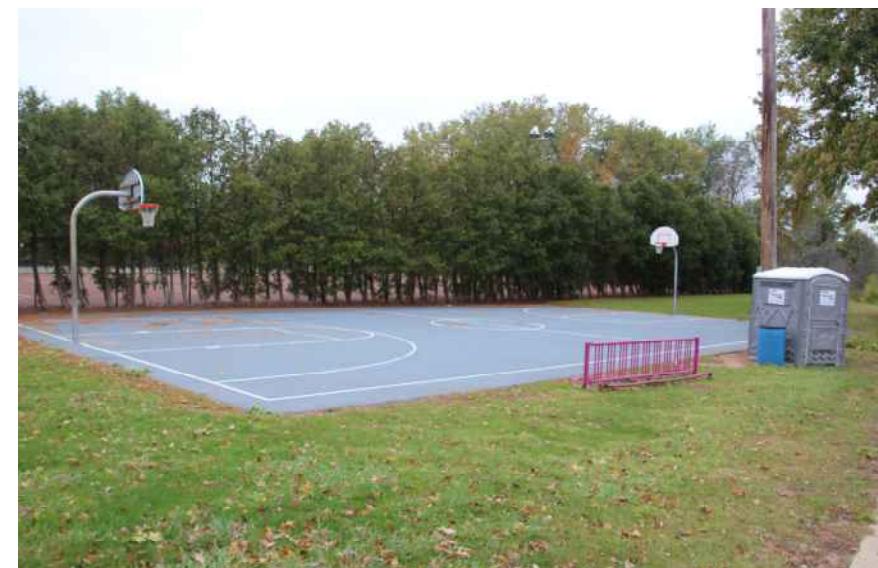
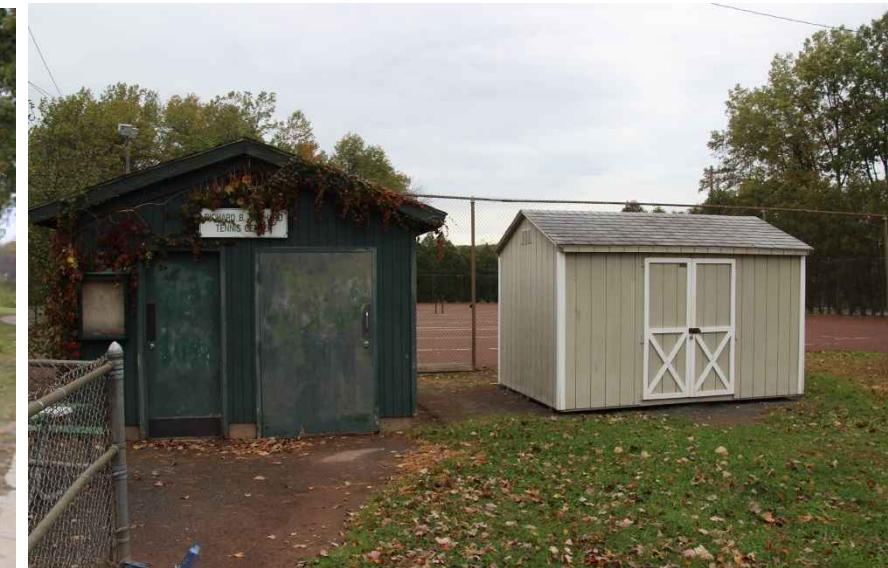
Tennis Courts and Basketball Court

The tennis facility, inclusive of the courts, fencing and storage buildings is in very poor condition and in need of complete replacement.

The basketball court suffers from cracks, broken edges and uneven pavement and is also in need of replacement.

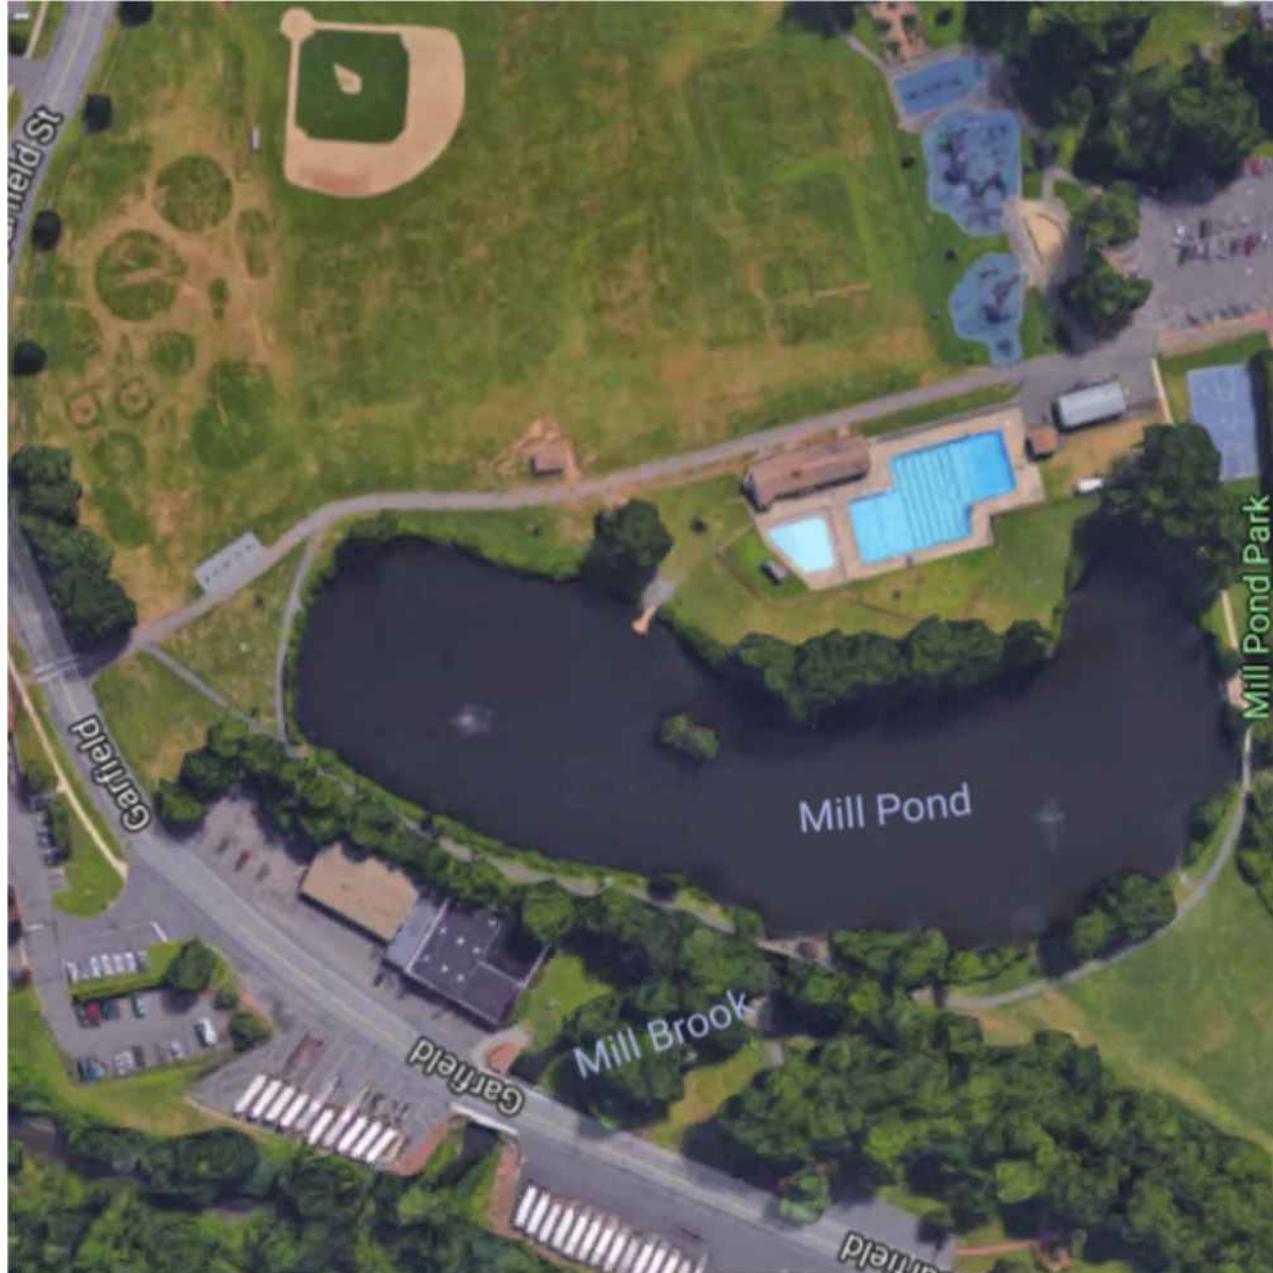
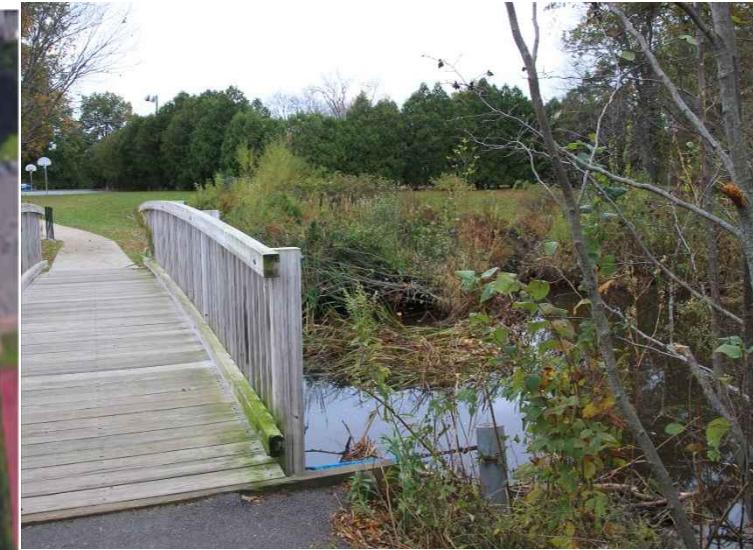
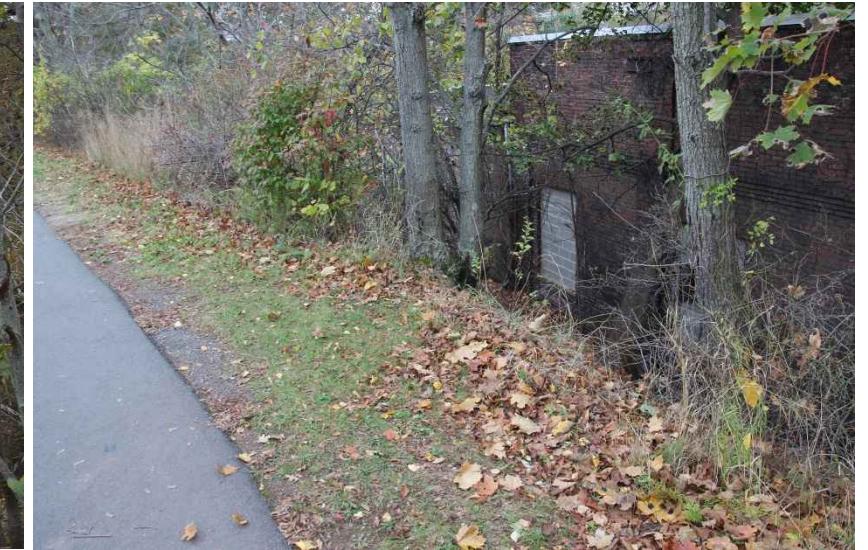
Walking Trails and Bridges

The walkways within the Park are limited to a linear path running from Garfield Street to the parking lot on Browning Street near the Tennis courts, and a loop around the Pond. These walks are bituminous concrete and are in poor condition. The Pond loop includes pedestrian bridges, which appear functional but are not rated for vehicle traffic, limiting emergency and maintenance access to areas of the Park.

There are areas at the south side of the Pond where significant grade changes pose a risk to pedestrians, including a significant drop-off in the area behind the Bus Garage. There is also a risk at the end of the smaller bridge at the east side of the Pond, where guardrails to protect the edge of the walkway, near the culvert.

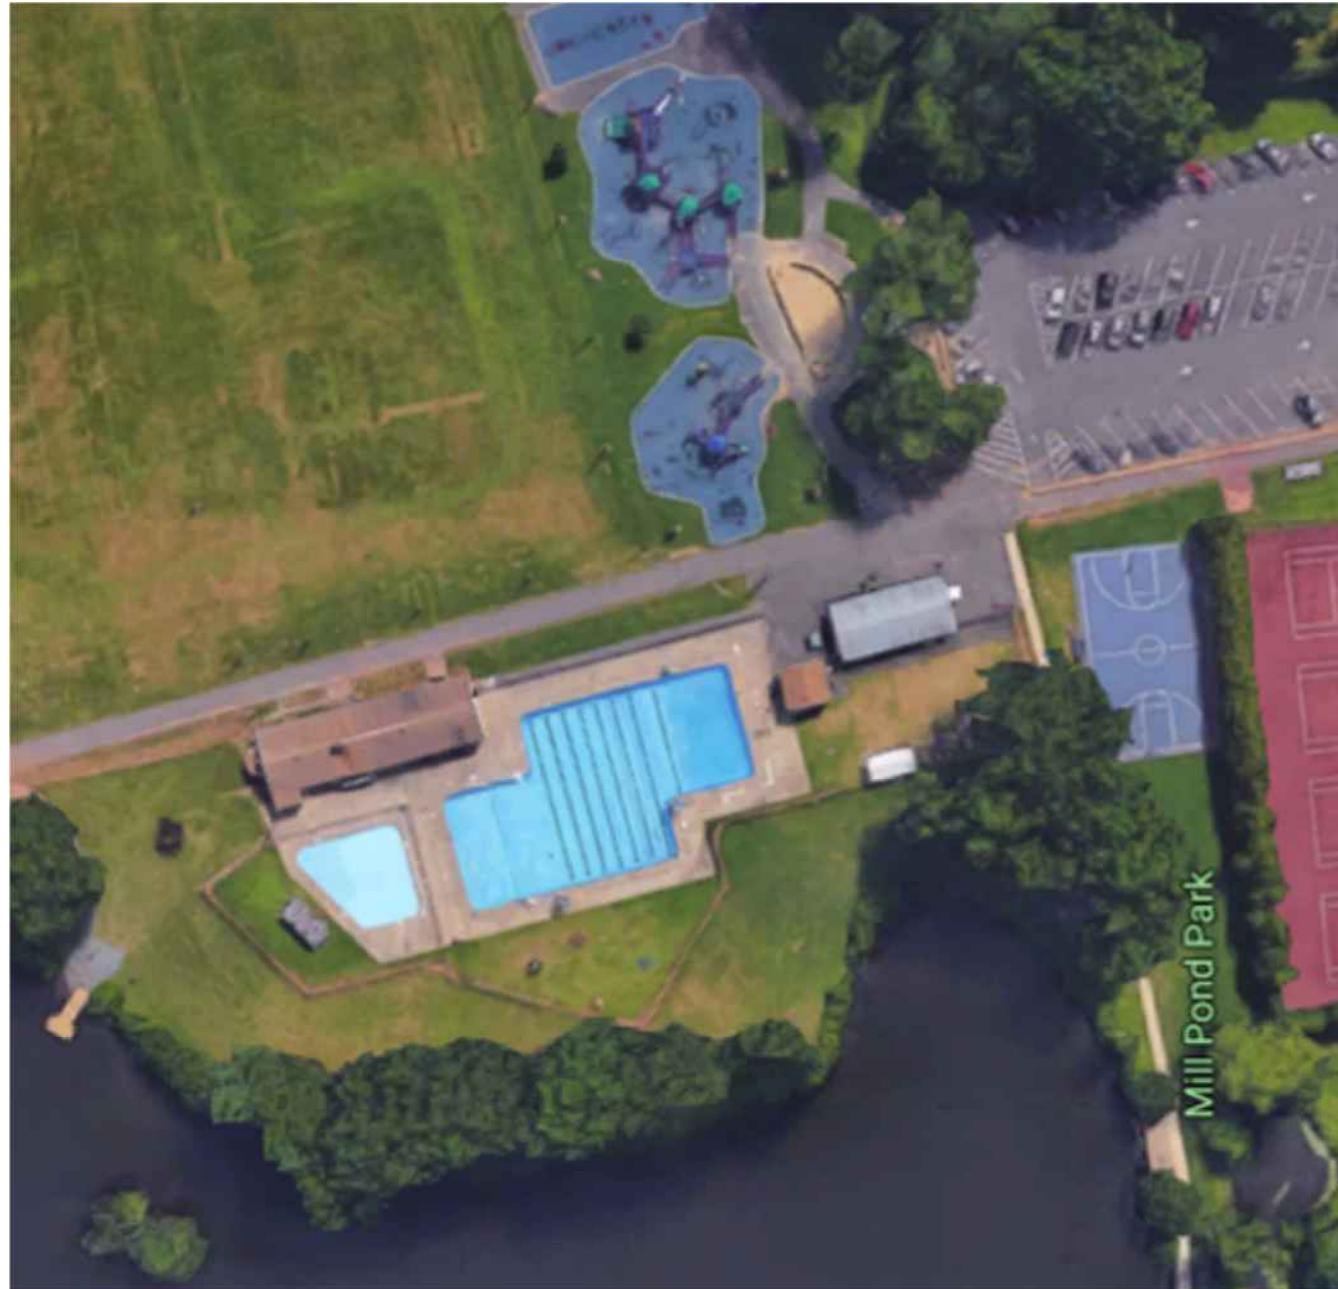
Swimming Pool and Bathhouse

The swimming pool complex consists of a six-lane lap pool with an attached shallow area to the north and an attached diving well to the south. There is also a separate wading pool to the north of the main pool. The pools are served by a masonry bathhouse building and surrounded by chain-link fencing. The pool was constructed in 1959 and renovated in 1999.

The pool has reached the end of its useful life and is in need of complete replacement. While significant renovation is an option, it is not recommended, as the underlying issues with ground water, deteriorated concrete and aging infrastructure can not be reliably repaired for the long-term.

In 2013 a comprehensive conditions assessment was performed, which details deficiencies with the pool. Of note in the study is the potential for PCB remediation, which will require further testing prior to demolition.

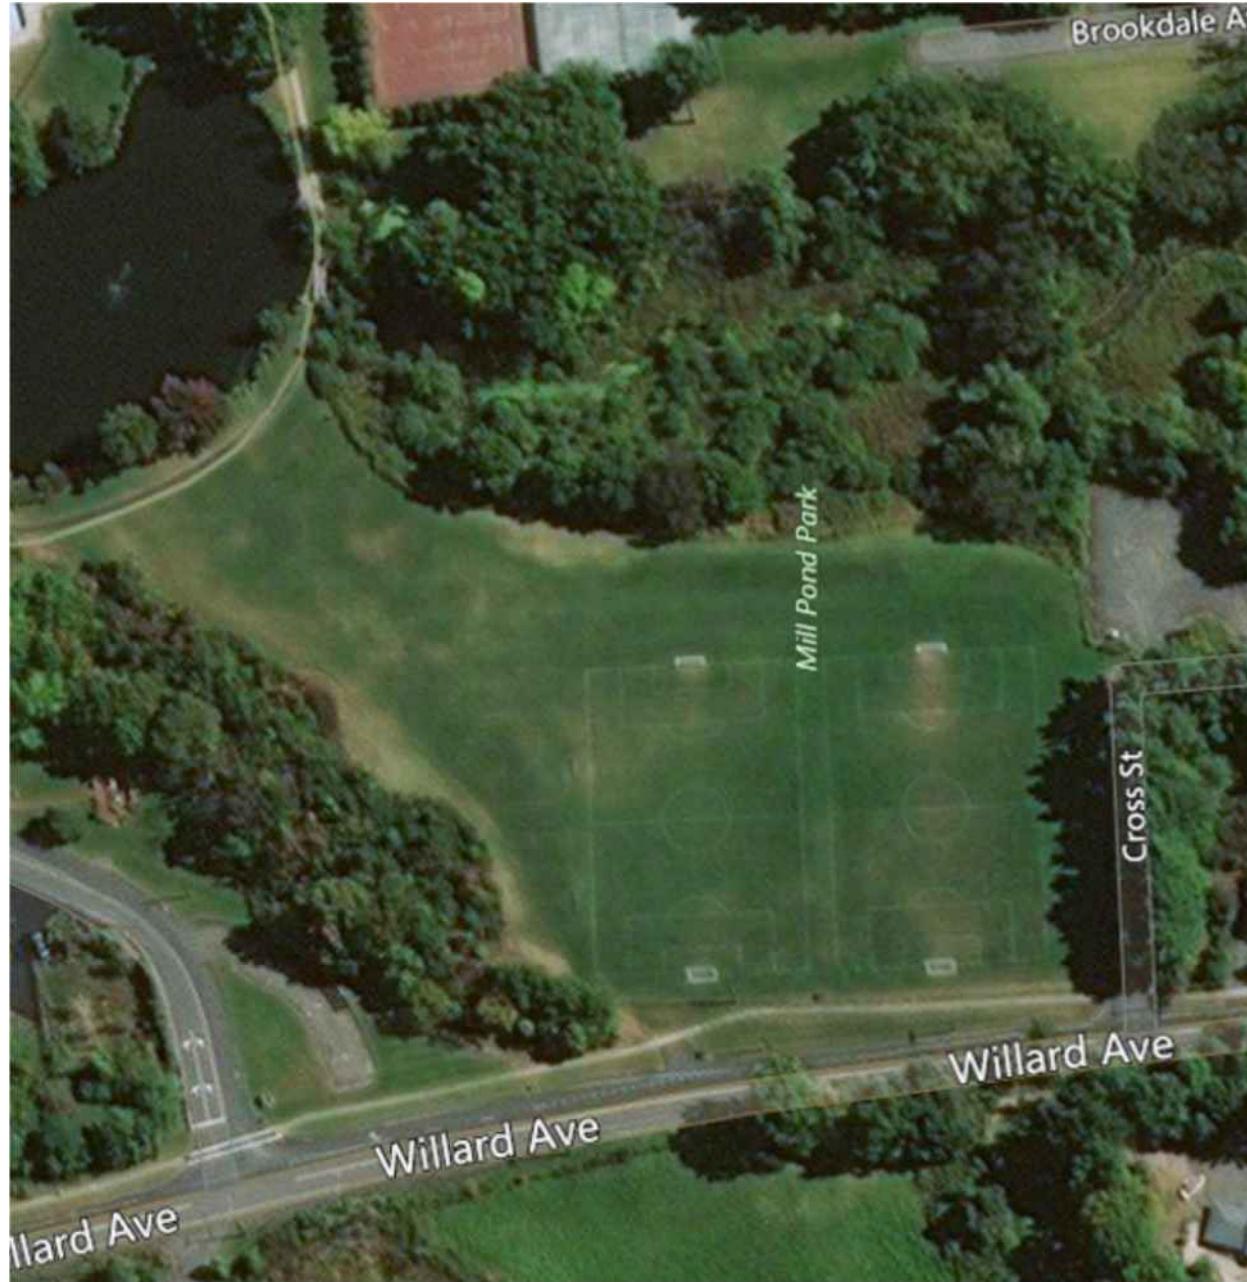
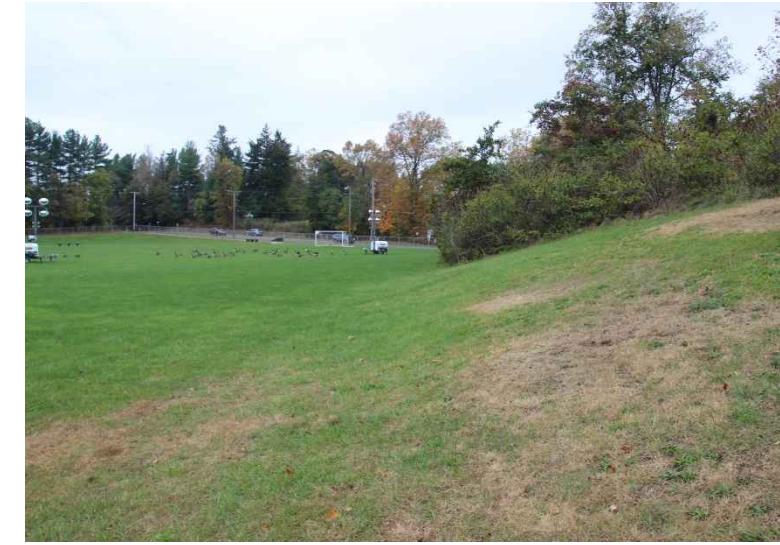
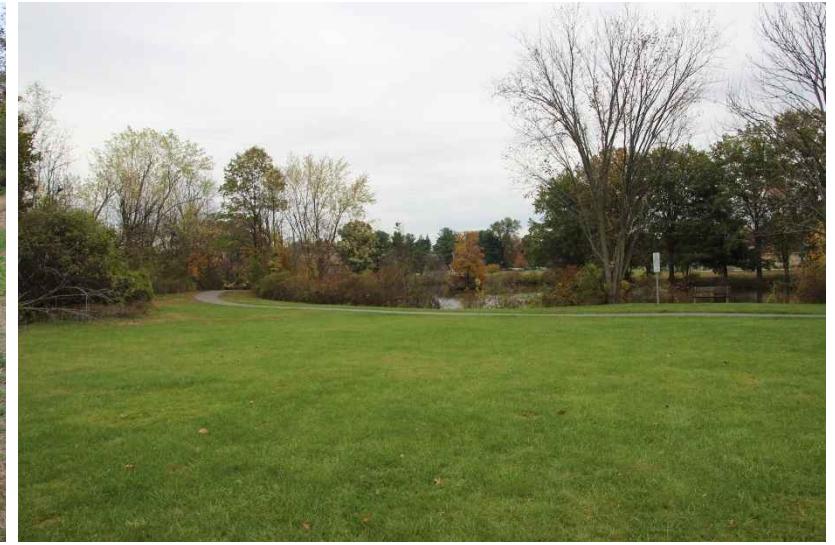
Soccer Fields and Open Space, Southeast

The southeast end of the Park provides open space for two youth soccer fields, near the corner of Willard Ave. and Cross Street. These heavily used fields have access by means of pedestrian sidewalks along Willard Avenue, a small parking lot at the corner of Cross Street and Mooreland Avenue and through a field within the park, off of the Pond Loop walkway.

The soccer fields have recently had an irrigation system installed, but changes to the field orientation may require significant modifications. Currently, there is not sufficient room to shift field striping to mitigate wear patterns.

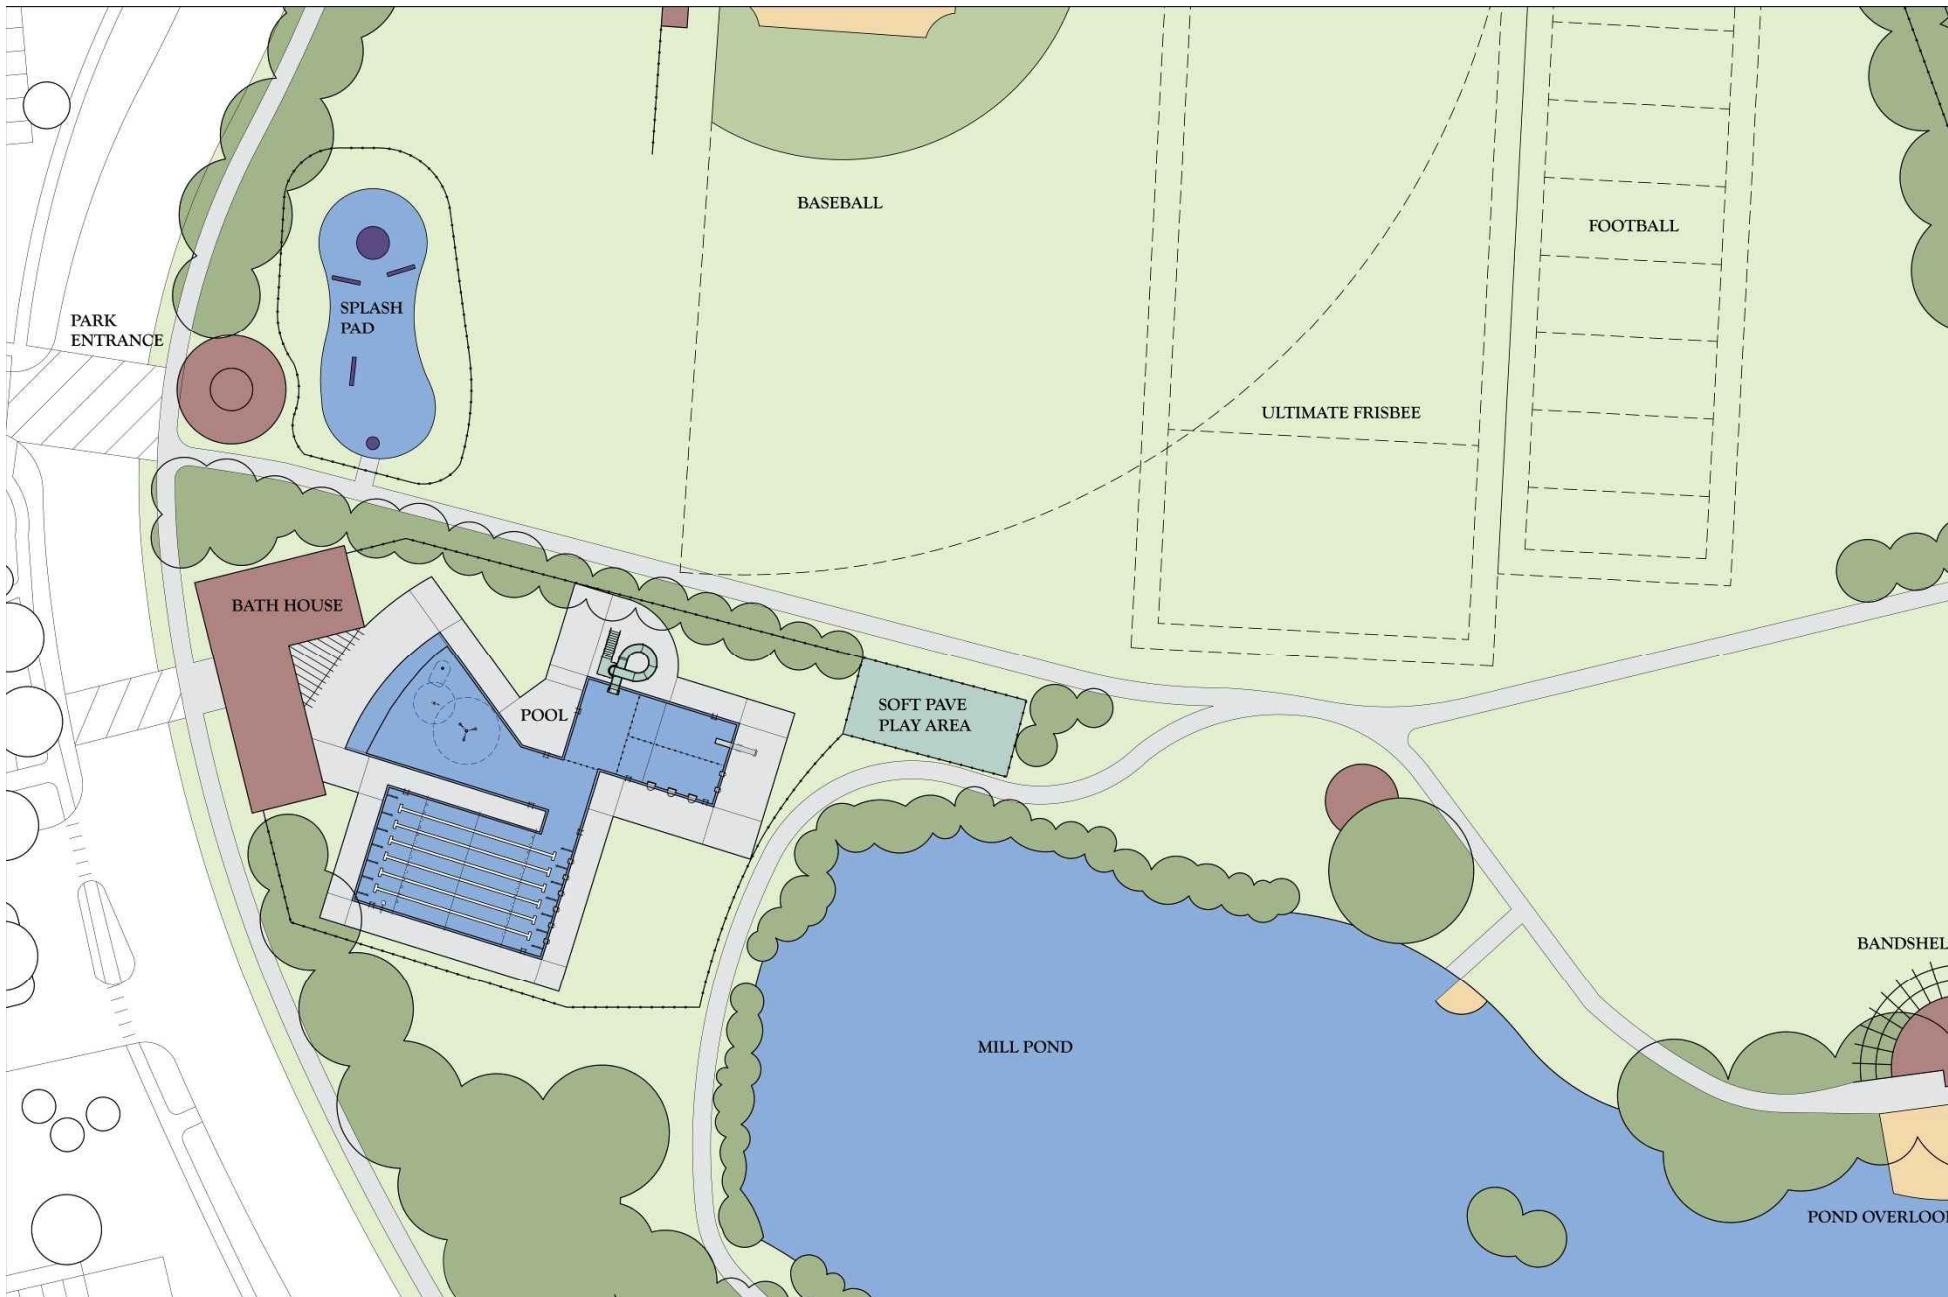
The proposed swimming pool and splash pad provides a variety aquatic programs, water depths and activities for swimmers of all ages and abilities.

The main swimming pool incorporates a zero-depth entrance with water spray features, a six-lane, 25-yard lap pool, ranging in depth from 3'-6" to 5'-0" and a deeper end incorporating a water slide, aquatic climbing walls and a 1-meter diving board, as well as competitive diving stands for training.

Pool decks surround the pool and are more generous in areas where patrons will tend to gather. Separate lawn areas are provided to attract swimmers for longer periods of time.

Trees and shade structures should be provided in strategic locations to provide protection from the sun and visual buffers between the pool area and the Park as a whole. The entire pool must be enclosed by fencing.

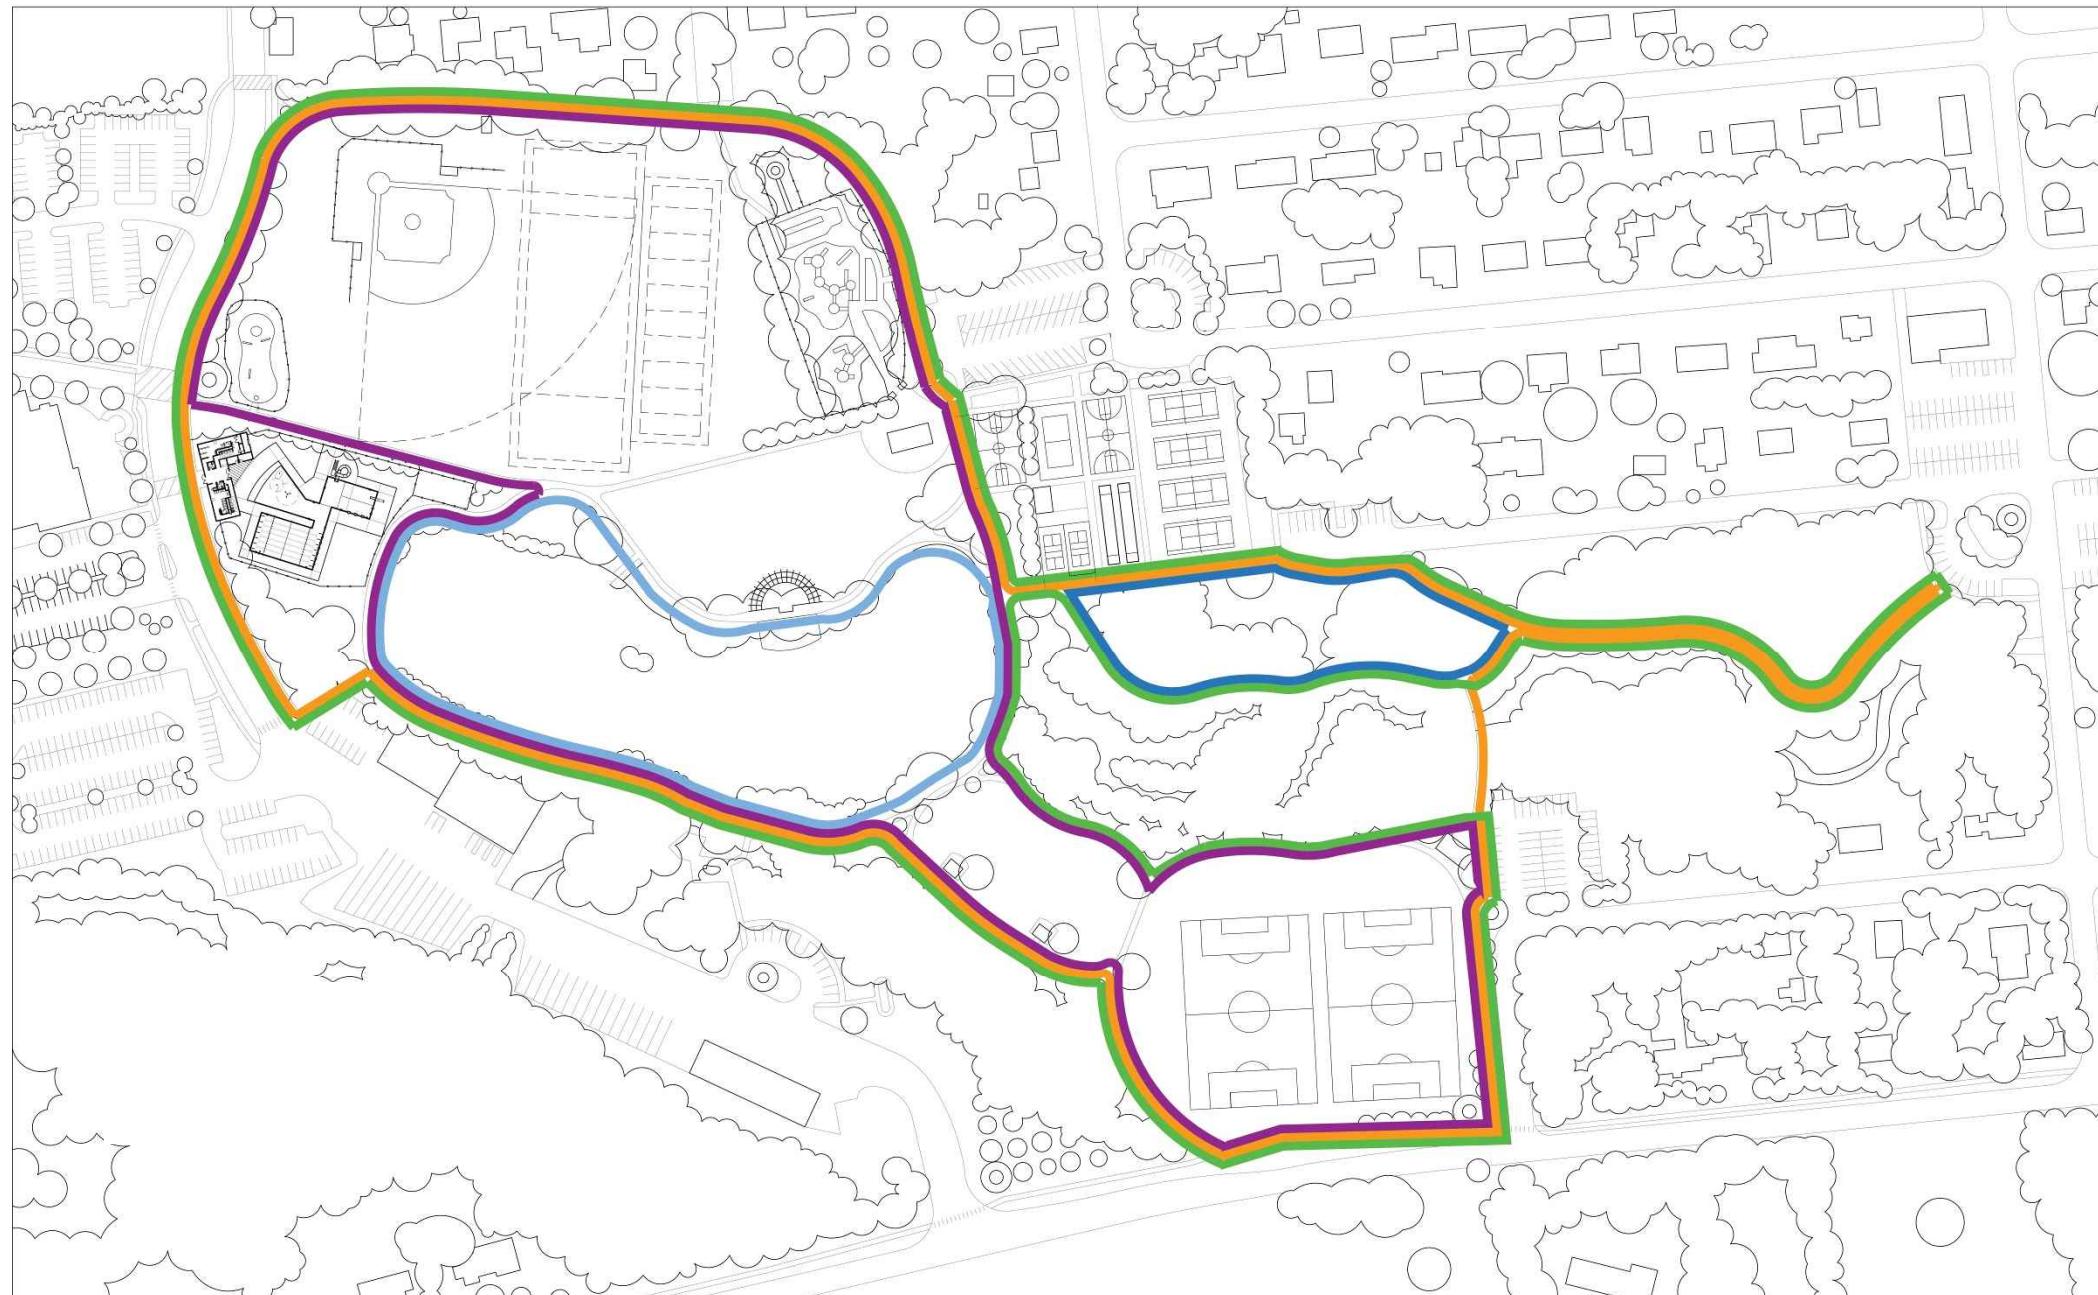
- PARK LOOP - $1\frac{1}{4}$ MI
- MILE LOOP - 1 MI
- MILE LOOP 1 MI
- POND LOOP - $\frac{1}{3}$ MI
- BROOK LOOP - $\frac{1}{2}$ MI

Existing walking paths are maintained and additional paths proposed to provide a variety of distances and types of experiences.

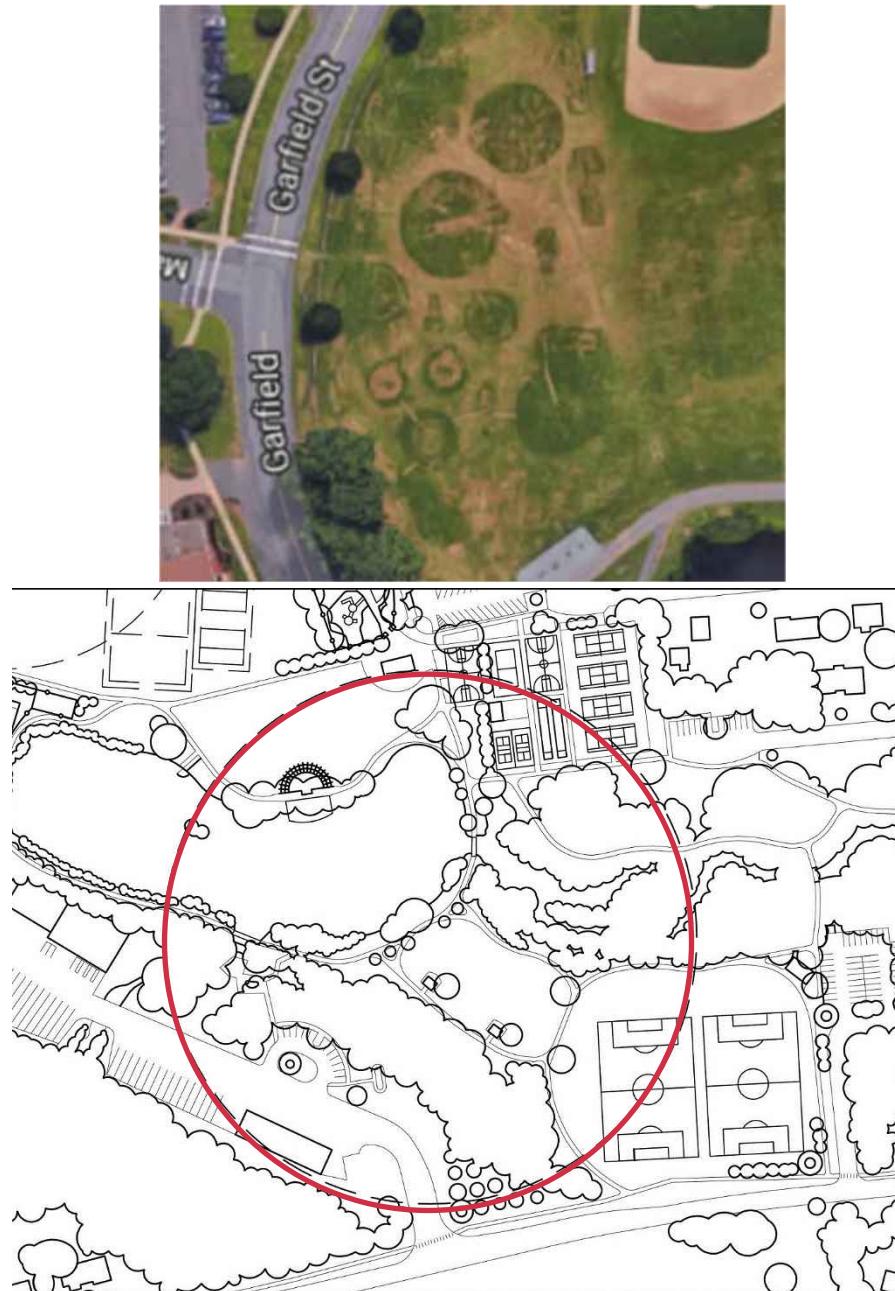
Layout for Extravaganza and Fireworks Safe Zone

The relocation of the pool will shift some of the carnival toward the east, essentially wrapping the infield and occupying more space in the area of the Ultimate Frisbee Field.

During the fireworks show, there is a regulated safe-zone that must be maintained. This safe zone will make it necessary to keep the public away from the area of the bandstand and a portion of the Court Sports.

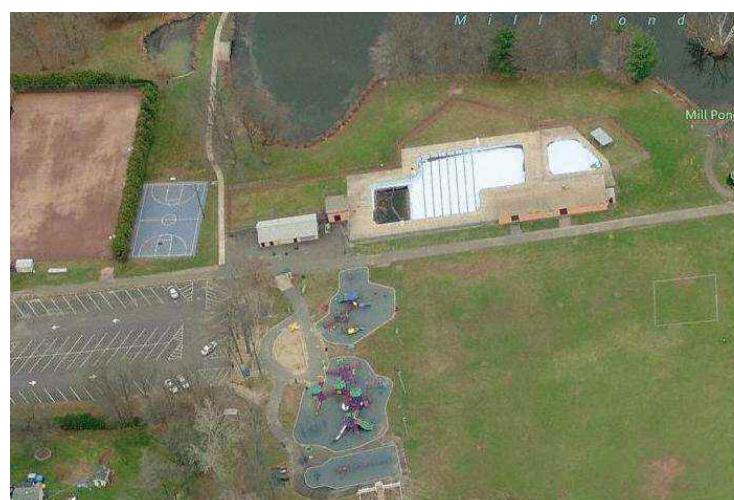
Figure 2 – Overview of Mill Pond Pool facility

The aerial photograph (Figure 2) to the right gives a general layout of the existing pool facility.

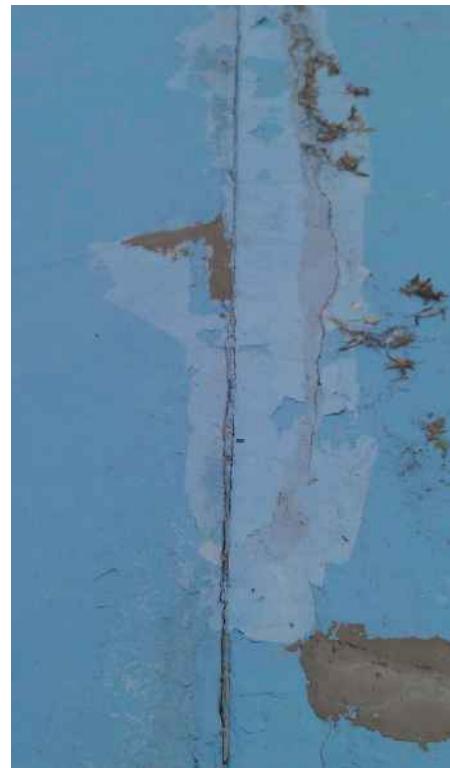
Figure 5 – Expansion joint, cracks, and patches

Mill Pond is located very close to the pool and water comes through cracks in the wall when the pool is drained. The static water pressure relief valve in the deep end has been cemented over. The static valve should be working correctly to allow water to enter the pool if the ground water table rises. The concrete pool floor is lightly reinforced and not designed to handle upward pressures due high ground water. The pool floors and walls have numerous cracks, and have been patched in various locations. (Figure 5) The expansion joints in the pool appear to be properly caulked.

- Option 1: Repair cracks in the pool walls with hydrophobic polyurethane grout crack injection. Replace all caulking and backer rod in expansion joints.
- Option 2: Install a new gunite pool inside the shell of the existing pool.
- Option 3: Remove the existing pool shell and install a completely new pool.
- Replace corroded valves, fittings, main pool pump, and corroded hardware.
- Replace the acid injection system with a CO₂ system.
- Install new chemical control equipment.
- Epoxy paint entire pool
- Replace depth markings.
- Replace concrete pool deck and sub base. Incorporate deck drains where needed.
- Replace diving board & stand.
