Mill Pond Park Newington, Connecticut

PRELIMINARY MASTER PLAN

MARCH 2018

TLB Architecture

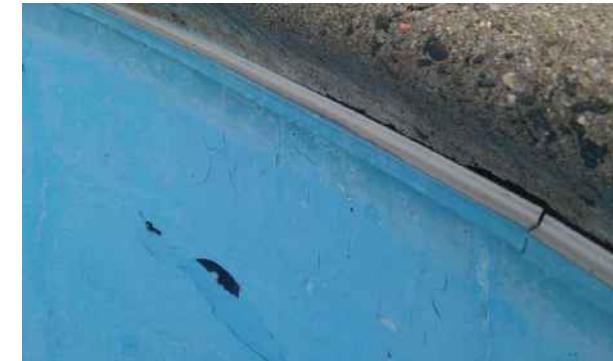
Figure 6 – Peeling paint and PVC joint separation

The curvature of the floor and walls in the deep end of the pool do not meet the requirements for a 1-meter diving board. The pool operator plans to repaint the pool this year and stated that the concrete under the paint in some areas seems to be powdery and flakes off down to the aggregate. The paint is flaking and delaminating in many areas. The coping

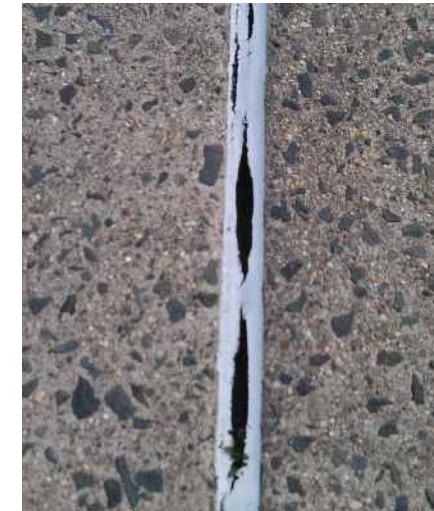
Figure 7 – Failed expansion joint caulking

The deck shows signs of settling and cracking in some areas that creates potential tripping hazard and can be uncomfortable and possibly cause an injury to bare feet. (Figure 8) Areas of the deck are discolored and some areas have been repaired. Overall the deck is not in too bad of shape for its age. Most of the caulking in the expansion joints on the decks is old brittle and cracked allowing for water to get beneath the deck and increase settling of the deck and the possibility of frost heaves. (Figure 7) Some of the expansion joints in the middle of the deck and the expansion joints between the deck and bathhouse are not sealed.

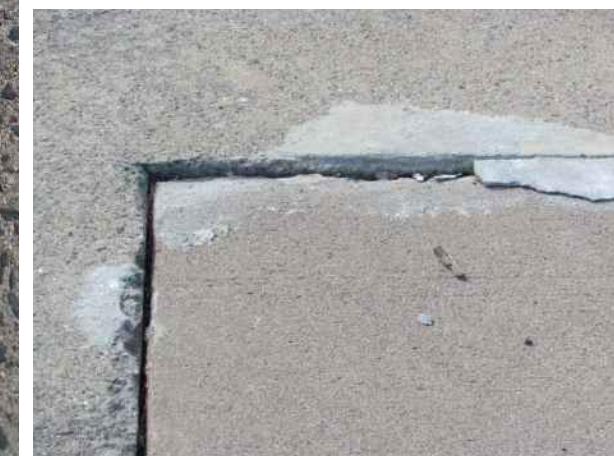
Figure 8 – Frost heave or settling concrete deck

The lack of a gutter or drain in the low spot between the bathhouse building and the pool has caused concrete deck separation. All water in this area is

draining through cracks and is saturating the soil under the deck. Water saturated soil can also put pressure on pool and foundation walls. The perimeter of the deck closest to the pool is newer than the rest of the deck. This portion of the deck was removed in 1999 when the piping was replaced. Rust is showing through the concrete deck in some areas. The welded wire mesh may have been installed too close to the surface.

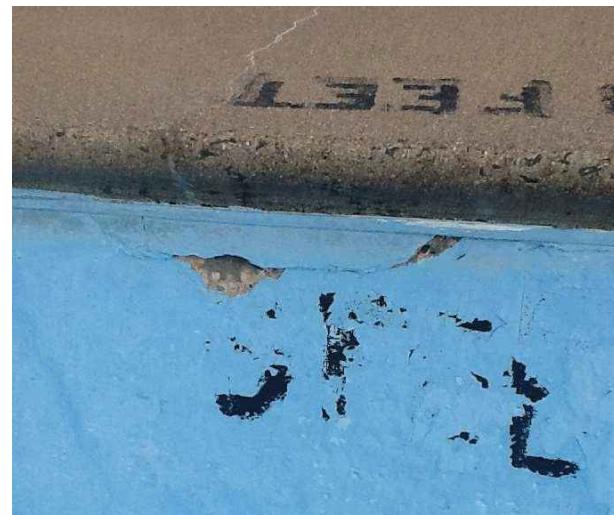
Figure 9 – Peeling depth markers

The depth markers on the pool walls and deck are hand painted or stickers. Most are faded or missing. (Figure 9) Some of the depth markers are incorrect. The depth must be measured from the floor of the pool to the water level.

- Repair gaps in fence, and secure loose fence areas.
- Review the inventory of lifesaving equipment and replace or supplement as necessary.
- Modify the main drain piping to keep water velocity flow rates under the rating on the Virginia Graeme Baker covers. This may conflict with CT pool guidelines, but is the only short-term solution.
- Remove the existing diving boards, and install smaller up to date boards that are compliant with the deep end dimensions.
- Replace depth markings.

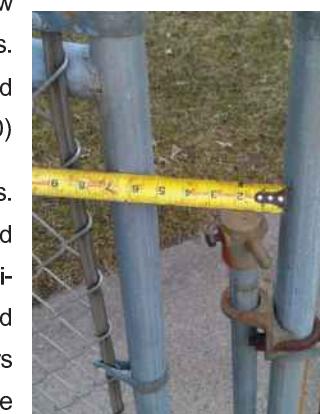
Figure 10 – Fence gate

The fence around the pool is galvanized, but is starting to show signs of rust. The fence is bent in some areas and has large gaps. The gaps between vertical members and between the ground and the bottom of the fence cannot be greater than 2-inches. (Figure 10)

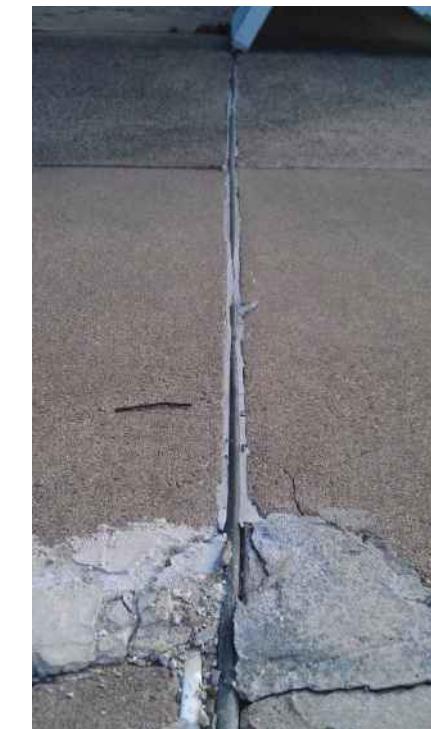
Figure 11 – Copper pipe for handicap lift

Pool staff reports new handicap lifts will be ordered for the upcoming season. The lifts will be hydraulic portable units, which need to be permanently anchored to meet ADA requirements (even though they are portable). This pool used to be equipped with a permanently mounted hydraulic (water powered) lift. The same connection can be used. The copper pipe connecting the lift was installed in an expansion joint in the concrete. The copper pipe is above the caulking and sticking out of the ground in areas. (Figure 11)

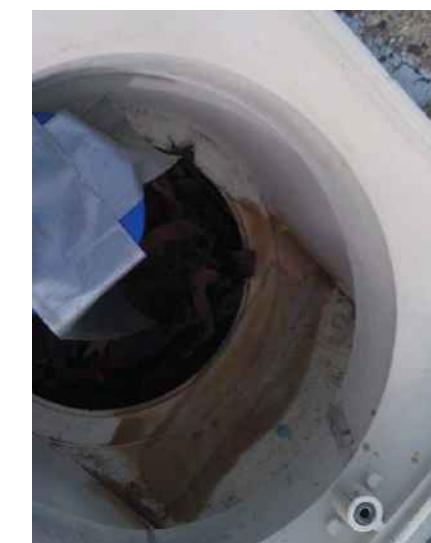
Figure 12 – Repaired skimmer

Many of the skimmers have stress cracks on the inside but have been repaired with fiberglass resin. (Figure 12) There are no skimmers along the deep end wall closest to

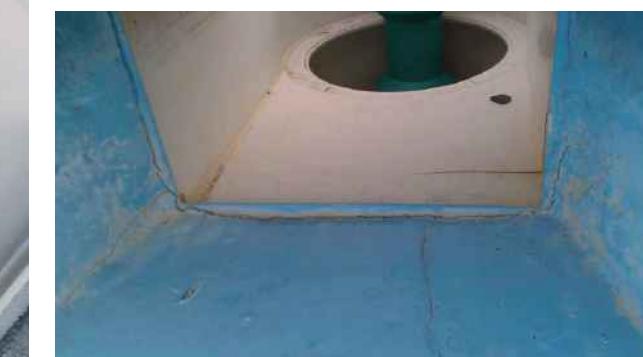
Figure 13 – Cracked joint between concrete and skimmer

the diving board. Skimmers are recommended in the deep end. The skimmers do not have equalization ports which are recommended by CT pool design guidelines. The skimmers appear to be cast in concrete with no caulking around the mouth of the skimmers. (Figure 13) The shrinkage between the skimmers and the concrete should be caulked to prevent water loss.

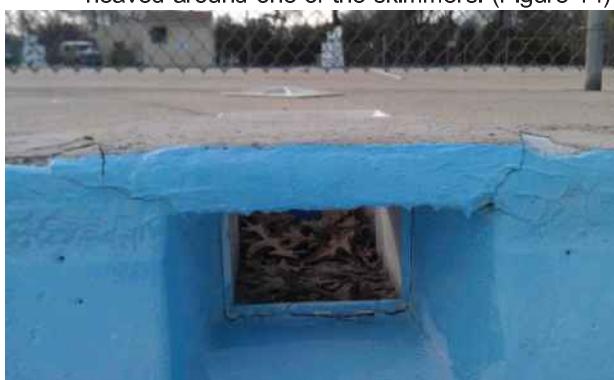
Figure 14 – Wading pool cracked coping above skimmer

The concrete coping is cracked in areas and has heaved around one of the skimmers. (Figure 14) The

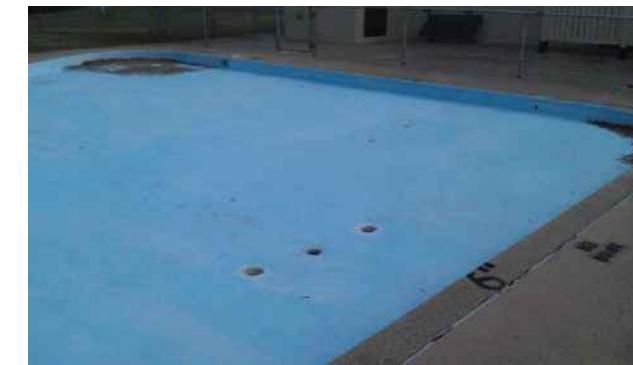
Figure 16 – Wading pool

The wading pool contains approximately 6,500 gallons. Water in the wading pool is circulated with a 1.5hp pump and filtered with a duel filter arrangement. The majority of the concrete shell appears to be in good shape with minimal cracks. As with the main pool, the caulking joints in the deck and coping around the wading pool are cracked.

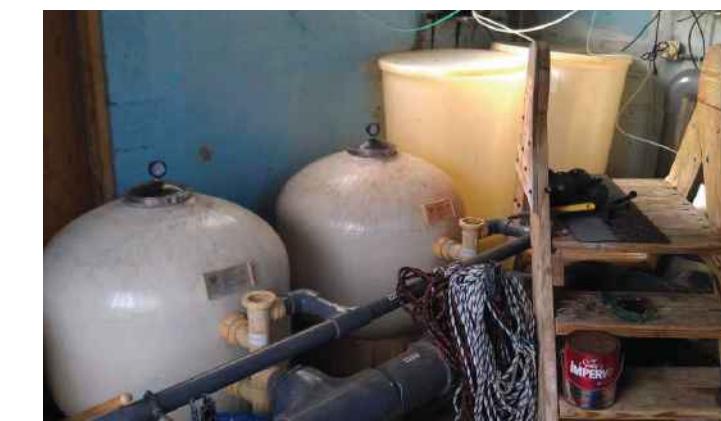
Figure 17 – Main pool filters, chemical storage, and stairs

The main pool filter system consists of five (5) sand filters which were installed in 1993. The sand has not been replaced since then. Water chemistry is controlled automatically through the use of liquid chlorine and liquid acid. Stenner chemical feed pumps transport the chemicals to injection points. The pool pump is 15hp and has a 6-inch suction and a 4-inch discharge. Two (2) filters are backwashed at a time through a 2" pipe to the backwash pit. The backwash pit is connected to city sewer.

An emergency eyewash station was present. Acid is used to lower pH. Carbon Dioxide (CO₂) is much more commonly used than acid because it is less hazardous and is commonly available. Chemical tanks should have secondary containment in case of a leak. (Figure 17)

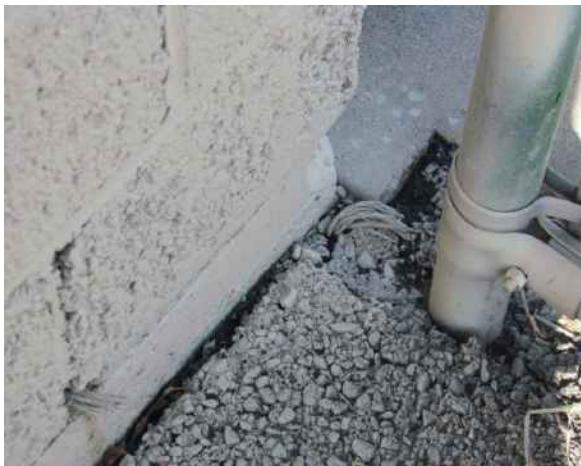
Figure 18 – Cut bonding or grounding wire

The existence of an electrical bonding grid around the pool is unknown, and probably non-existent. If major repairs are made metal deck equipment in the pool area and concrete reinforcement will need to be connected to a bonding grid. The bonding grid must connect to the pool pump. The pump is not bonded, and no bonding is shown on the plans. A wire just outside of the equipment room has been cut after it exits the building and before it enters the ground. (Figure 18) This wire may be either a ground wire or bonding wire.

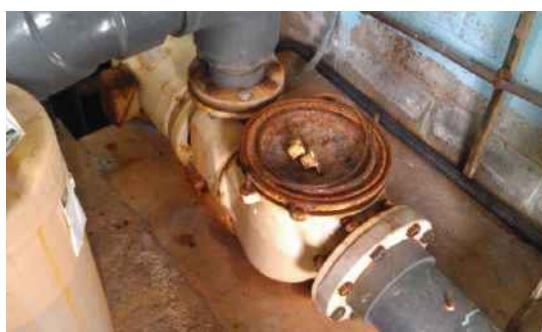
Figure 19 – Main pool pump

General corrosion inside the equipment room is apparent. Electrical panels, the pump, pipe flanges, and flange hardware are corroded. The paint on the cement block walls is delaminating (either from cement deterioration, moisture, or chemical exposure). Improved ventilation will reduce corrosion. A copper water pipe is not securely attached to the wall and is free to vibrate.

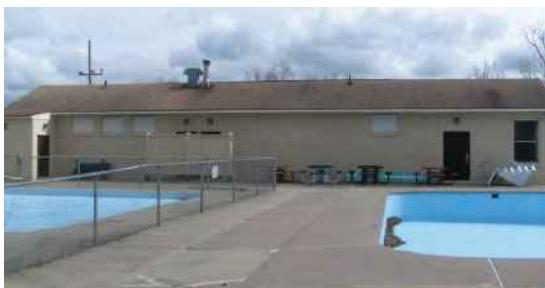
Figure 20 – Rear of bathhouse

Two separate building were inspected as part of this evaluation. The bathhouse located to the East of the pool and the main pool filter building located to the South of the pool. The bathhouse was completely renovated in 1988, at which time according to the drawings, a new system of wood trusses were installed above the flat steel bar joints to give the building a gable roof design.

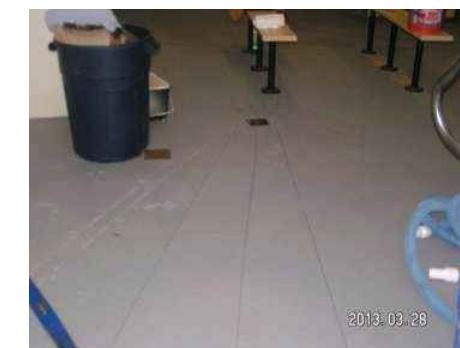
Figure 24 – Floor drains

The bathrooms are not ADA accessible and will need to be made compliant if any major renovations are made. A handicap shower is available (Figure 23), but does not have a private enclosure for a wheelchair bound person. In multiple locations, such as the main entrance, there is greater than a 1/4-inch bump in floor elevation. Floor transitions between rooms must be smooth. The four other showers share two floor drains. Each shower floor must be pitched so that water does not pass from one bather to another. It appears the original floor was not pitched correctly in the vicinity of the showers and drainage slits were cut into the floor to reduce puddling. (Figure 24)

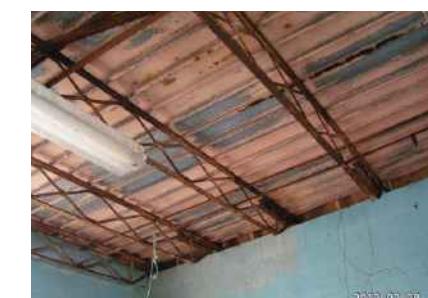
Figure 29 – Original steel roof structure of filter building

The original building was constructed in 1958 and renovated in 1988 at which time the roof was converted into a gable roof. The building is 90 feet long by 24 feet wide, one-story masonry bearing wall structure and does not have a basement. The original roof framing consisted of 12" deep steel bar joints spaced at 30" on center clear span across the width of the building. (Figure 29)

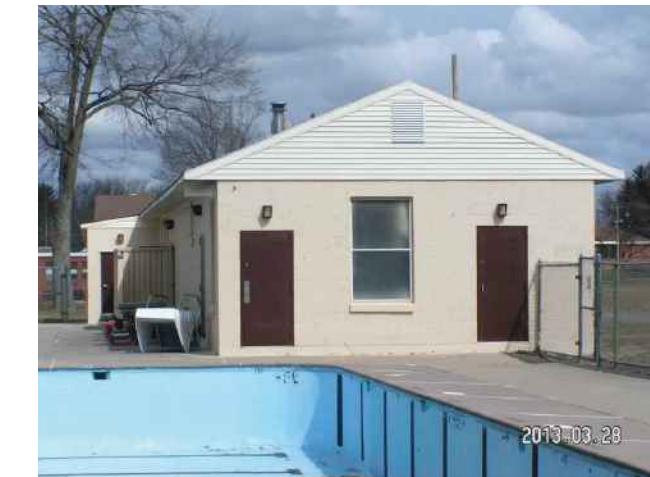
Figure 30 – Side of bathhouse

The bathhouse is at the pool deck level and includes the patron's entrance, separate men's and women's lockers, showers and changing rooms. Interior partition walls are constructed of masonry block walls. Exterior walls are constructed of 8-inch masonry units.

The foundation is constructed of reinforced concrete wall with a continuous concrete strip footing set below the frost line (-3'-6"). The floor is a 6-inch concrete slab on grade reinforced with welded wire fabric.

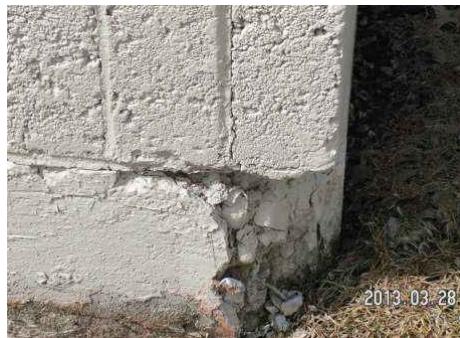
Figure 31 – Foundation spalling

The foundation is experiencing some cracking and spalling of concrete at the northeast corner of the building. (Figure 31) The threshold at the patron's entrance at the rear double door does not

1. Apply block filler on the exterior masonry walls and repaint. (10 years) (\$15,000)
2. Replace the asphalt shingles (5 years) (2,800 SF Roof Area, \$41,000)
3. Repair foundation (5 years) (\$1,000)
4. Adjust threshold at double door entrance (Immediate) (\$3,000)
5. Emergency Lighting & Smoke Alarm (Immediate) (\$5,000)
6. Paint Exposed Metal Deck and Bar Joist in Filter Building (5 years) (\$2,500)
7. General Renovation / Updates (5 years) Cost per square foot (\$60/SF, 2,200 SF, \$132,000)

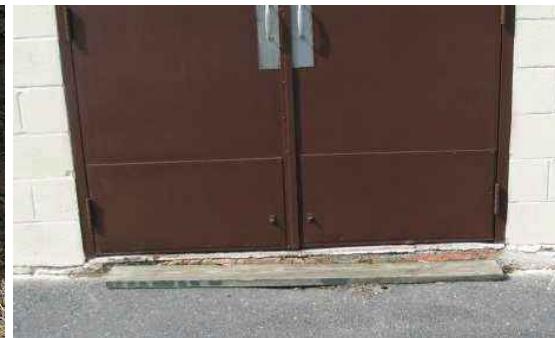
Figure 32 – Bathhouse entrance trip hazard

meet ADA due to the finish grade of the bituminous walkway. There is a loose 2x plank used to mitigate the change in elevation, which poses a tripping hazard. (Figure 32)

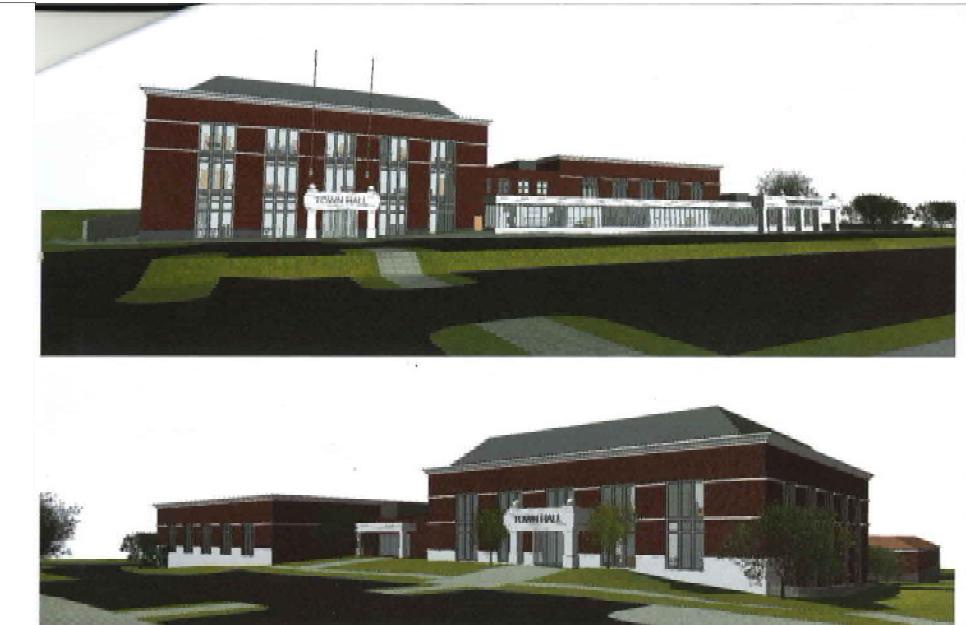
Town Hall Front & Rear Entrance

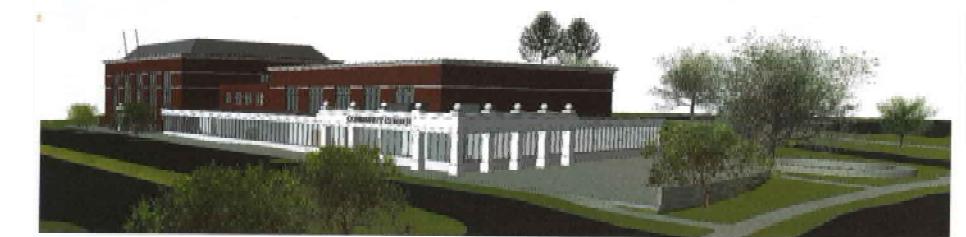
COMMUNITY CENTER
