Owens Realty Services has been retained to provide consulting services to provide a conditions assessment, inclusive of a visual inspection and Code compliance review of the outdoor swimming pools at Churchill Park.

The assessment includes an outdoor 'C'-shaped swimming pool and an outdoor wading pool, decks and fencing, as well as swimming pool recirculation, filtration and chemical control systems.

Churchill Pool was built in 1965 on an elevated parcel of land at the southeast corner of Churchill Park. As with any pool of 55 years old it has a number of issues as a result of a harsh New England environment, heavy use, wear and tear.

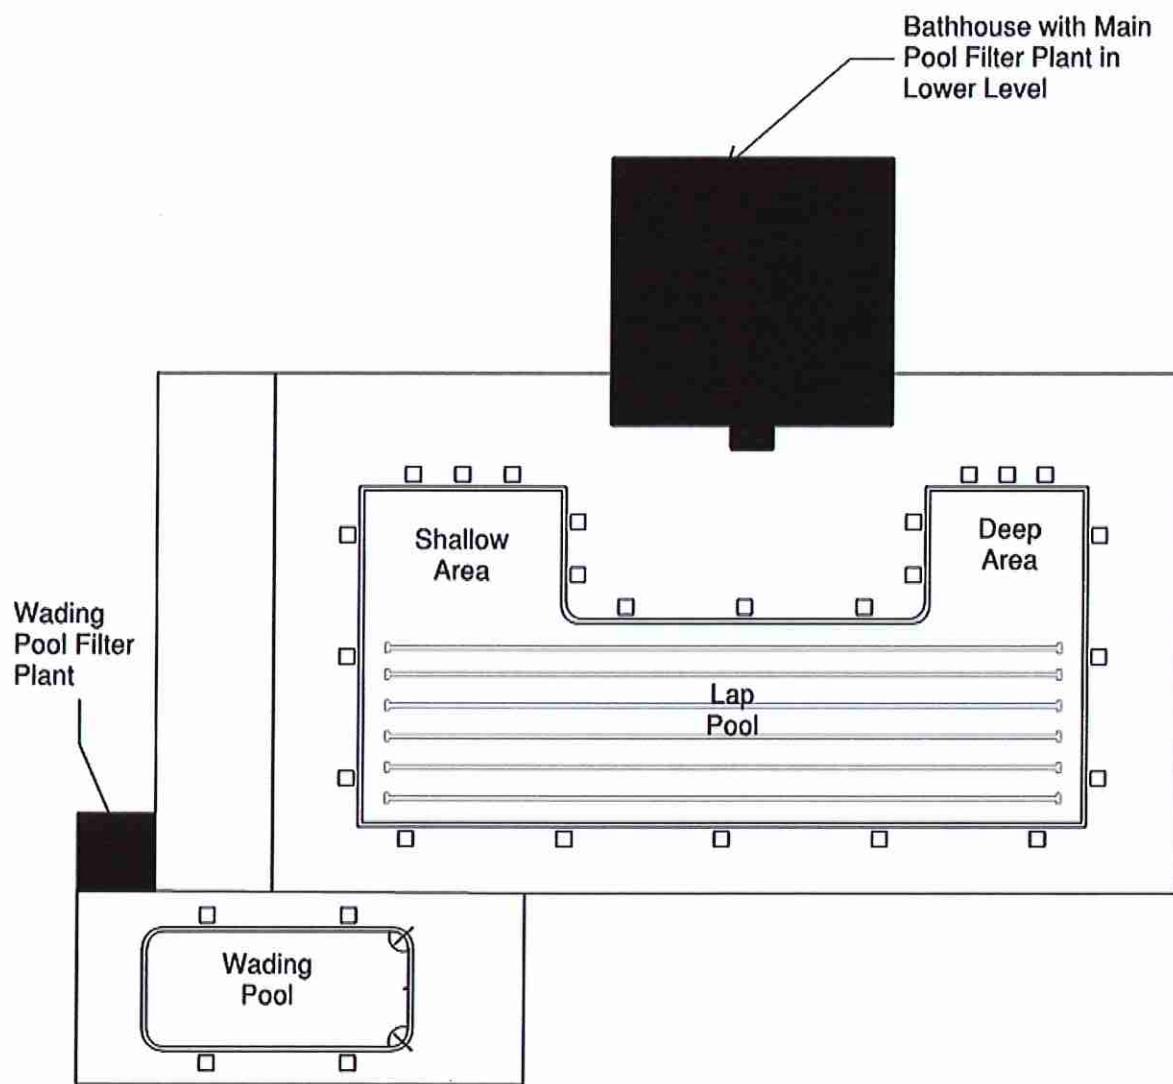
The pool perimeter is surrounded by a six-feet high, galvanized chain-link fence. The wading pool is separated from the main pool by a 6-foot fence. The perimeter fence provides a complete enclosure, using the bathhouse and wading pool filter building as a portion of the enclosure. It is in fair condition with rusting, limited misalignment and some gaps exceeding allowable dimensions, both between posts and to grade below the fencing.

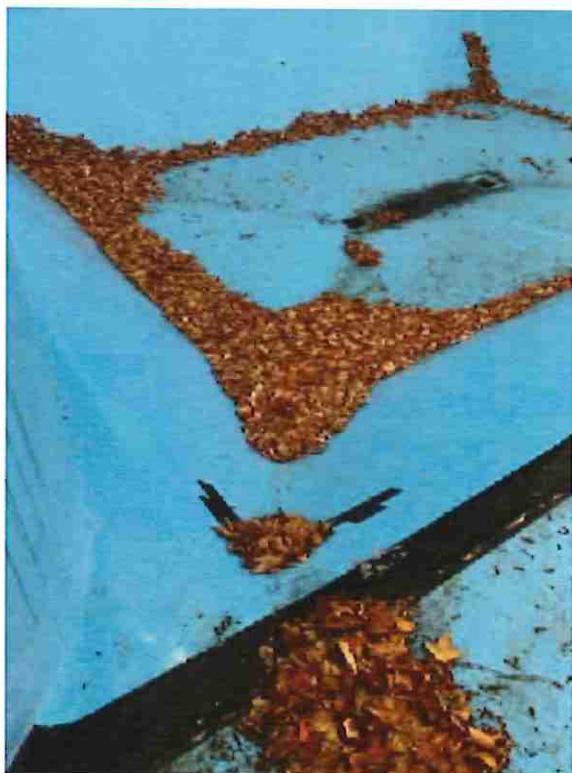
Deep end. Diving boards have been removed due to non-compliant hopper geometry

The shelf around the hopper provides an effective foot ledge, but is not compliant with current CT DPH Regulations. Should any significant work to the pool be done, which would require a new Health Permit, this condition would need to be addressed.
