Town of Newington  
Connecticut

# Aquatic Facility Assessment Report

Mill Pond Park and Churchill Park

December 2025

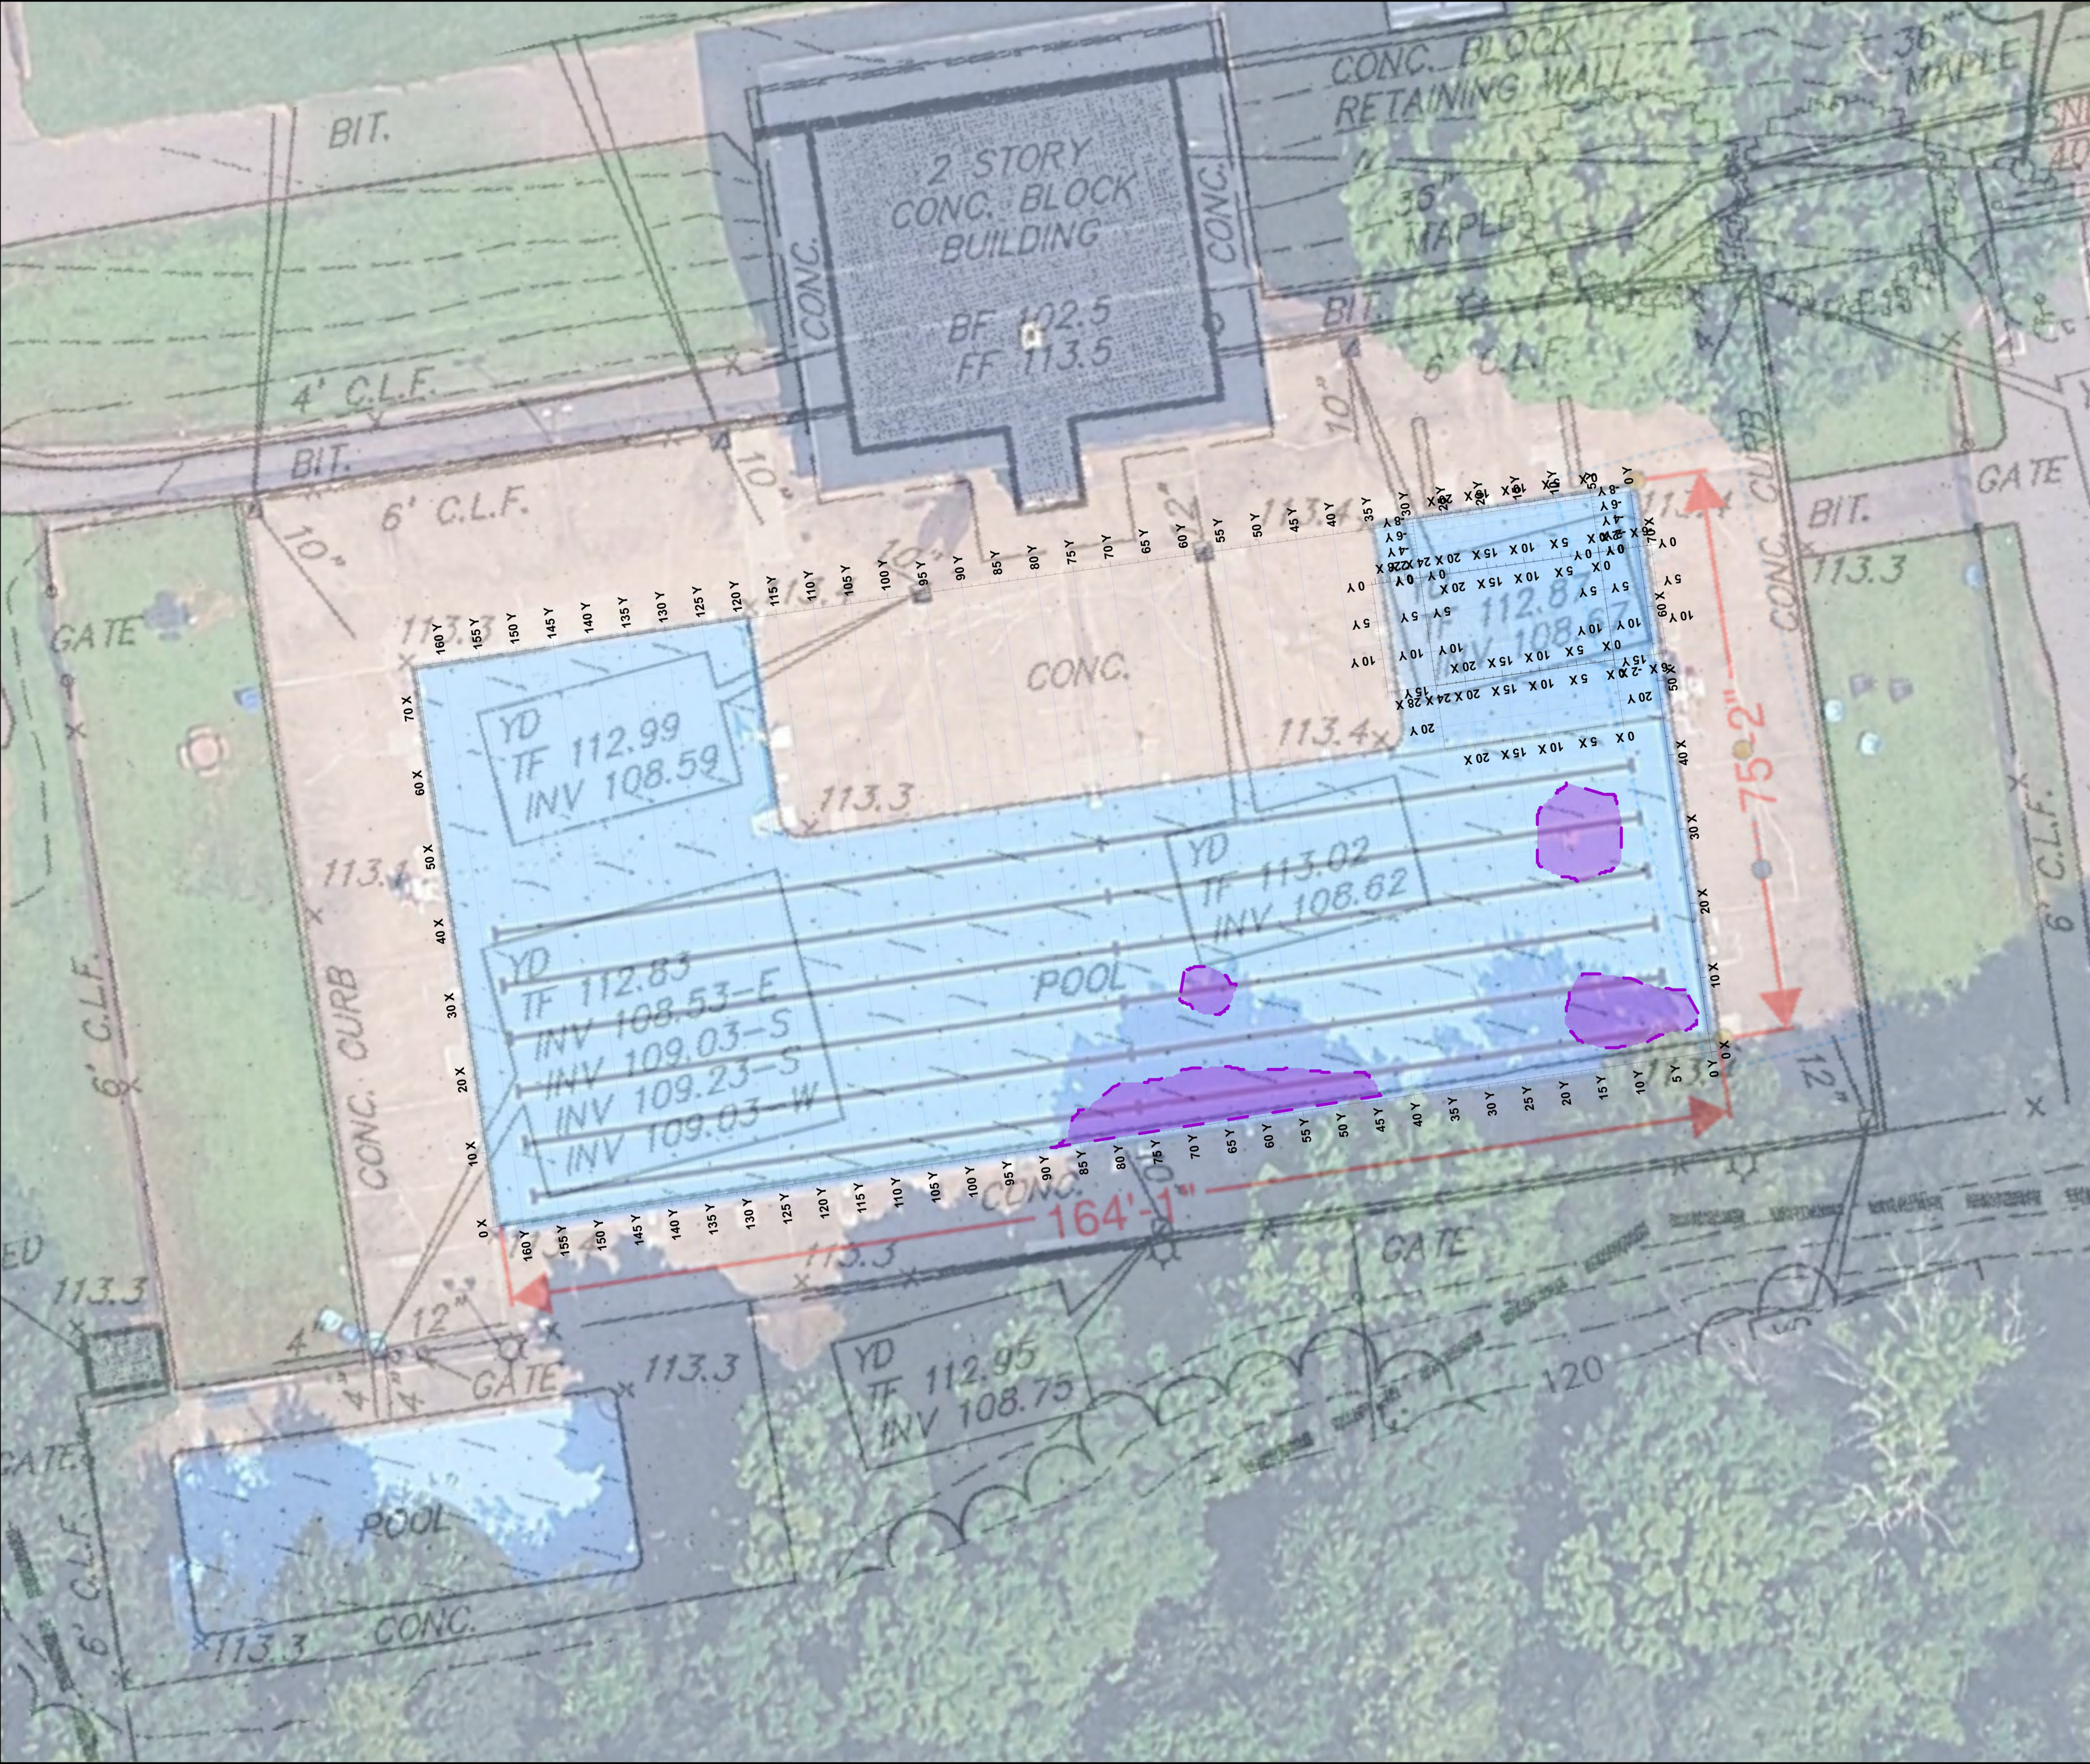
FIGURE 1  
AREA OF INVESTIGATION  
WITH EMI  
SURVEY COMPLETED 10/31/2025  
CHURCHILL PARK POOL  
1989 MAIN STREET  
NEWINGTON, CONNECTICUT  
Prepared for  
TOWN OF NEWINGTON CT  
OCTOBER 2025

- Figure 1 shows the outline of RSI's survey grids. The main grid extends to 164Y, increasing to the west, while the maximum "X" extent to the north is 75X. Because of the steepness of the deep-end of the pool, and the physical size of the GPR antennas, smaller grids were included in the interior portion of the deep-end. Figure 1 shows the different grid coordinates. Because of the different grids, some anomalous contours have been generated from "edge" effects of the contouring process.

- Based upon RSI's field interpretation, shown on Figure 1, there are two small to moderately large areas, outlined by purple long-dashed line polygons, in the interior portion of the pool. These are centered around Grid Coordinates 31.5X, 12.75Y and 17.5X, 65.5Y. There are larger anomalous areas, interpreted in the field as potentially voided areas, along the southern edge and southeastern corner. These are located at: 3.5X, 65Y, and 7X and 10.5Y (Figure 1). It is possible that water has gotten inside the delaminated concrete, causing GPR signal to reverberate throughout the radargram, making it obvious to identify in the field. There seems to be correlation between what was observed in the field using GPR and a later "hammer" sounding test, performed by WSE's Engineers.

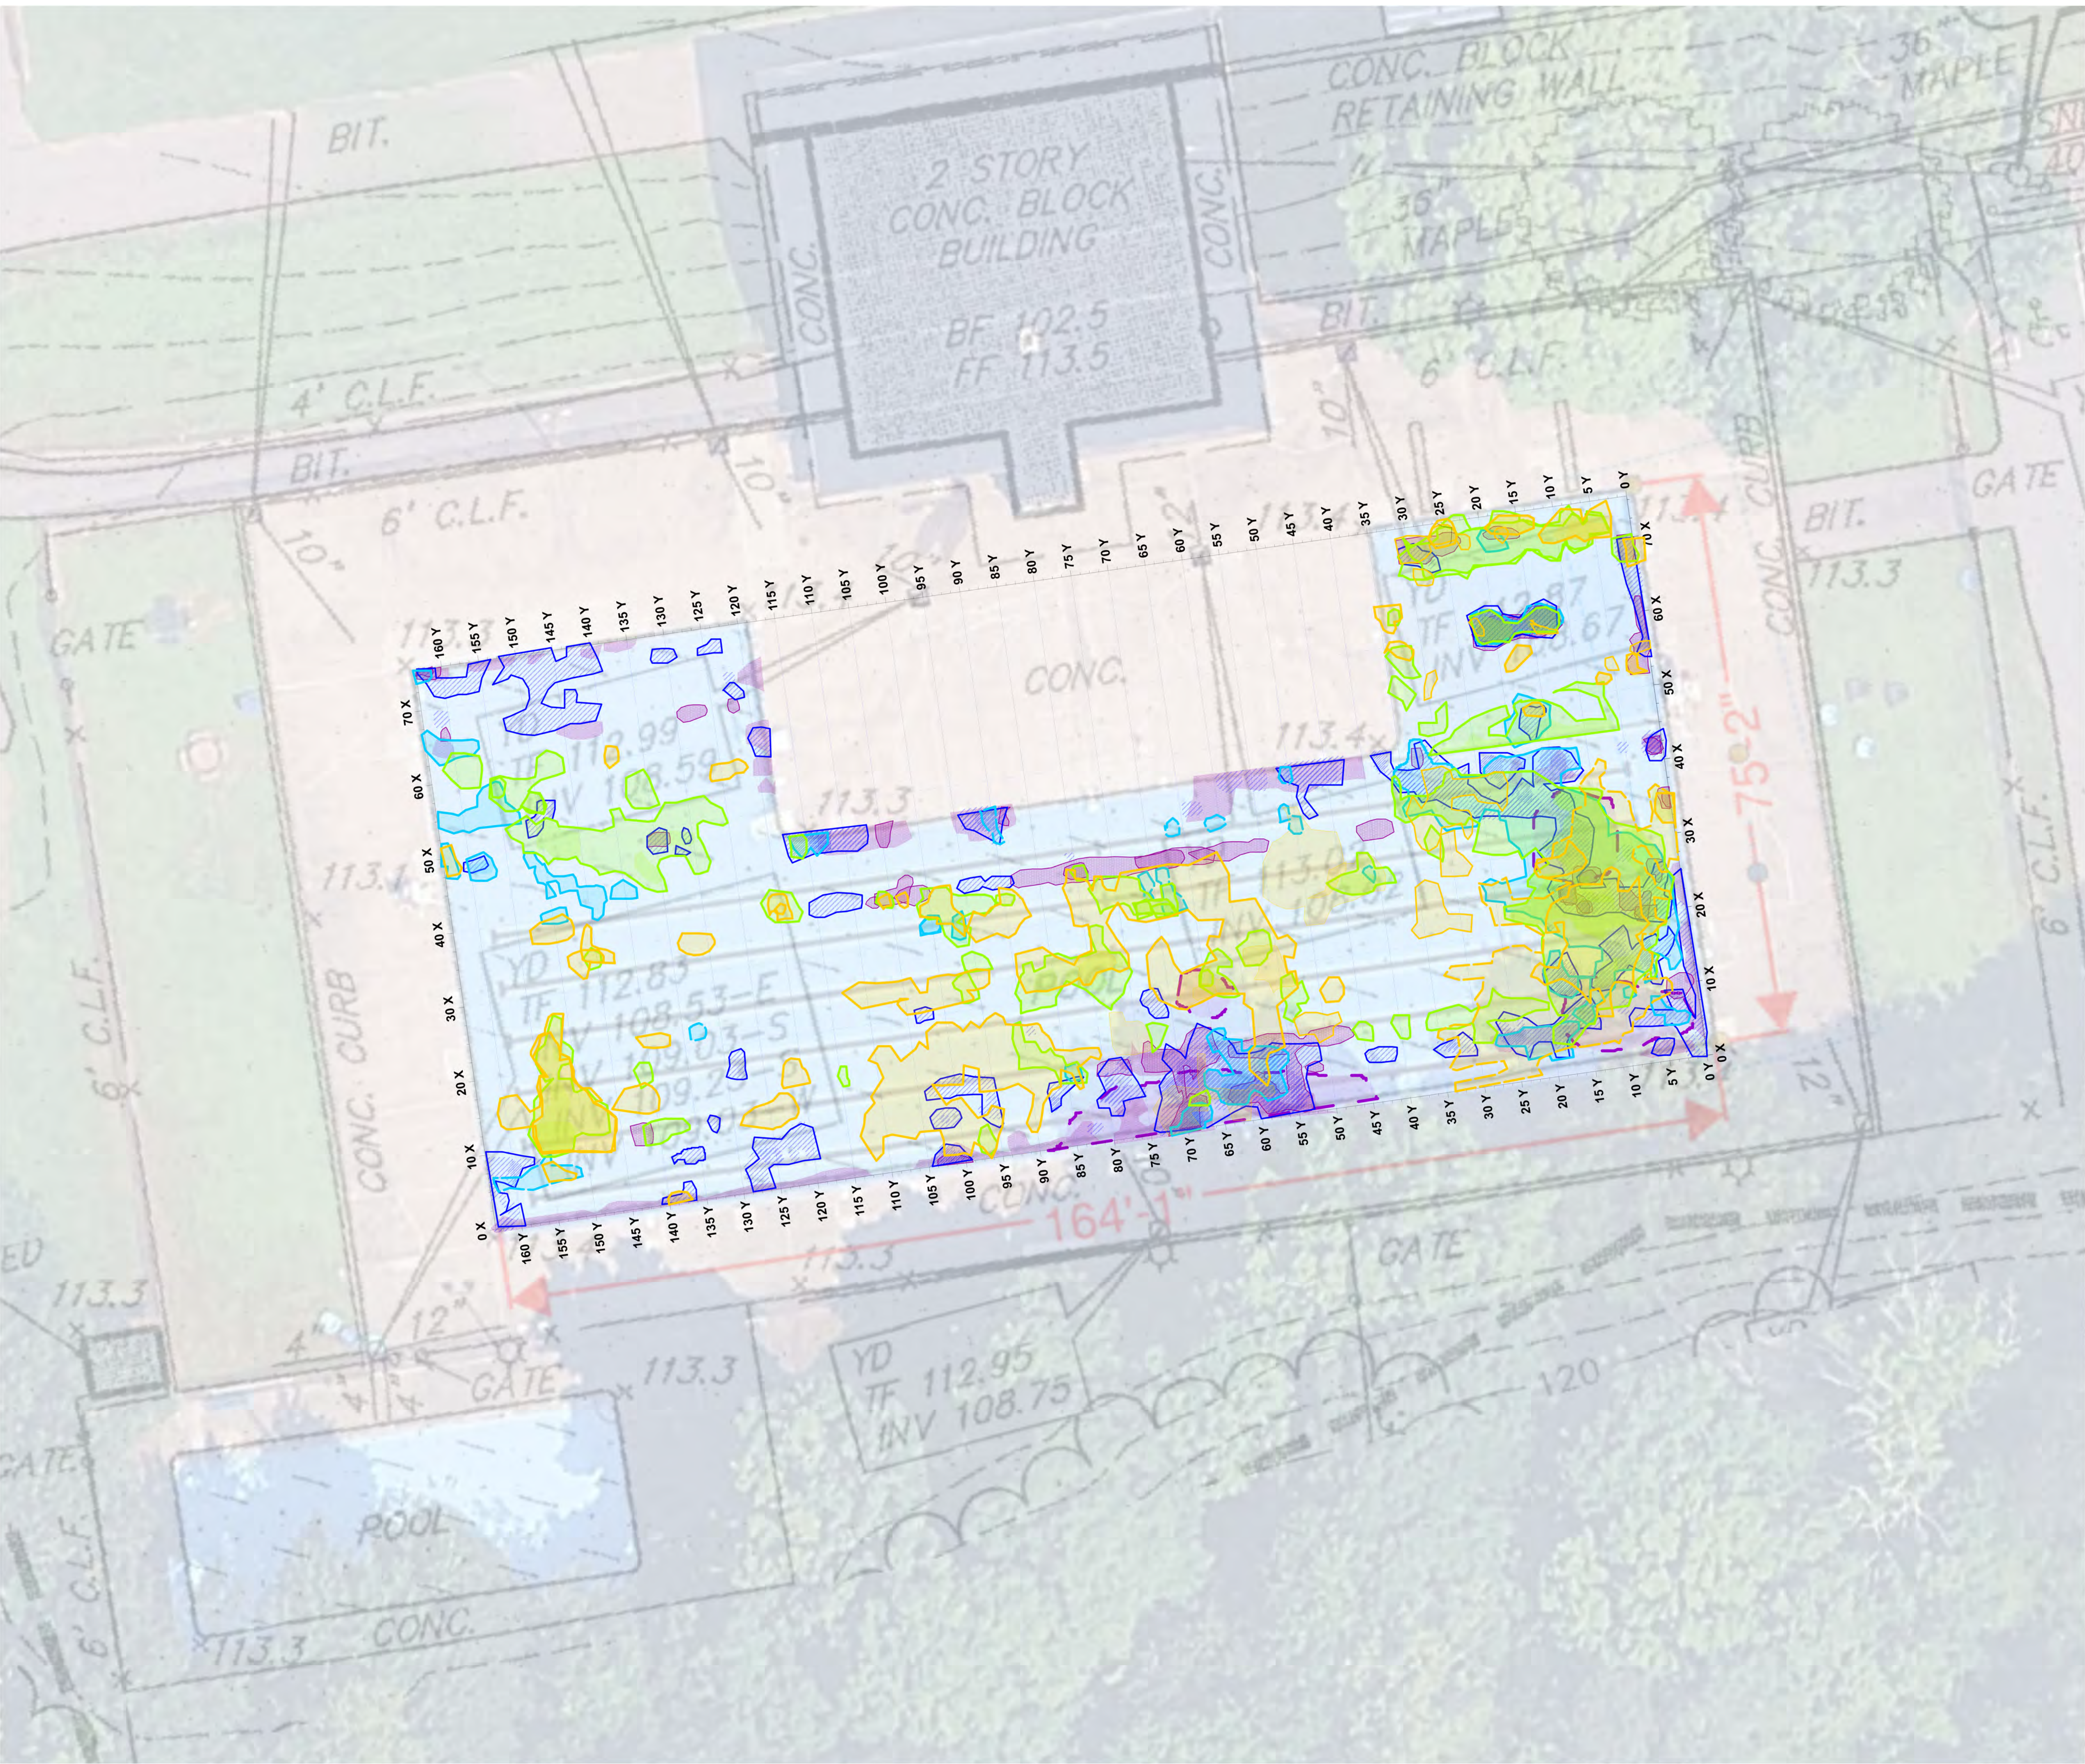
- Zone of High-Amplitude GPR Reflections that could indicate an area of voiding and/or moisture accumulation, or structural steel, if linear
- Concentration of possible voids, loosely packed soil and moisture accumulation observed 0-1 foot below grade. Deeper shading indicates a more dense concentration and greater vertical extent of potential voids

- Concentration of possible voids, loosely packed soil and moisture accumulation observed 1-2 feet below grade. Deeper shading indicates a more dense concentration and greater vertical extent of potential voids

- Concentration of possible voids, loosely packed soil and moisture accumulation observed 2-3 feet below grade. Deeper shading indicates a more dense concentration and greater vertical extent of potential voids

- Concentration of possible voids, loosely packed soil and moisture accumulation observed 3-4 feet below grade. Deeper shading indicates a more dense concentration and greater vertical extent of potential voids

- Concentration of possible voids, loosely packed soil and moisture accumulation observed 4-5 feet below grade. Deeper shading indicates a more dense concentration and greater vertical extent of potential voids

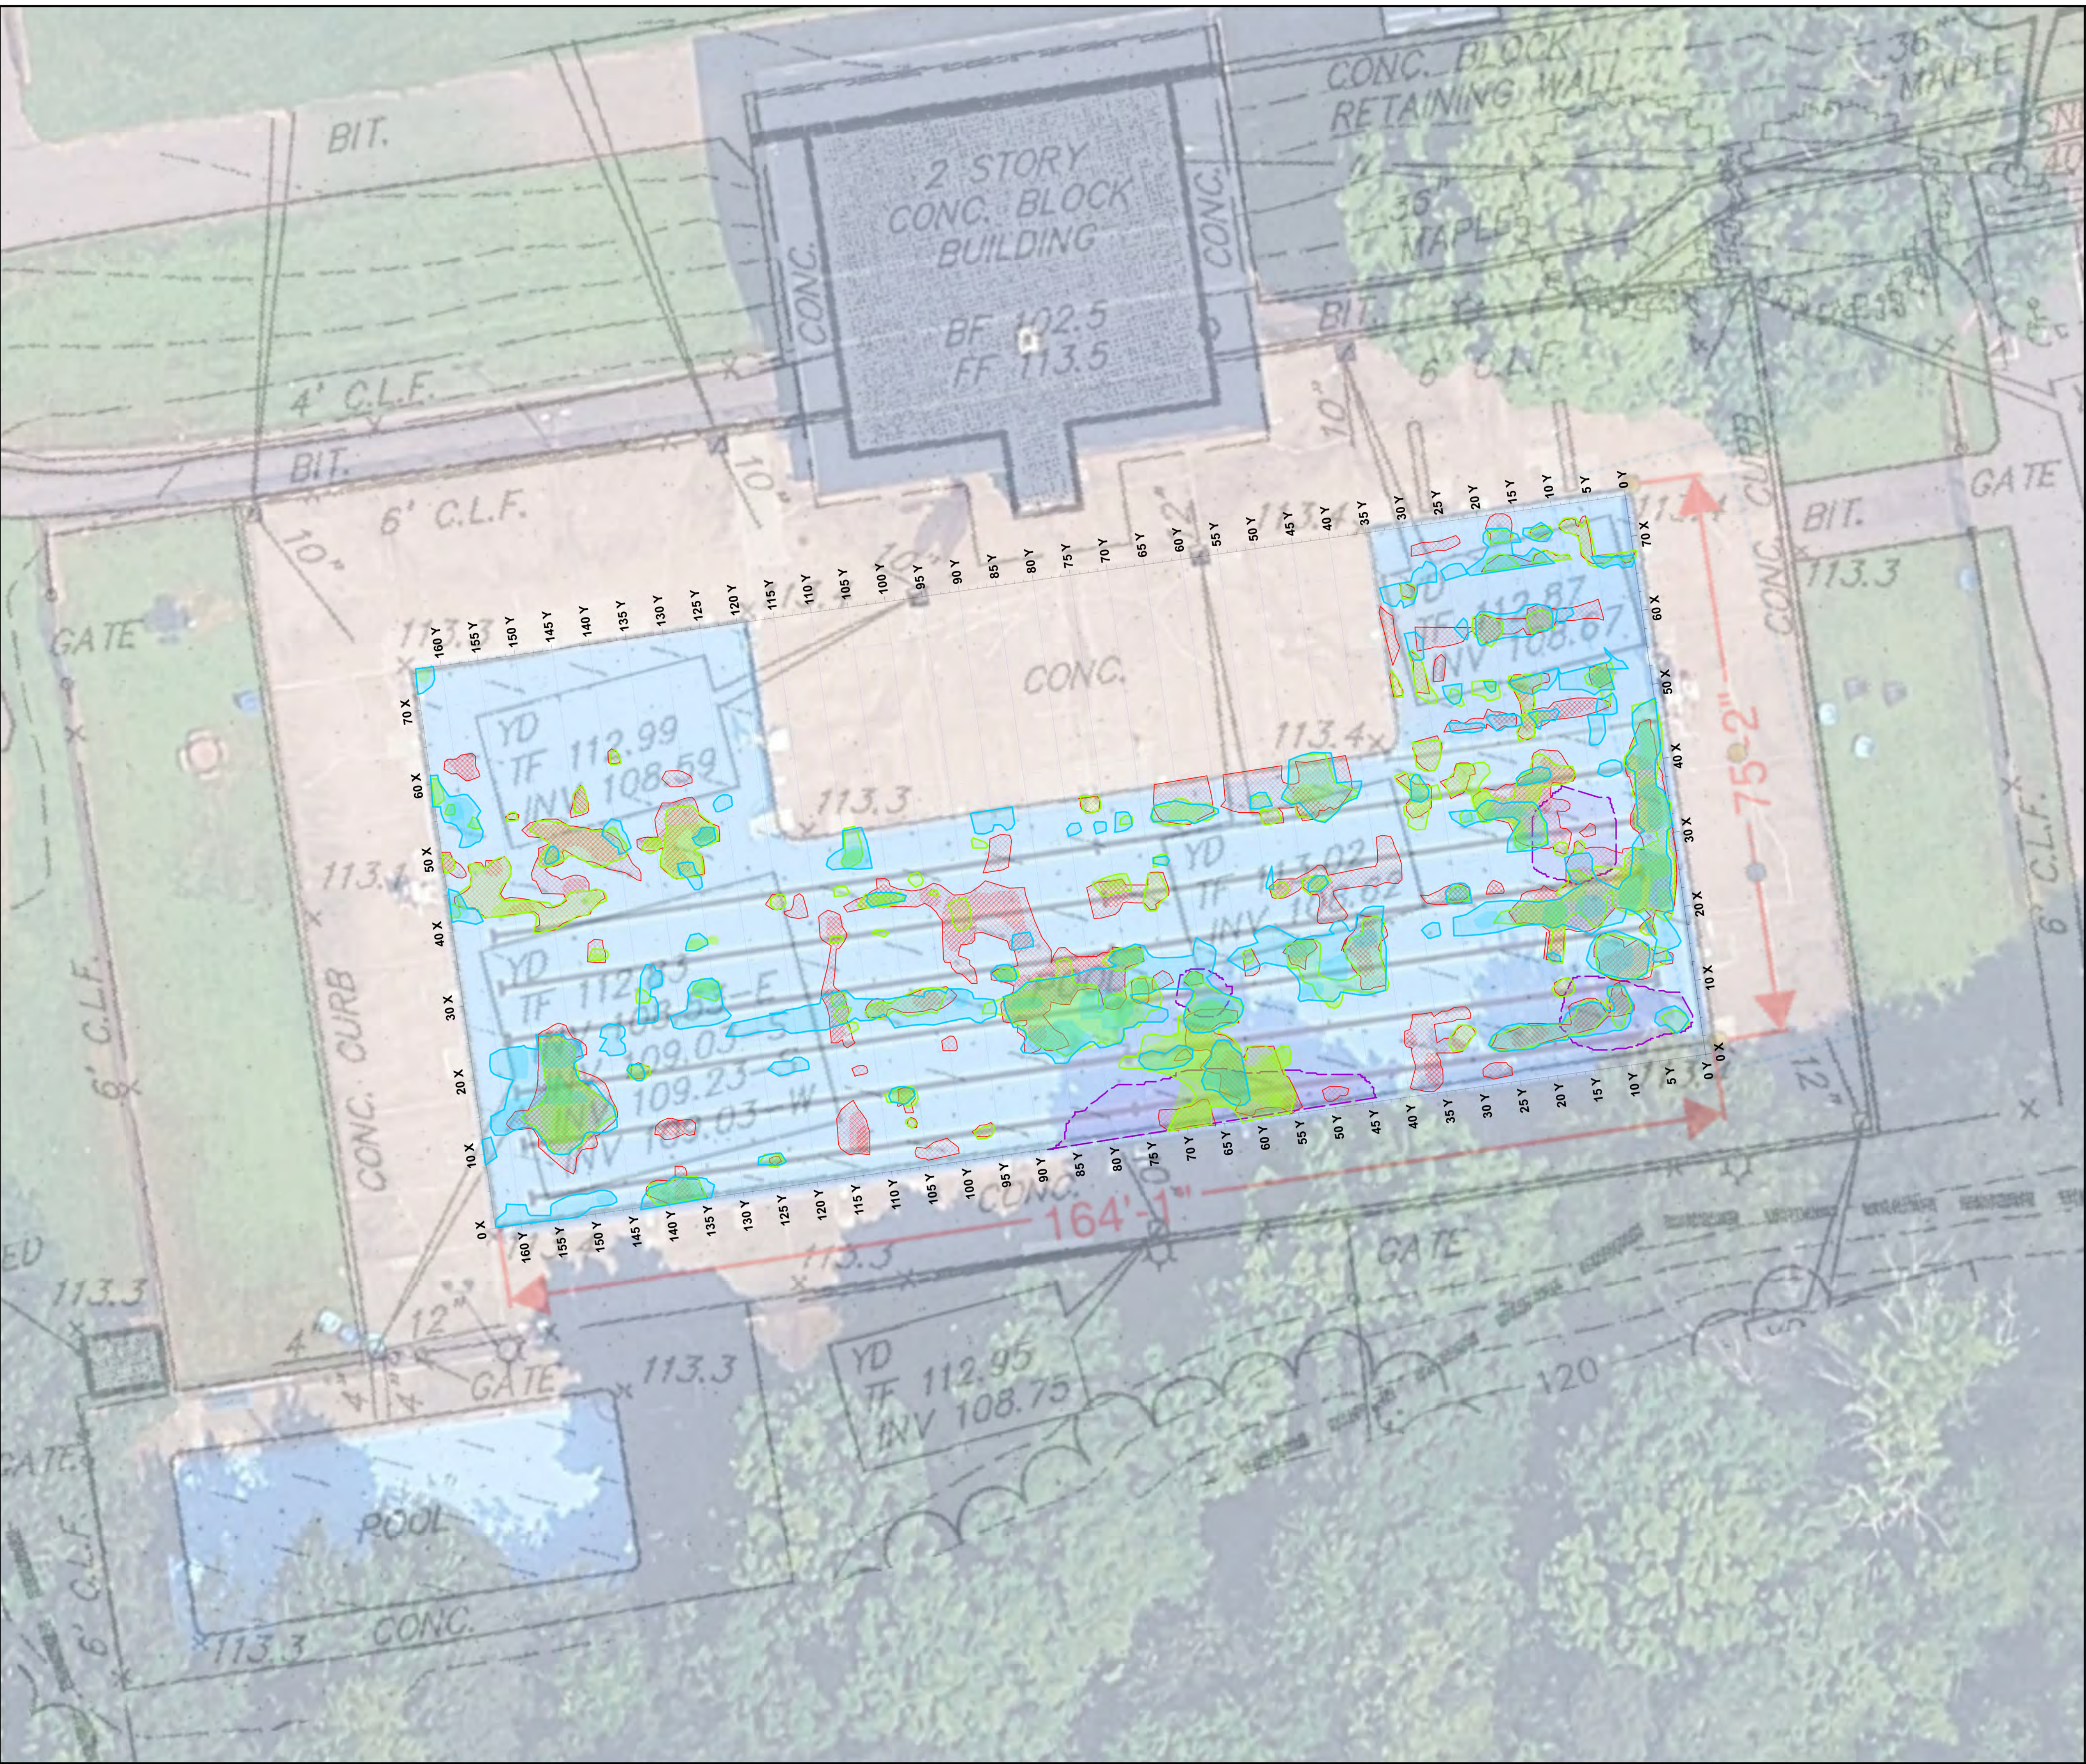
- Zone of High-Amplitude GPR  
Reflections that could indicate  
an area of voiding and/or moisture  
accumulation, or structural steel,  
if linear
- Concentration of possible voids,  
loosely packed soil and moisture  
accumulation observed 0-3 feet  
below grade. Deeper shading  
indicates a more dense concentration  
and greater vertical extent of potential  
voids
- Concentration of possible voids,  
loosely packed soil and moisture  
accumulation observed 3-6 feet  
below grade. Deeper shading  
indicates a more dense concentration  
and greater vertical extent of potential  
voids
- Concentration of possible voids,  
loosely packed soil and moisture  
accumulation observed 6+ feet  
below grade. Deeper shading  
indicates a more dense concentration  
and greater vertical extent of potential  
voids

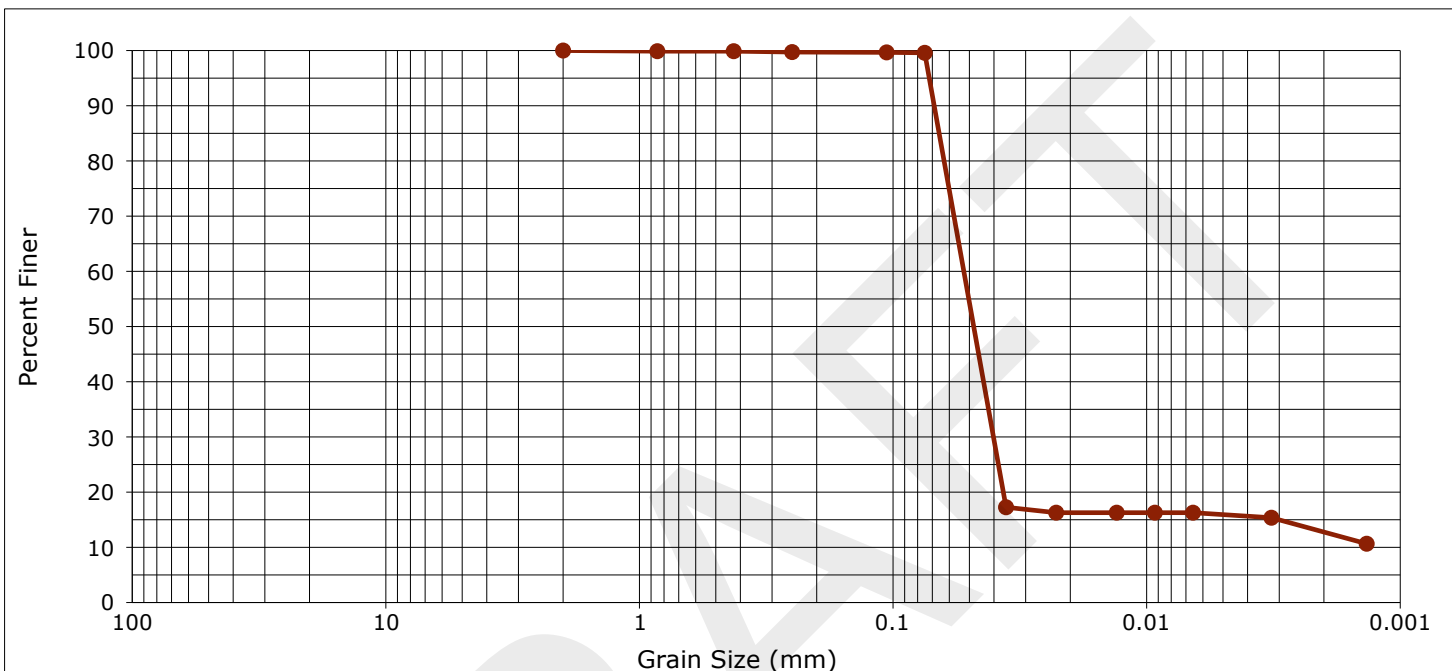
Spec. Location	Description	% Cobbles	% Gravel	% Sand	% Fines	% Silt	% Clay	USCS
B-16/S6 15'-17'	Silt	0.0	0.0	0.4	99.6	83.7	15.9	ML

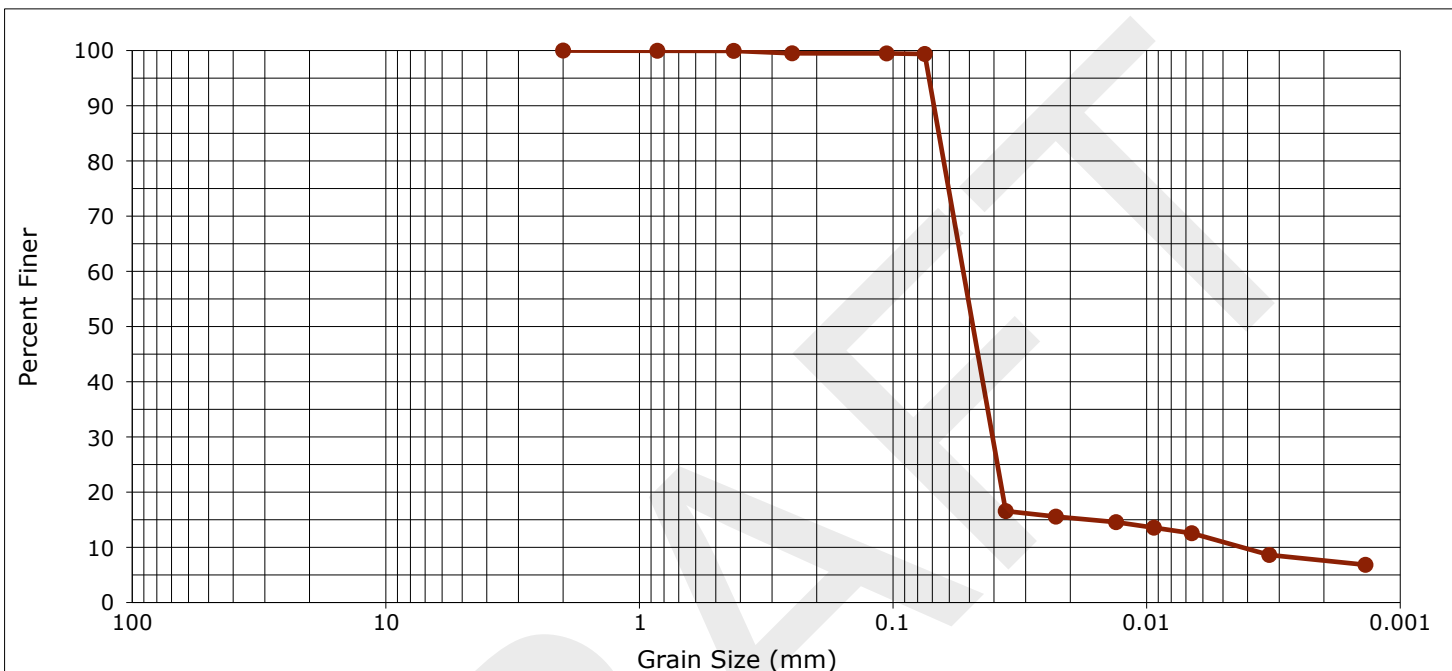
Spec. Location	Description	% Cobbles	% Gravel	% Sand	% Fines	% Silt	% Clay	USCS
B-16/S8 25'-27'	Silt	0.0	0.0	0.6	99.4	88.4	11.0	ML
