## Mill Pond Park Pool Evaluation

Town of Newington  
131 Cedar Street  
Newington, CT 06111

March 2013

## **ENGINEERS REPORT**

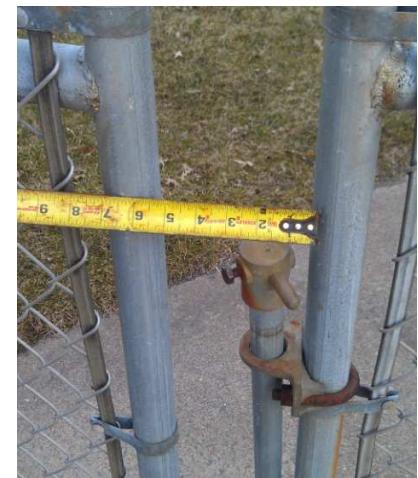
The fence around the pool is galvanized, but is starting to show signs of rust. The fence is bent in some areas and has large gaps. The gaps between vertical members and between the ground and the bottom of the fence cannot be greater than 2-inches. (Figure 10)

Figure 10 – Fence gate

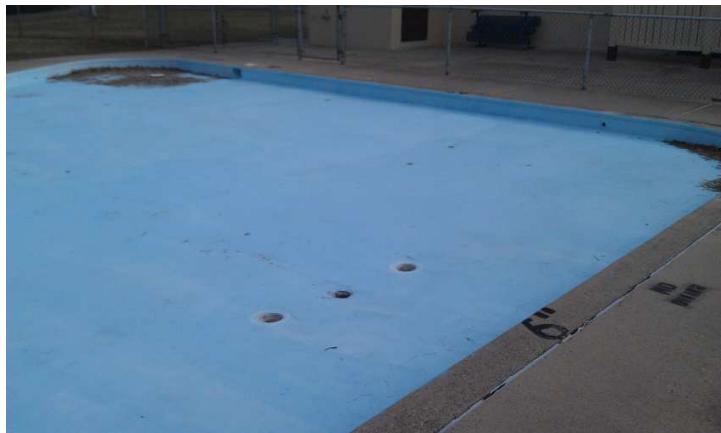
Figure 16 – Wading pool

The wading pool contains approximately 6,500 gallons. Water in the wading pool is circulated with a 1.5hp pump and filtered with a duel filter arrangement. The majority of the concrete shell appears to be in good shape with minimal cracks. As with the main pool, the caulking joints in the deck and coping around the wading pool are cracked.

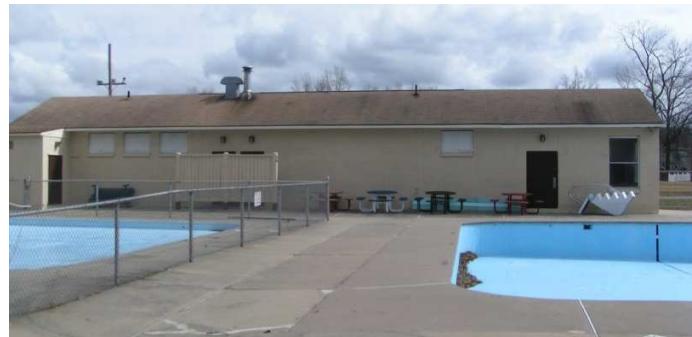
Figure 20 – Rear of bathhouse

The exterior CMU block walls on both buildings are painted. The masonry joints need to be caulked or repointed in numerous areas. There are a handful of holes in the CMU block on the outside of the building that should be filled with mortar or caulk. The holes may be from old piping or conduit. Some of the joints on the filter building show traveling cracks. (Figure 22)

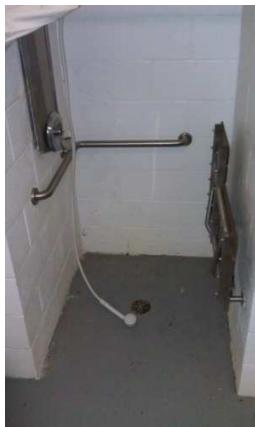
The bathrooms are not ADA accessible and will need to be made compliant if any major renovations are made. A handicap shower is available (Figure 23), but does not have a private enclosure for a wheelchair bound person. In multiple locations, such as the main entrance, there is greater than a  $\frac{1}{4}$ -inch bump in floor elevation. Floor transitions between rooms must be smooth. The four other showers share two floor drains. Each shower floor must be pitched so that water does not pass from one bather to another. It appears the original floor was not pitched correctly in the vicinity of the showers and drainage slits were cut into the floor to reduce puddling. (Figure 24)

Figure 23 – Existing handicap shower

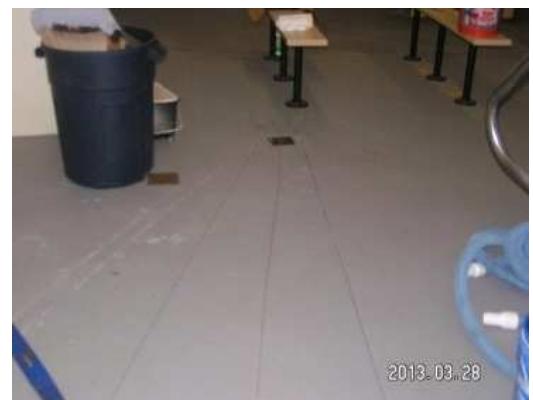
Figure 24 – Floor drains

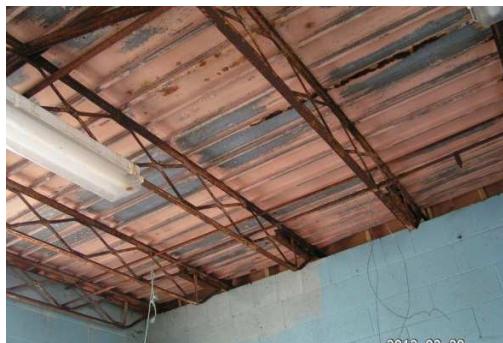
The original building was constructed in 1958 and renovated in 1988 at which time the roof was converted into a gable roof. The building is 90 feet long by 24 feet wide, one-story masonry bearing wall structure and does not have a basement. The original roof framing consisted of 12" deep steel bar joints spaced at 30" on center clear span across the width of the building. (Figure 29)

Figure 29 – Original steel roof structure of filter building

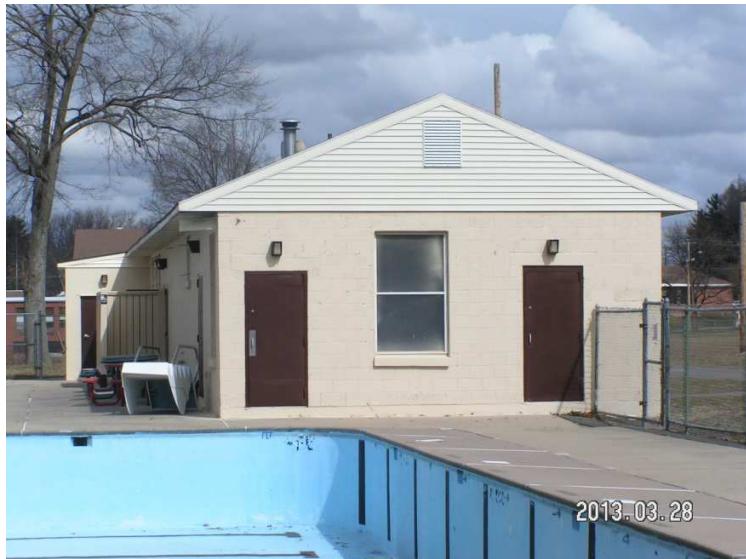
Figure 30 – Side of bathhouse

The 1988 renovation drawings call-off the design loads which are consistent with the snow loads currently required by the Connecticut State Building Code, therefore the framing should be adequate for the anticipated snow loads.
