Mill Pond Park Newington, Connecticut

PRELIMINARY MASTER PLAN

TLB Architecture

01—2013 and 2020 Mill Pond Pool Evaluations

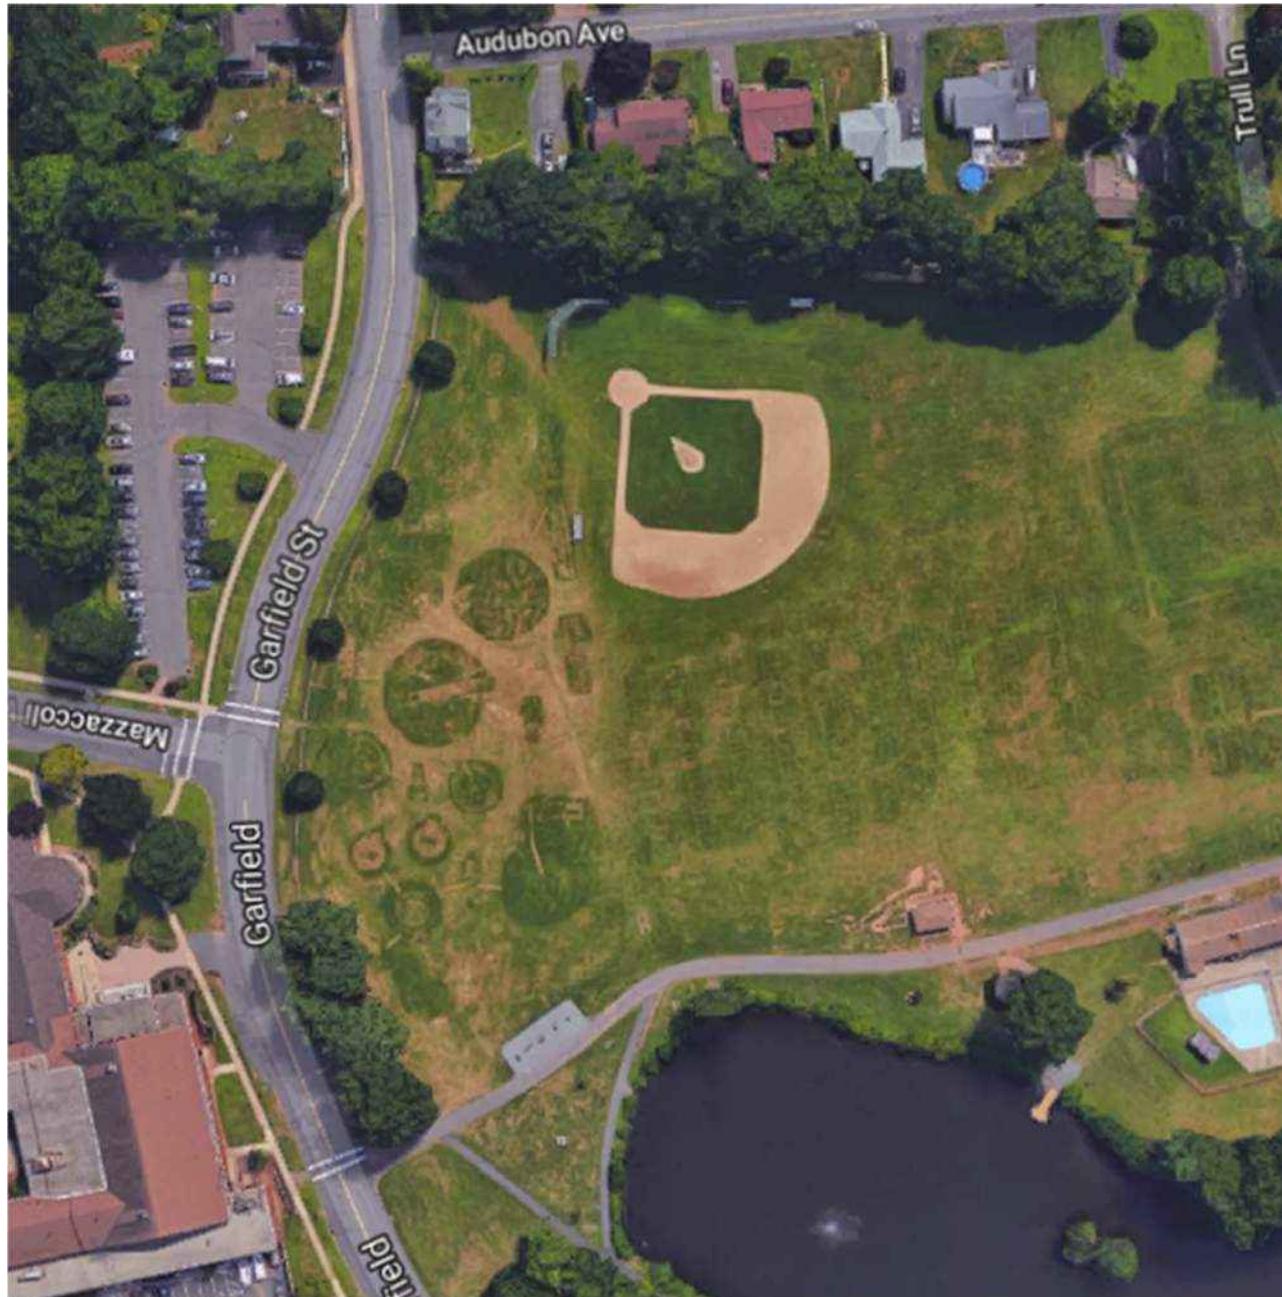
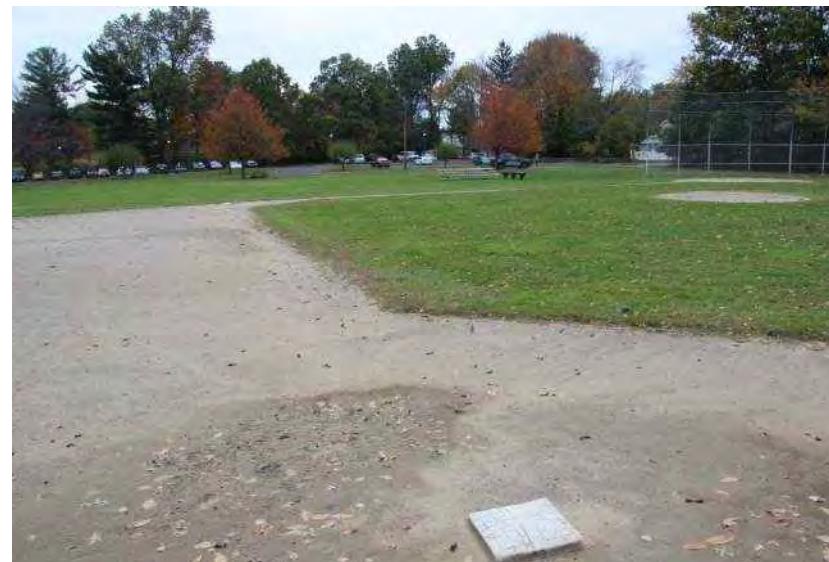
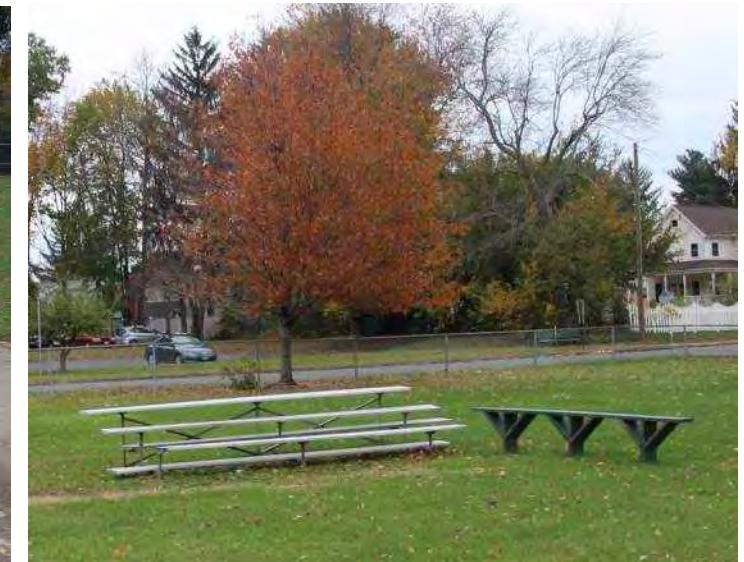
The baseball field currently occupies a significant portion of the Park's open space, east of the pond. It is used by Newington High School Baseball Team as well as other youth and adult recreational teams. The field is in generally good condition, requiring typical maintenance to the pitcher's mound and the lip between the infield and outfield.

The backstop and team benches are reaching the end of their useful life and replacement should be planned for player safety and functionality.

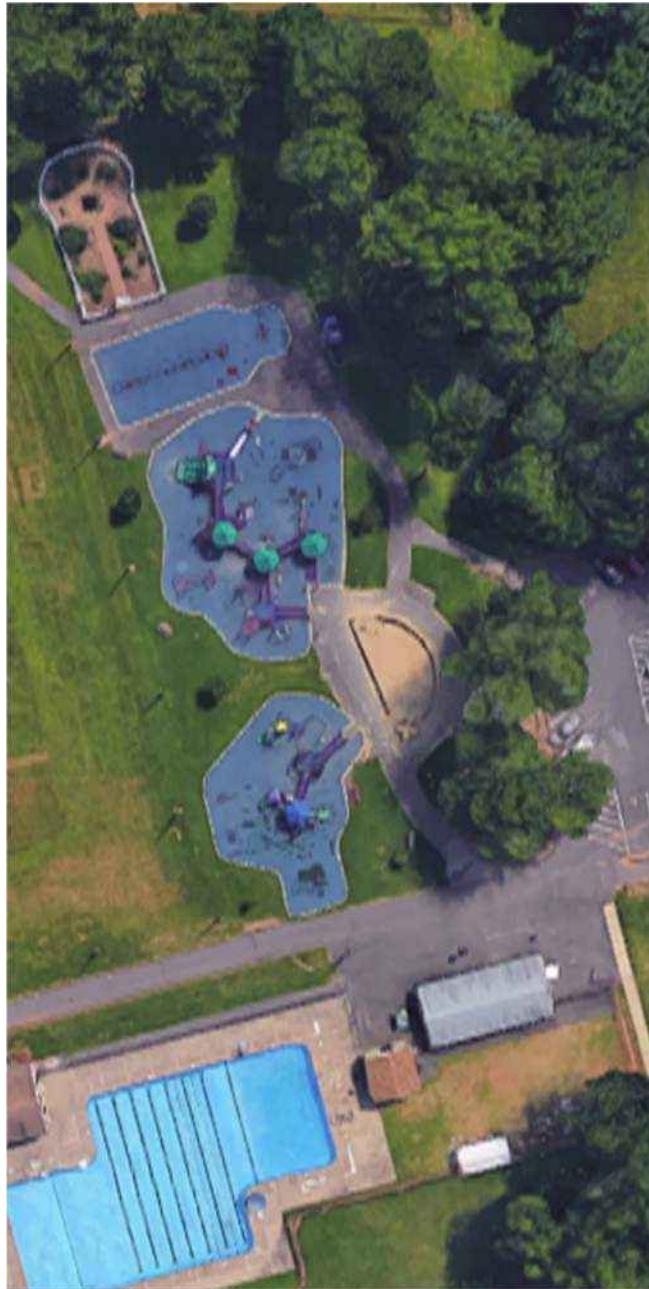
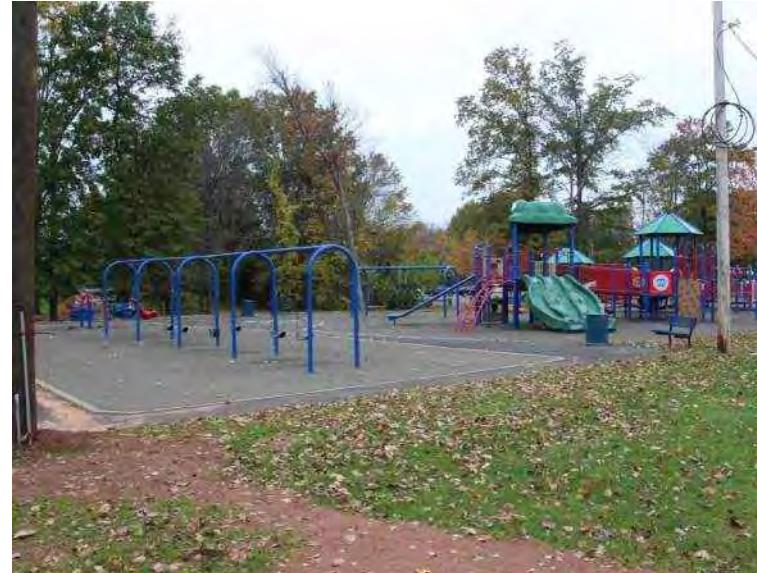
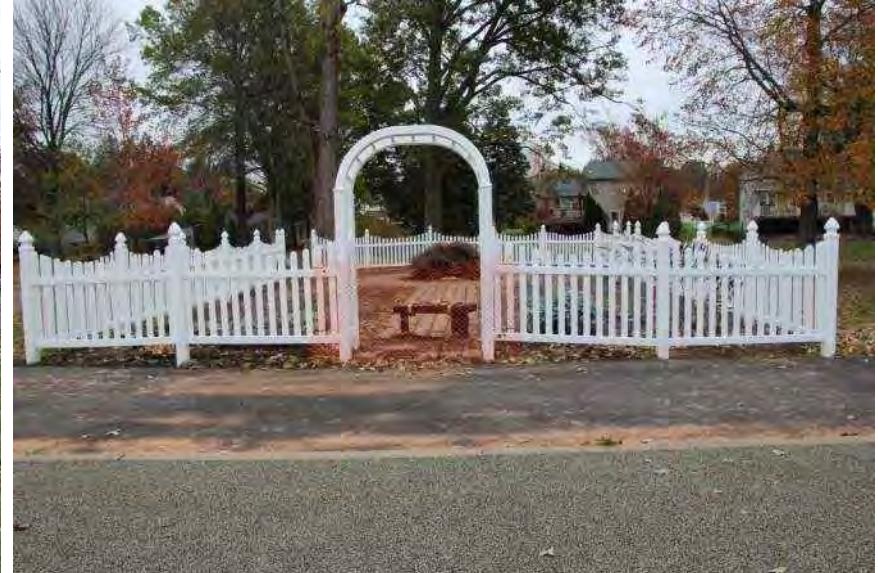
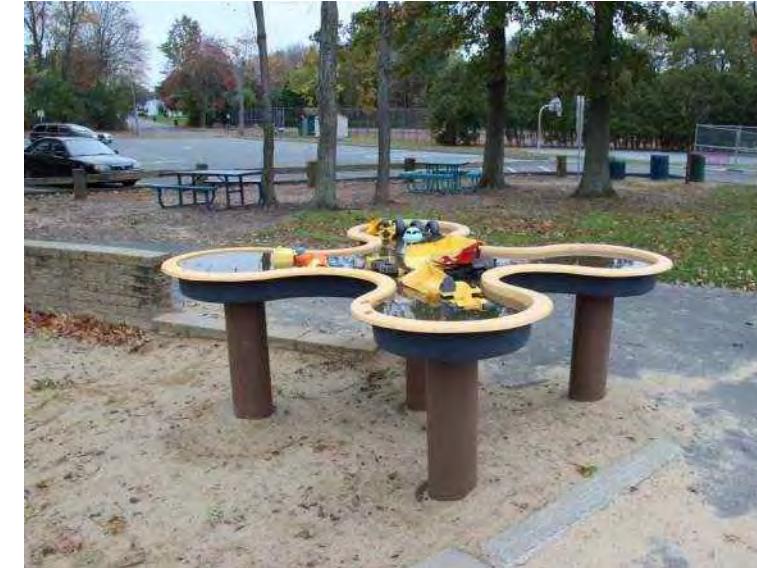
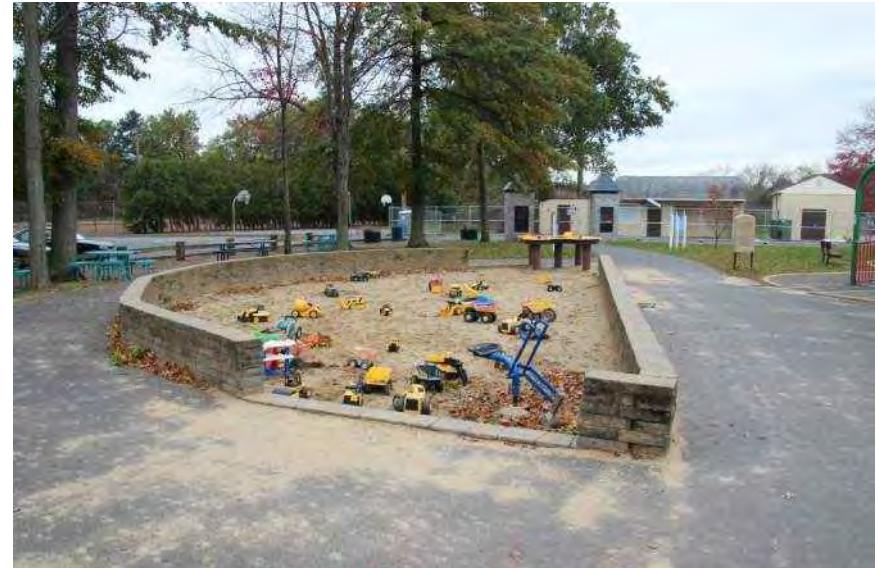
Playgrounds and Sensory Garden

These playgrounds are a heavily used asset within the Park, are in good condition and appear well-maintained. Qualified Town staff should perform safety inspection and make necessary repairs. The need to separate the toddler play area from visible water at the pond should be evaluated further, and fencing added as may be necessary. No work is required as part of this long-range planning effort, except as required for continued safety.

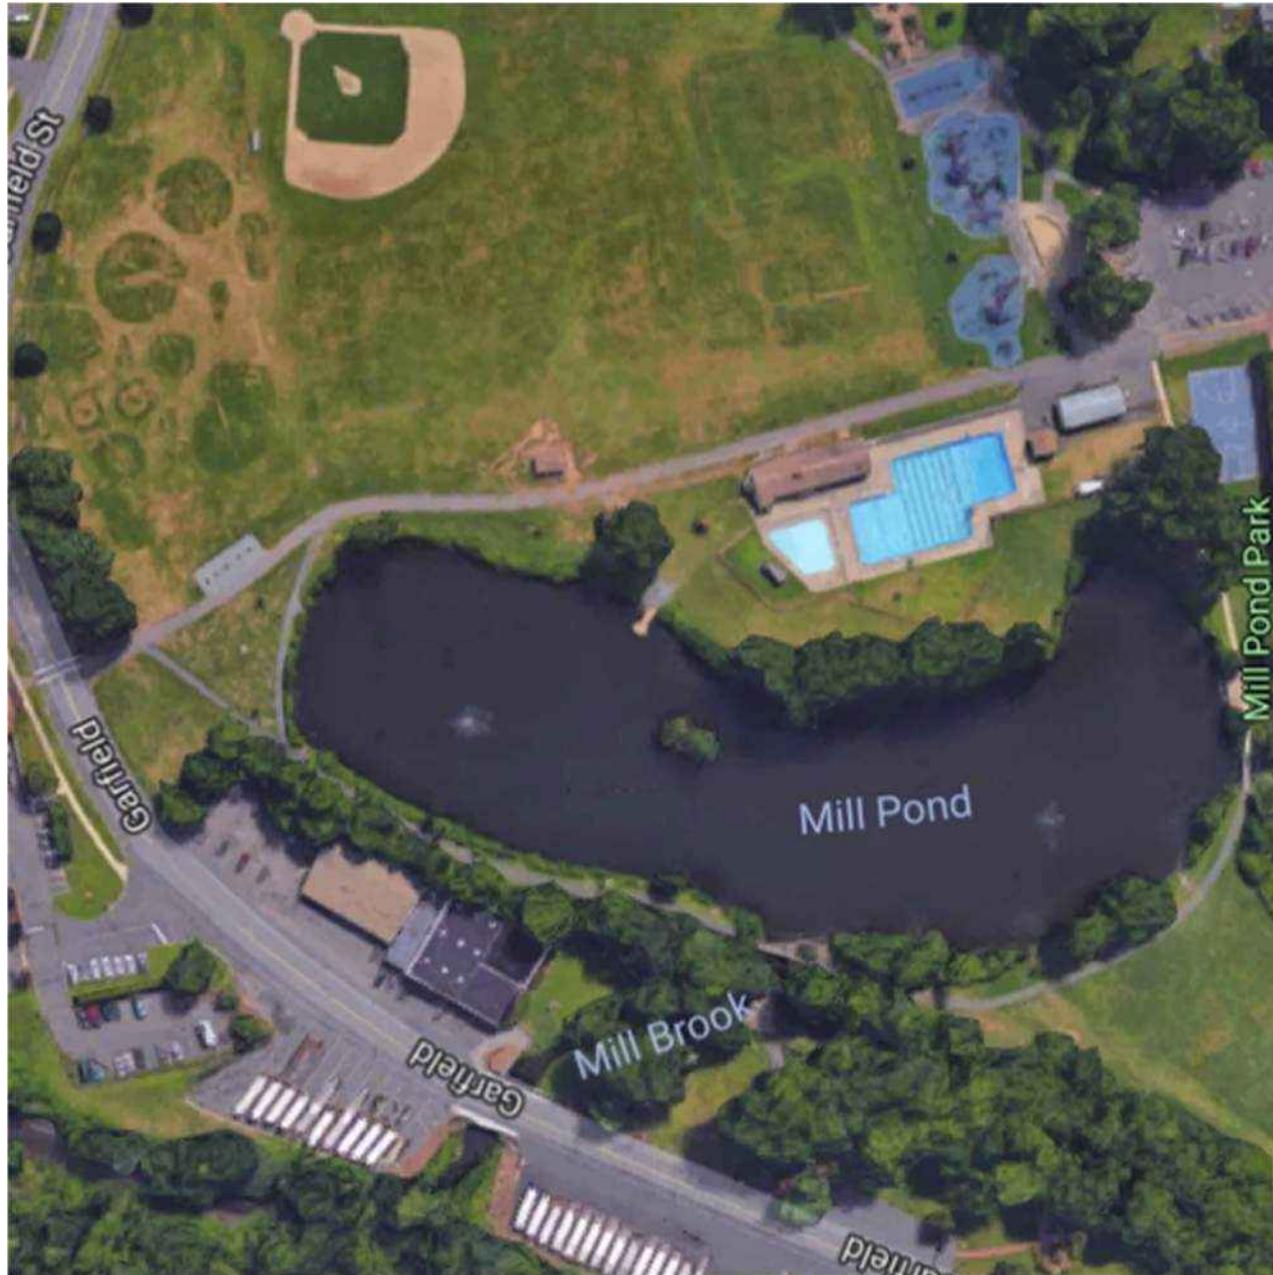
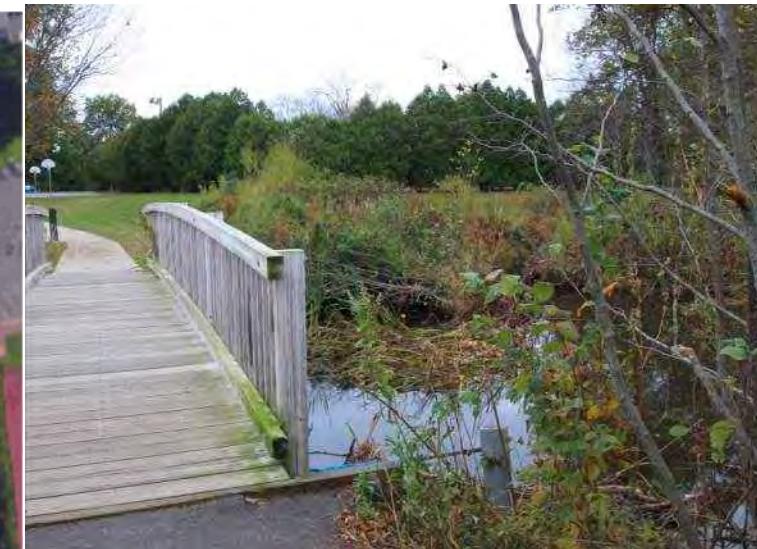
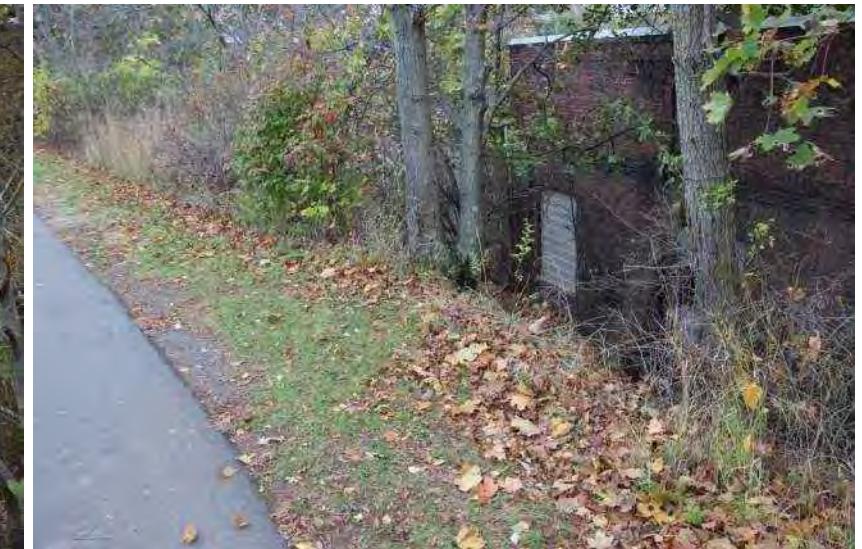
Walking Trails and Bridges

The walkways within the Park are limited to a linear path running from Garfield Street to the parking lot on Browning Street near the Tennis courts, and a loop around the Pond. These walks are bituminous concrete and are in poor condition. The Pond loop includes pedestrian bridges, which appear functional but are not rated for vehicle traffic, limiting emergency and maintenance access to areas of the Park.

There are areas at the west side of the Pond where significant grade changes pose a risk to pedestrians, including a significant drop-off in the area behind the Bus Garage. There is also a risk at the end of the smaller bridge at the south side of the Pond, where guardrails to protect the edge of the walkway, near the culvert.

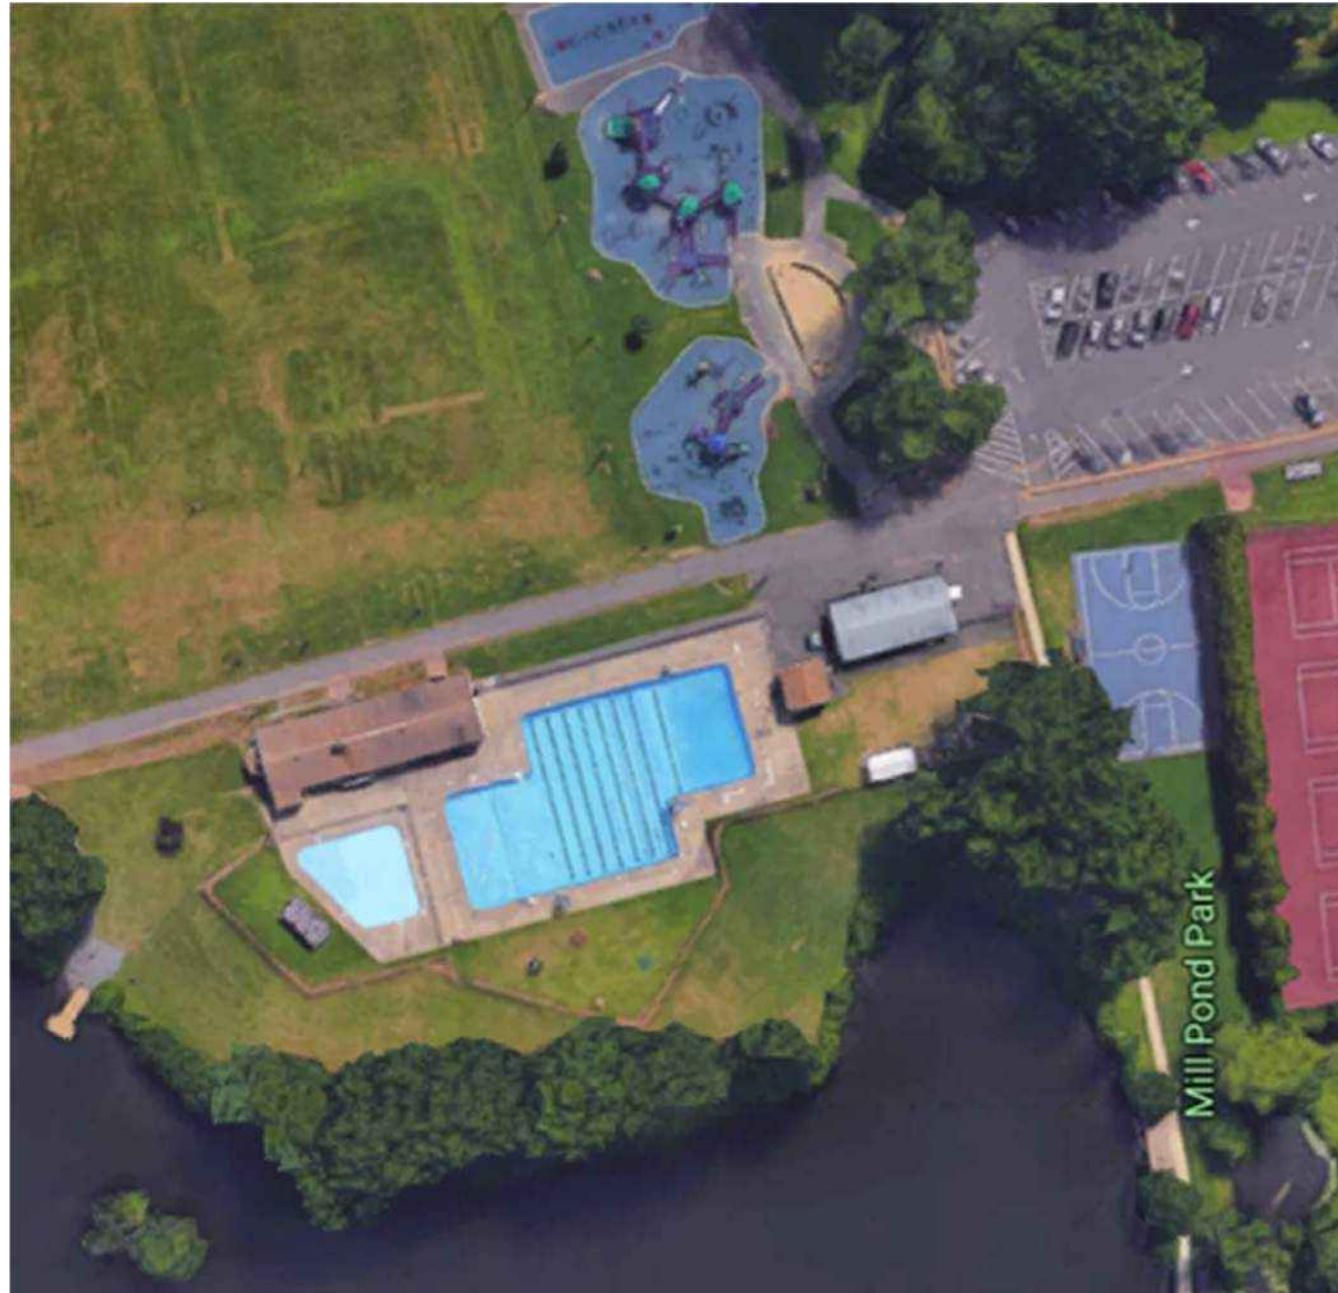
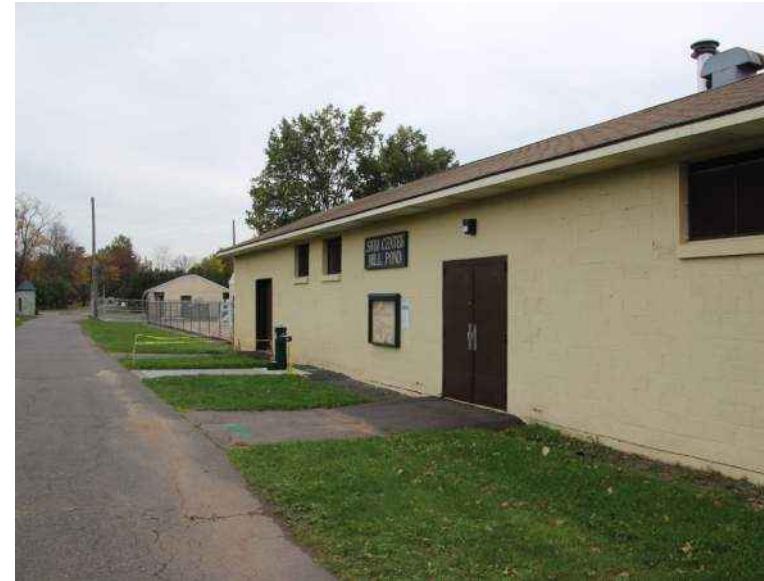
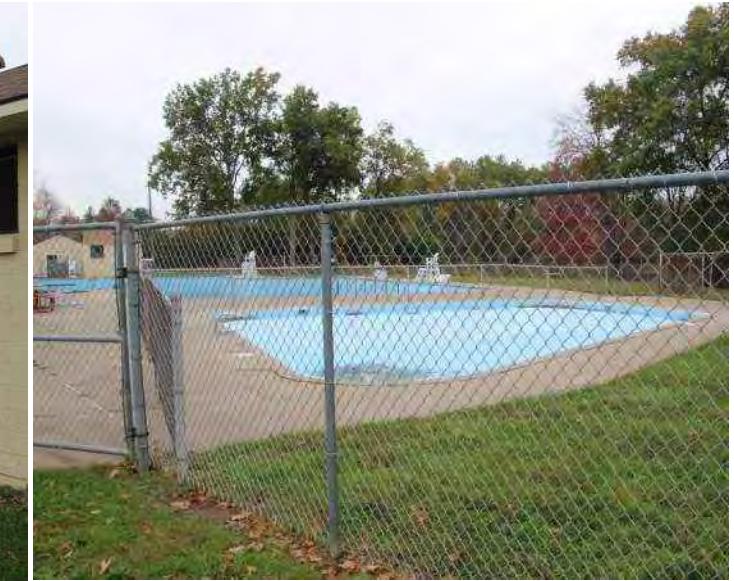
Swimming Pool and Bathhouse

The swimming pool complex consists of a six-lane lap pool with an attached shallow area to the north and an attached diving well to the south. There is also a separate wading pool to the north of the main pool. The pools are served by a masonry bathhouse building and surrounded by chain-link fencing. The pool was constructed in 1959 and renovated in 1999.

The pool has reached the end of its useful life and is in need of complete replacement. While significant renovation is an option, it is not recommended, as the underlying issues with ground water, deteriorated concrete and aging infrastructure can not be reliably repaired for the long-term.

In 2013 a comprehensive conditions assessment was performed, which details deficiencies with the pool. Of note in the study is the potential for PCB remediation, which will require further testing prior to demolition.

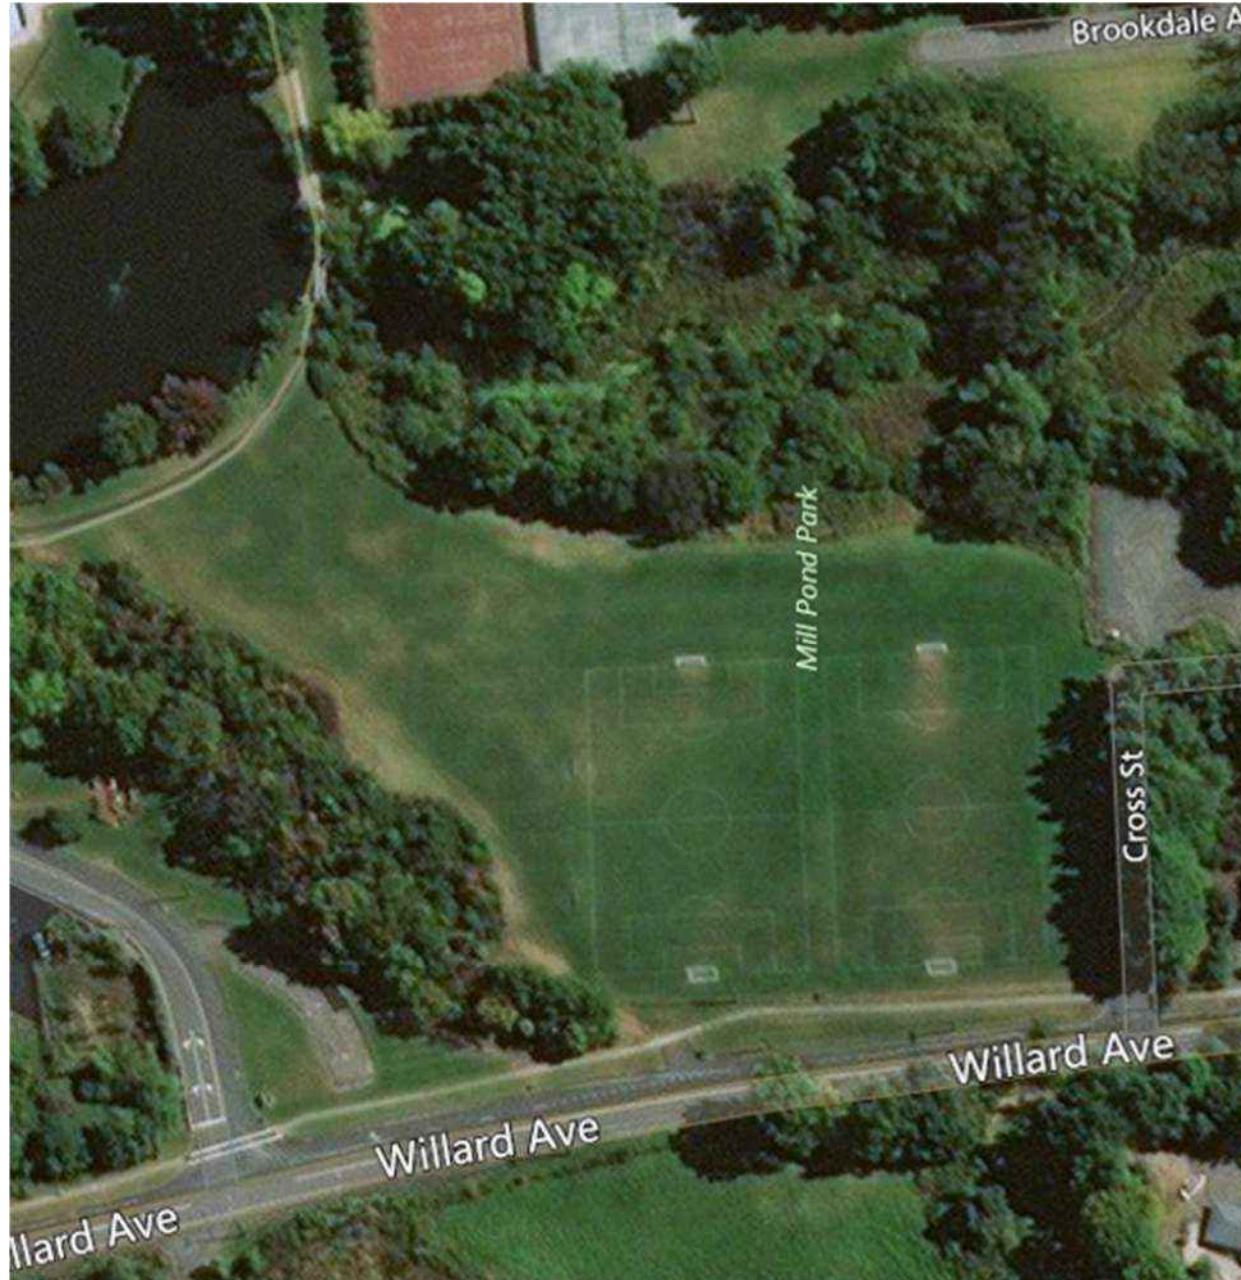
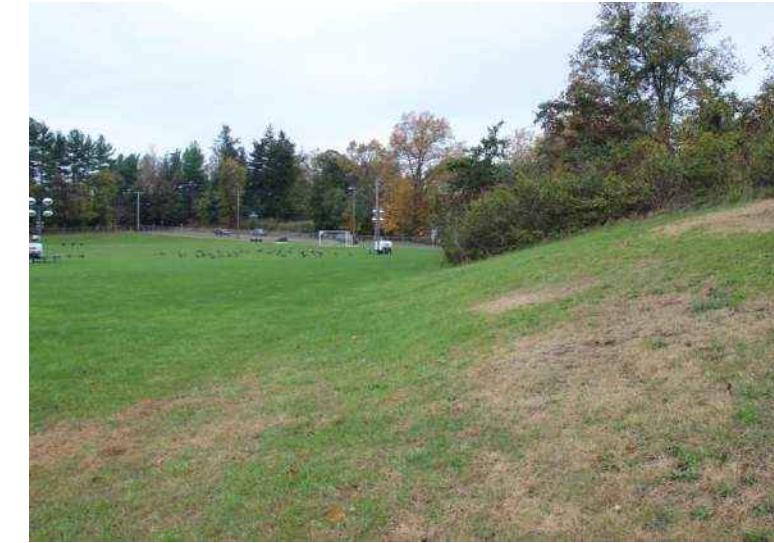
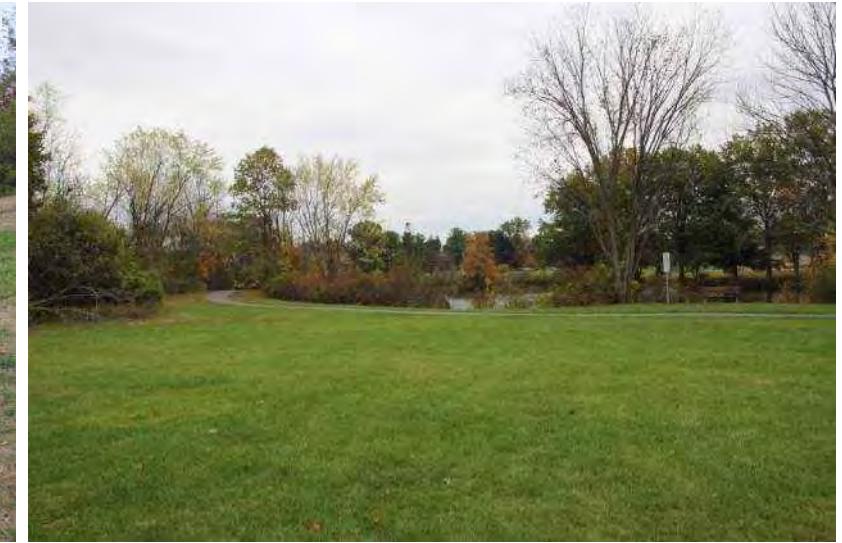
Soccer Fields and Open Space, Southwest

The southwest end of the Park provides open space for two youth soccer fields, near the corner of Willard Ave. and Cross Street. These heavily used fields have access by means of pedestrian sidewalks along Willard Avenue, a small parking lot at the corner of Cross Street and Mooreland Avenue and through a field within the park, off of the Pond Loop walkway.

The soccer fields have recently had an irrigation system installed, but changes to the field orientation may require significant modifications. Currently, there is not sufficient room to shift field striping to mitigate wear patterns.

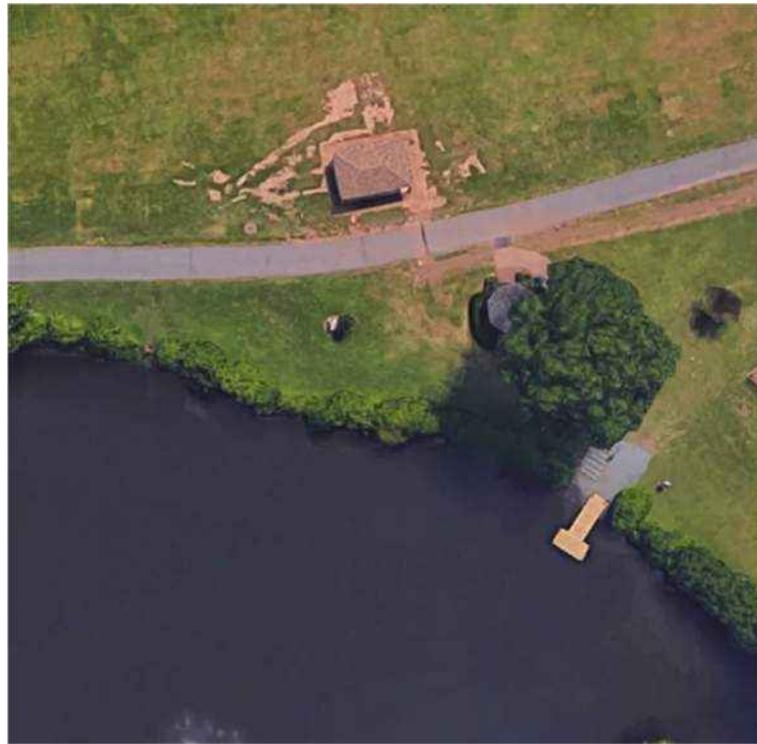
In the area east of the Pond, there are three small structures, including a Gazebo, Pavilion and Dock.

The pavilion serves as a bandstand for concerts in the Park. While functional, it is not ideally located or appointed. With concerts primarily occurring in the evening, the setting sun obscures the view to the bandstand.

These structures should be evaluated in the context of an overall plan and modified or removed as necessary.

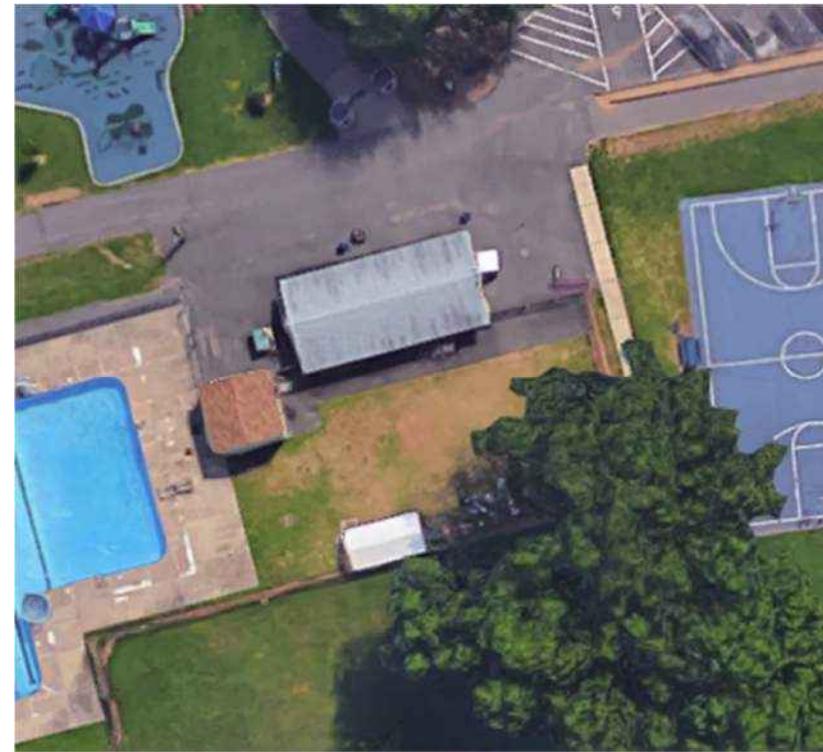
There is a Snack Bar and Toilet Room Building located between the swimming pool and the basketball courts. The building experienced a fire recently, but has been fully reconstructed. It will continue to serve its present use and should be included in the overall planning of the Park.

Additional architectural and programming improvements may be studied to better integrate the building with any new construction. Outbuildings may also be removed if storage is planned into a building addition.

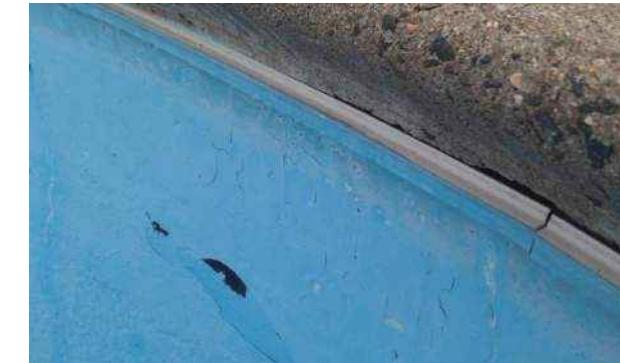
Figure 6 – Peeling paint and PVC joint separation

strip at the top of the pool walls is coming out in places and may be a source of water loss. (Figure 6)

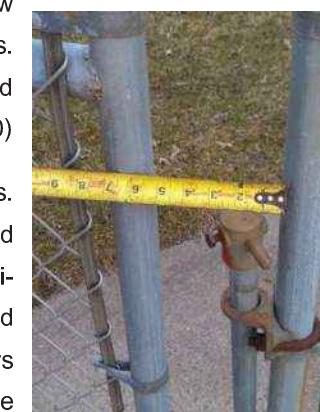
Figure 10 – Fence gate

The fence around the pool is galvanized, but is starting to show signs of rust. The fence is bent in some areas and has large gaps. The gaps between vertical members and between the ground and the bottom of the fence cannot be greater than 2-inches. (Figure 10)

- Repair gaps in fence, and secure loose fence areas.
- Review the inventory of lifesaving equipment and replace or supplement as necessary.
- Modify the main drain piping to keep water velocity flow rates under the rating on the Virginia Graeme Baker covers. This may conflict with CT pool guidelines, but is the only short-term solution.
- Remove the existing diving boards, and install smaller up to date boards that are compliant with the deep end dimensions.
- Replace depth markings.

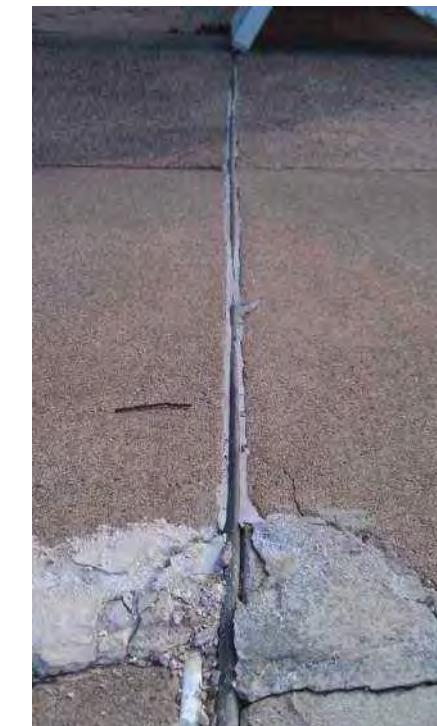
Figure 11 – Copper pipe for handicap lift

Pool staff reports new handicap lifts will be ordered for the upcoming season. The lifts will be hydraulic portable units, which need to be permanently anchored to meet ADA requirements (even though they are portable). This pool used to be equipped with a permanently mounted hydraulic (water powered) lift. The same connection can be used. The copper pipe connecting the lift was installed in an expansion joint in the concrete. The copper pipe is above the caulking and sticking out of the ground in areas. (Figure 11)

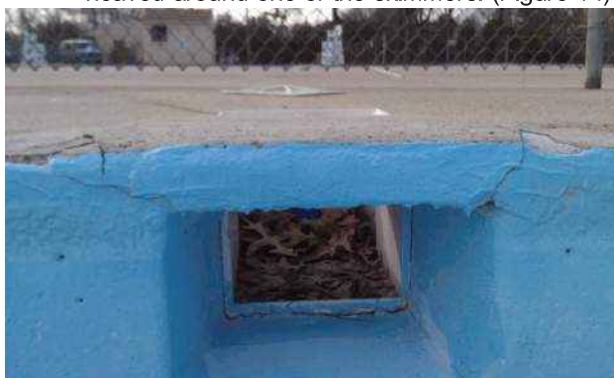
Figure 14 – Wading pool cracked coping above skimmer

The concrete coping is cracked in areas and has heaved around one of the skimmers. (Figure 14) The

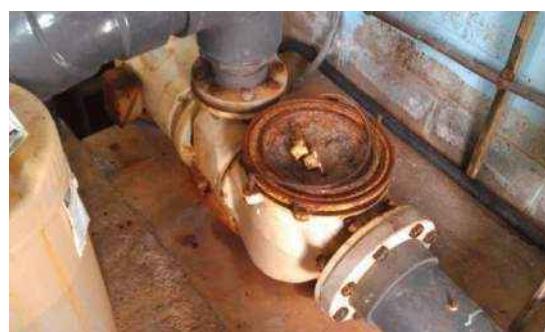
Figure 19 – Main pool pump

General corrosion inside the equipment room is apparent. Electrical panels, the pump, pipe flanges, and flange hardware are corroded. The paint on the cement block walls is delaminating (either from cement deterioration, moisture, or chemical exposure). Improved ventilation will reduce corrosion. A copper water pipe is not securely attached to the wall and is free to vibrate.

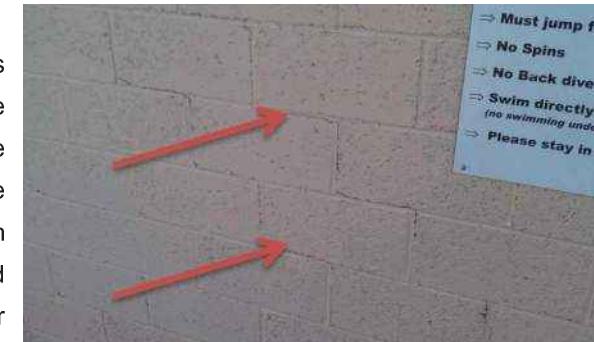
Figure 22 – Traveling cracks on filter building

The exterior CMU block walls on both buildings are painted. The masonry joints needs to be caulked or repointed in numerous areas. There are a handful of holes in the CMU block on the outside of the building that should be filled with mortar or caulk. The holes may be from old piping or conduit. Some of the joints on the filter building show traveling cracks. (Figure 22)

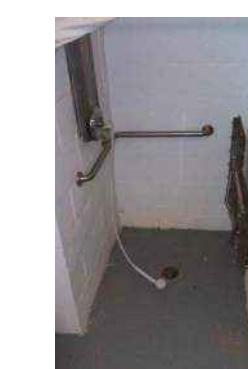
Figure 23 – Existing handicap shower

The bathrooms are not ADA accessible and will need to be made compliant if any major renovations are made. A handicap shower is available (Figure 23), but does not have a private enclosure for a wheelchair bound person. In multiple locations, such as the main entrance, there is greater than a 1/4-inch bump in floor elevation. Floor transitions between rooms must be smooth. The four other showers share two floor drains. Each shower floor must be pitched so that water does not pass from one bather to another. It appears the original floor was not pitched correctly in the vicinity of the showers and drainage slits were cut into the floor to reduce puddling. (Figure 24)

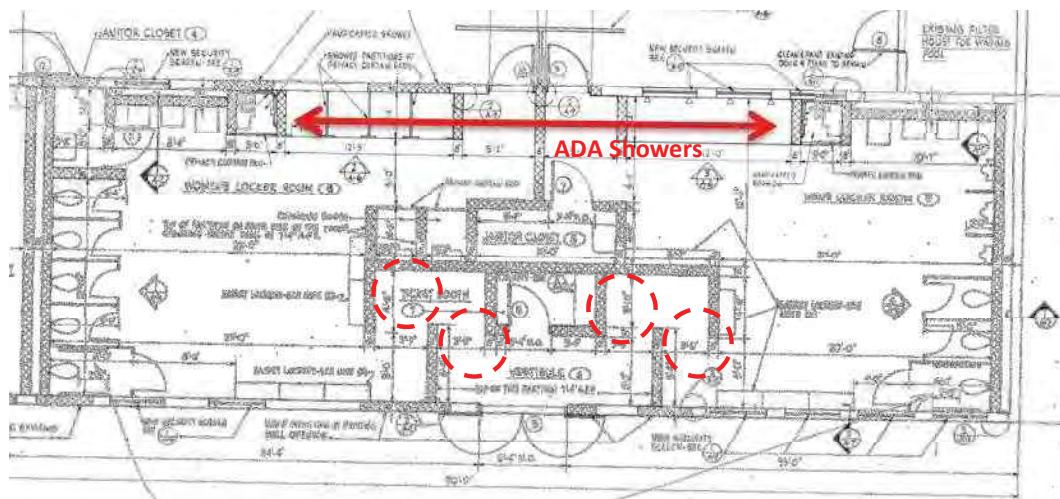
Figure 25 – ADA issue areas (showers and insufficient turning radiiuses)

A clear 5' of width is required at all turning points for wheelchairs. (Figure 25)

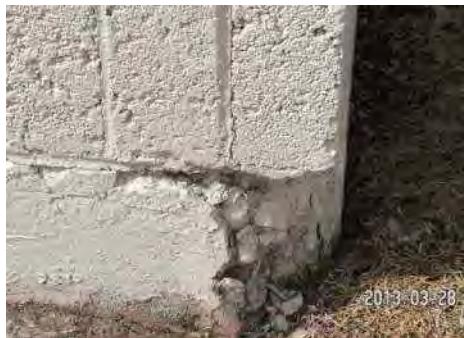
Figure 31 – Foundation spalling

The foundation is experiencing some cracking and spalling of concrete at the northeast corner of the building. (Figure 31) The threshold at the patron's entrance at the rear double door does not

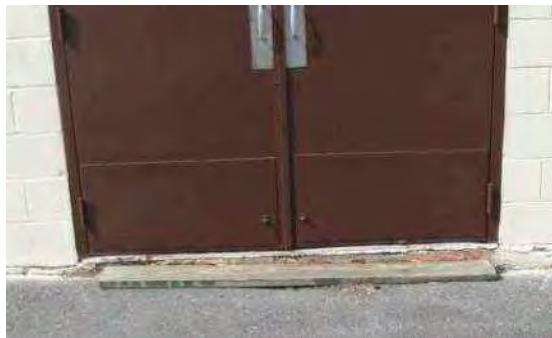
Figure 32 – Bathhouse entrance trip hazard

meet ADA due to the finish grade of the bituminous walkway. There is a loose 2x plank used to mitigate the change in elevation, which poses a tripping hazard. (Figure 32)

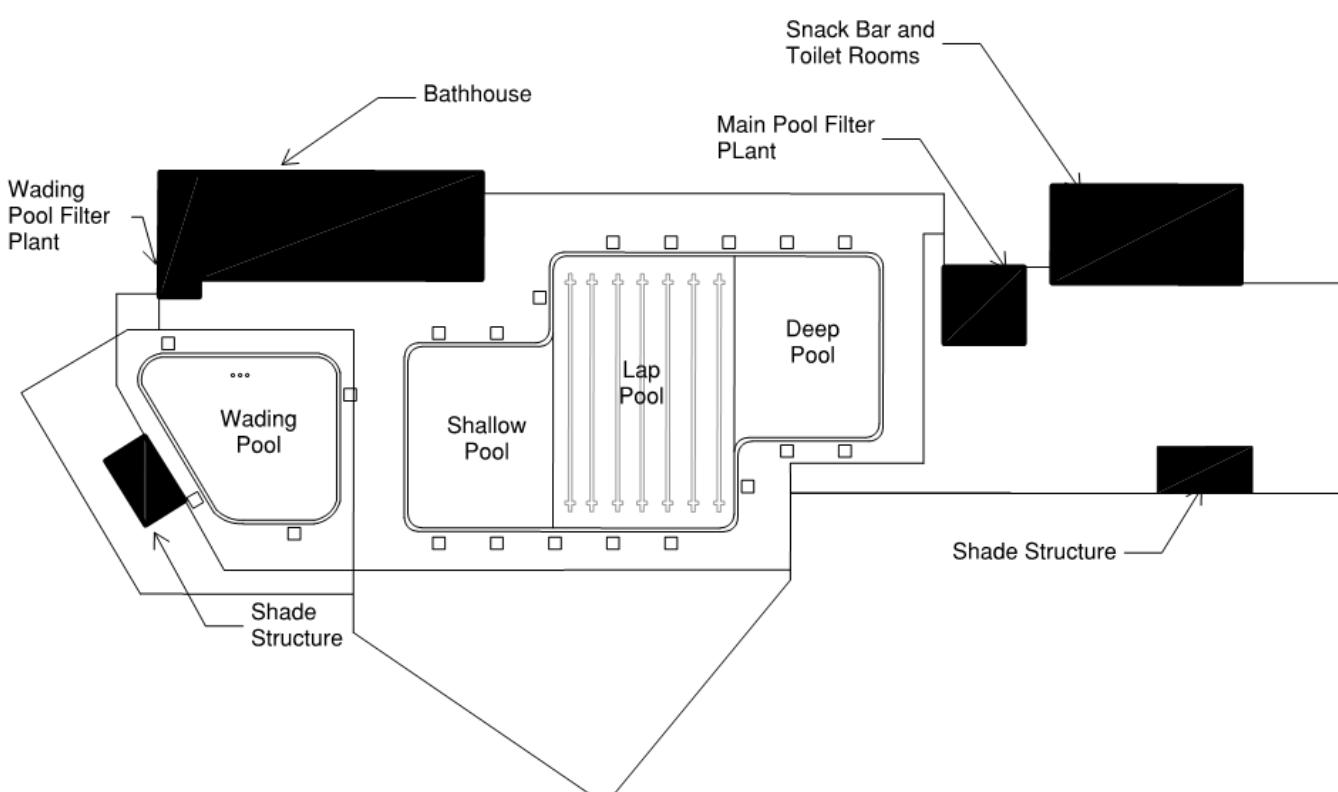
The pool perimeter is surrounded by a six-feet high, galvanized chain-link fence, with the portion separating the wading pool from the main pool standing 4-feet high. This outer perimeter fence provides a complete enclosure, using the bathhouse and filter building as a portion of the enclosure. It is in poor condition with significant rusting, misalignment and gaps exceeding allowable dimensions, both between posts and to grade below the fencing.

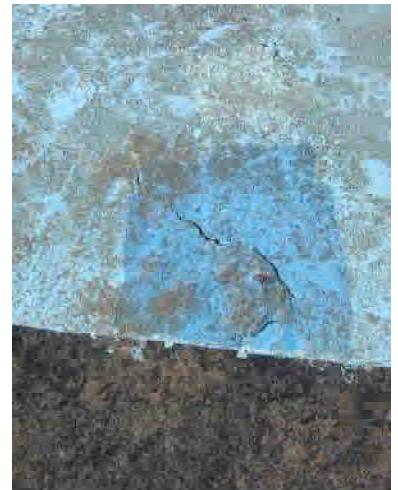
Previously repaired areas in pool floor with failure of repair materials

Many of the spalled areas and delaminated areas occur along cracks, which means water penetration is prevalent. In this pool, particularly in the deeper end, water is leaking out of the pool, but groundwater is pushing into the pool. This limits water loss as pressures are equalized, but saturates concrete and cause the deterioration seen throughout the pool.

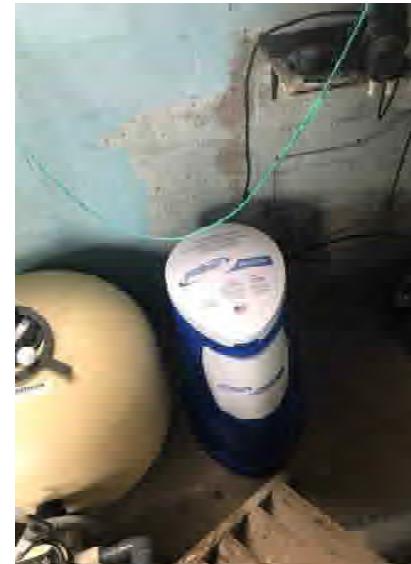
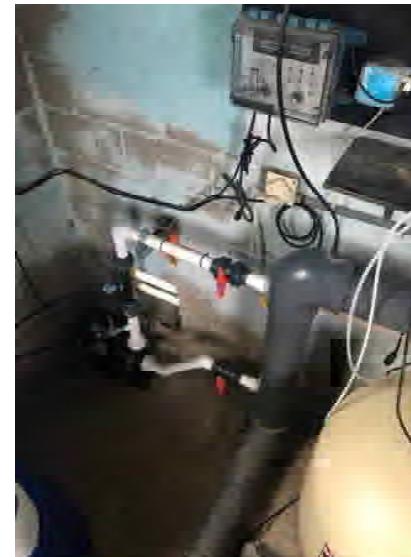
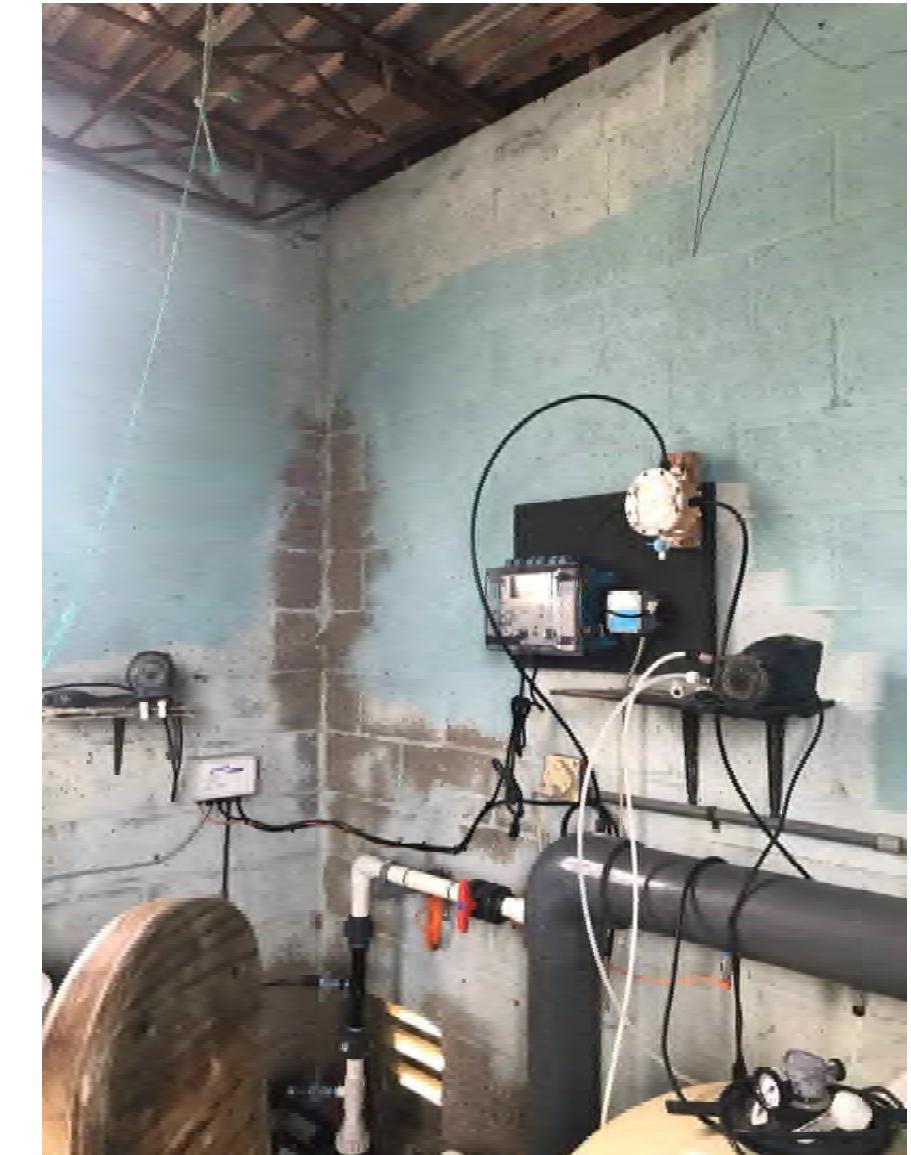
Pool water chemistry is maintained through an automatic water chemistry controller (AQUASOL). This system includes a flow-cell that monitors pool water conditions and adds chlorine for sanitizing and corrects pH by introduction of acid. This occurs continuously.

Water sanitizer is a calcium hypochlorite erosion feeder (Pulsar). pH correction is liquid acid, fed into the system through a peristaltic pump (Stenner). This system is appropriate and, pending verification that all components are operable, suitable for continued use.

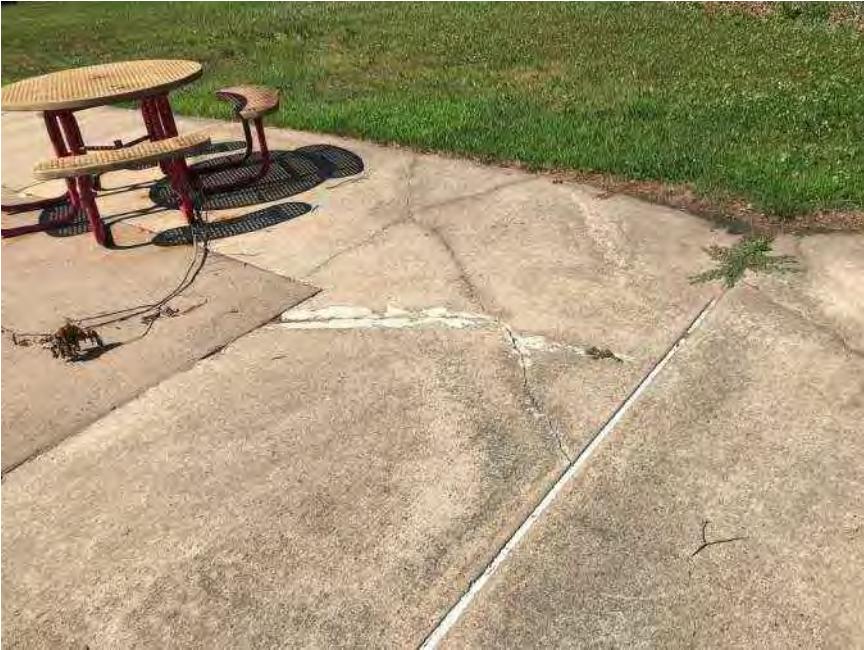
Miscellaneous cracking
